RE: 1164 Rosita Road Tree Removal Application

Arborist Report

Tree Risk Assessment

1164 Rosita Road Pacifica, CA 94044

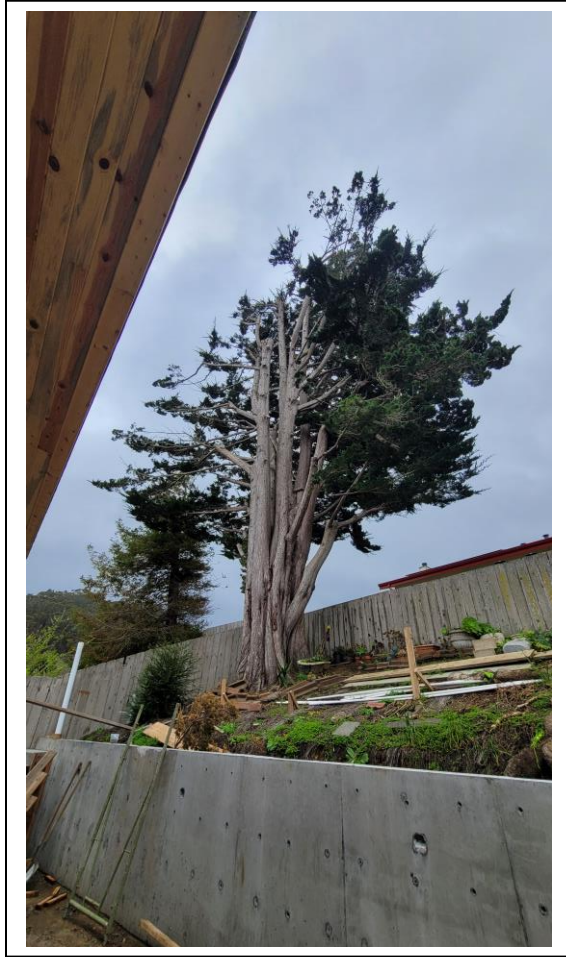
Age and Condition: Over-mature, estimate 70 years old. Fair physiological health, poor structural condition. **There is existing moderate risk of structural failure**, due to size and entirely imbalanced canopy, structural defects, with exposure to high-wind storm events off the nearby Pacific Ocean.

One-sided large cypress with heavy lean and structural defects.

Considering the compromised structural condition of the subject tree (structural defects and root-zone excavation), there is risk of structural failure and impact on high-value potential targets for a falling tree or tree parts. Tree removal and replacement with a suitable species should be considered.

The recommendation is for pre-emptive hazard abatement, to eliminate the risk of catastrophic property damage and personal injury. Remove and replace with one or two medium-size evergreen trees that are more in scale with the residential site, and will be much safer over the next 20 years or more.

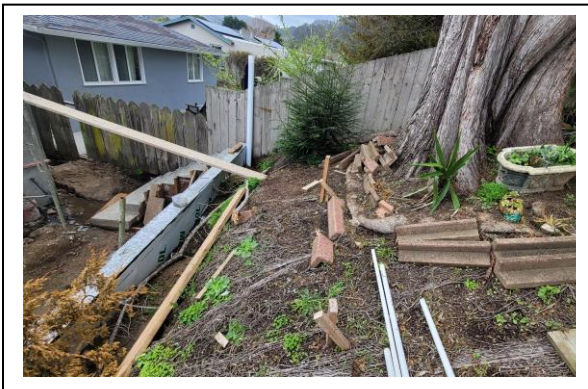
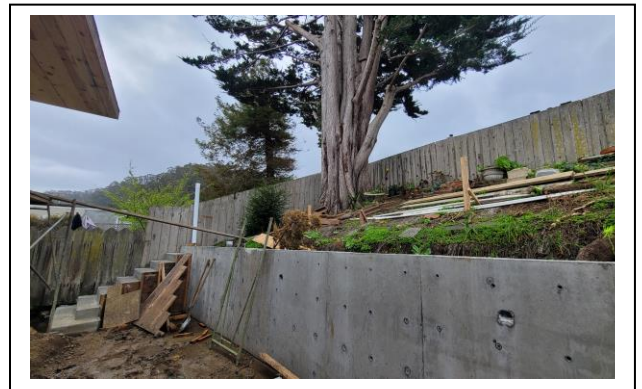
History of the new retaining wall construction and tree root damage impacts are unknown and are a large concern for tree structural integrity. It is obvious that the recommended tree protection zone has been violated and therefore compromised the structural root plate and anchoring capacity.

Compromised root plate. Root cutting at less than eight feet from the tree trunk.

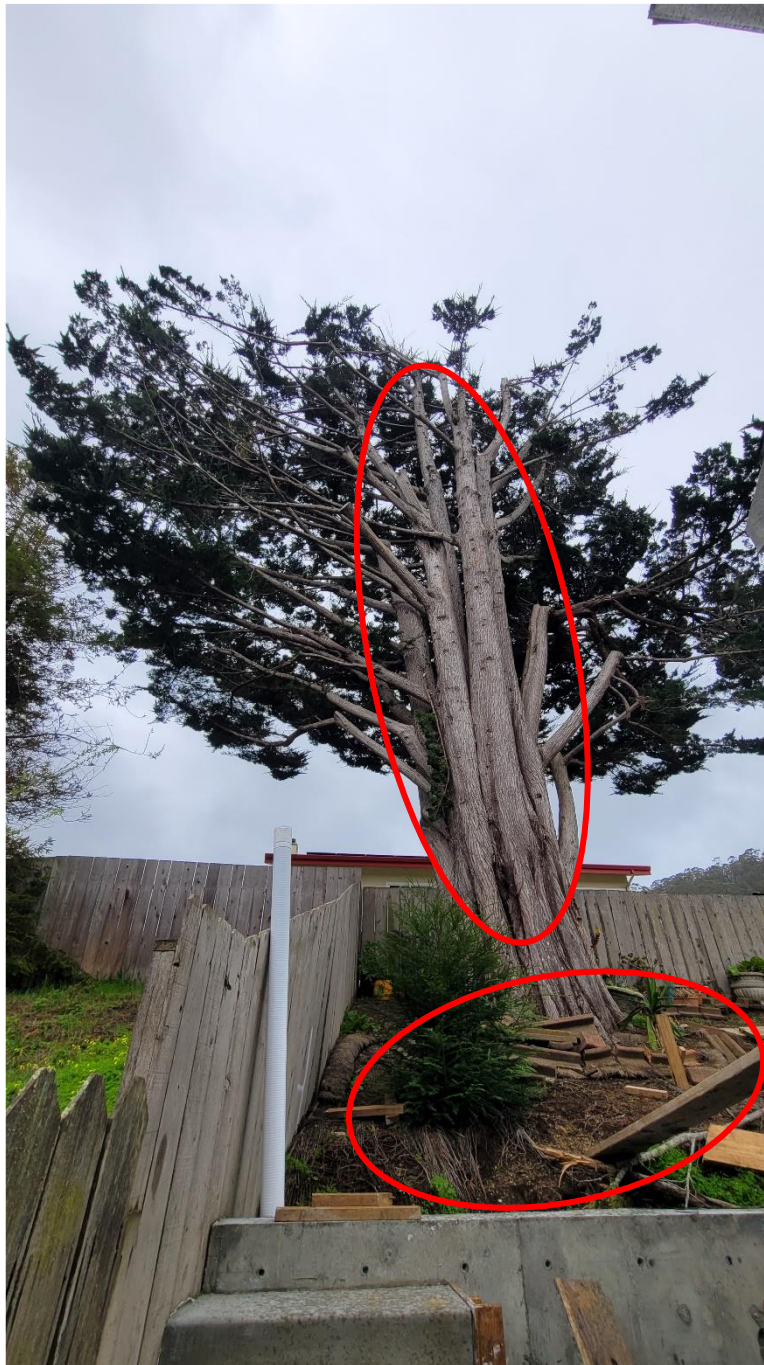
***Leaning one-sided tree with multiple co-dominant stems – prone to failure
Compromised structural root zone***
