Pacifica Municipal Fishing Pier

2023 Condition Assessment Report

City of Pacifica

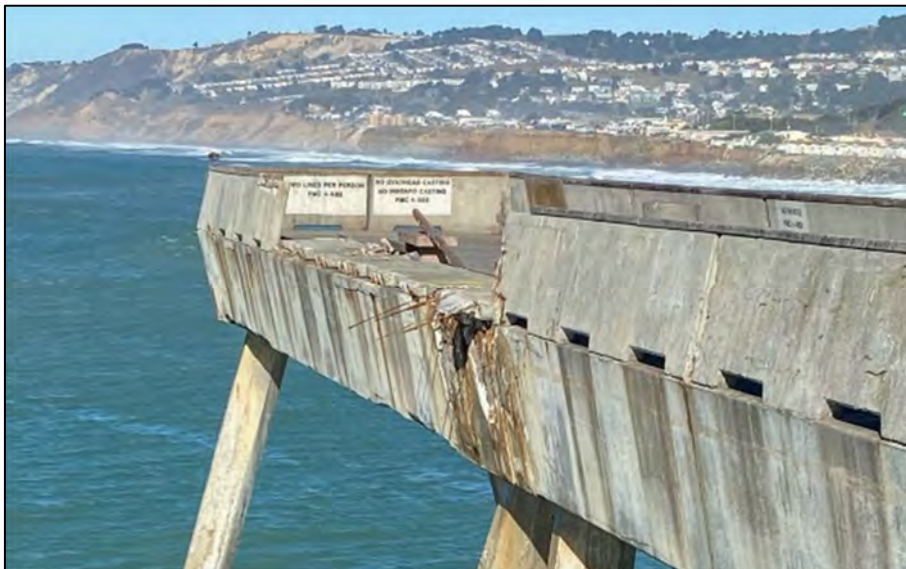
Figure 1.2 Damaged Pier Handrail (January 2021)

The Pier sustained damage to a section of the handrail during winter storms in December 2020 and January 2021, as shown in Figure 1.2. The damage was likely caused by large waves and/or strong winds impacting a handrail weakened by ongoing corrosion. The City of Pacifica engaged GHD to assess the condition of the existing structure at other locations and gather information that may assist with planning for future repairs and maintenance. The Condition Assessment Report documents the assessment methodology, field observations, assessments, and includes recommendations for potential repairs needed.

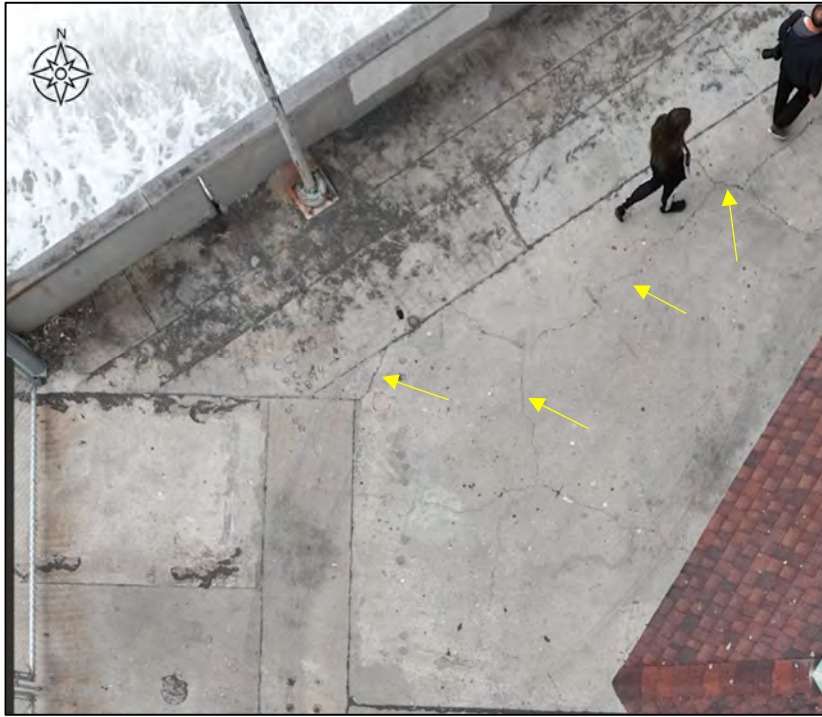
Figure 4.1 Visible Cracks on Abutment 1-A - Main Pier Entrance

The Pier abutment has several minor to moderate visible cracks on the deck surface, as shown on Figure 4.1. These cracks do not affect the structure and should be monitored over time. As cracks widen, they may cause localized spalls and/or tripping hazards for pedestrians.

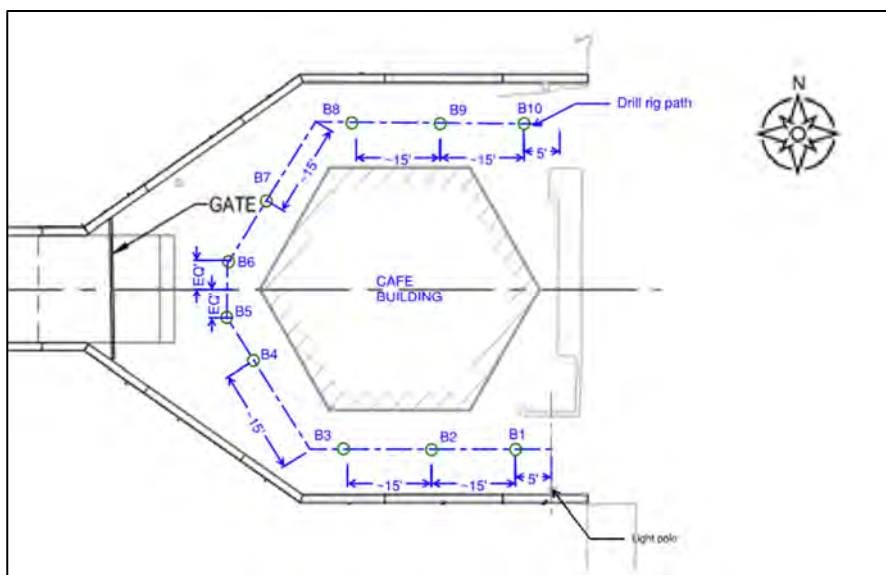
Figure 4.2 Plan View of Drill Rig Path and Borehole Locations

The abutment was drilled through at ten (10) locations around the Chit-Chat Café building. Drilling started from the south side of the building, coring holes at approximately 15' intervals, and ended on the north side entrance. The drill locations were labeled B-1 through B-10 as shown in Figure 4.2, to document the observations.

Core ID	Drilled Depth (ft)	Comments
B-1	30	No Rebar was noted in the core sample and no void in the abutment
B-2	30	No Rebar was noted in the core sample and no void in the abutment
B-3	15	0.5" Rebar was noted in the core sample and no void in the abutment
B-4	25	No Rebar was noted in the core sample and no void in the abutment
B-5	22	0.5" Rebar was noted in the core sample and no void in the abutment
B-6	25	0.5" Rebar was noted in the core sample and no void in the abutment
B-7	25	0.5" Rebar was noted in the core sample and no void in the abutment
B-8	25	0.5" Rebar was noted in the core sample and no void in the abutment. Water in core hole drained quickly, indicating no signs of water accumulation behind the wall
B-9	25	No Rebar was noted in the core sample and no void in the abutment
B-10	20	No Rebar was noted in the core sample and 4"-8" void was found directly under concrete deck.

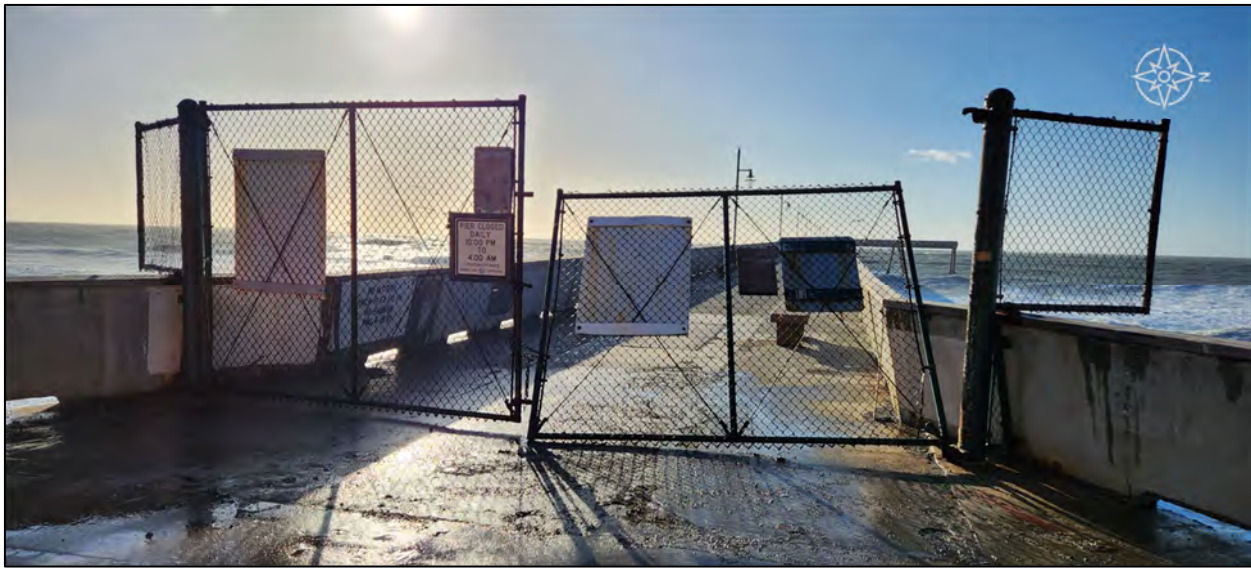
Figure 4.3 *Main Pier Entrance Gate - Damaged*

The old gate at the entrance broke due to high winds on 02/14/2023 and replaced by the time the deck delamination survey was performed (04/12/2023), as shown in Figure 4.3 and Figure 4.4, respectively.

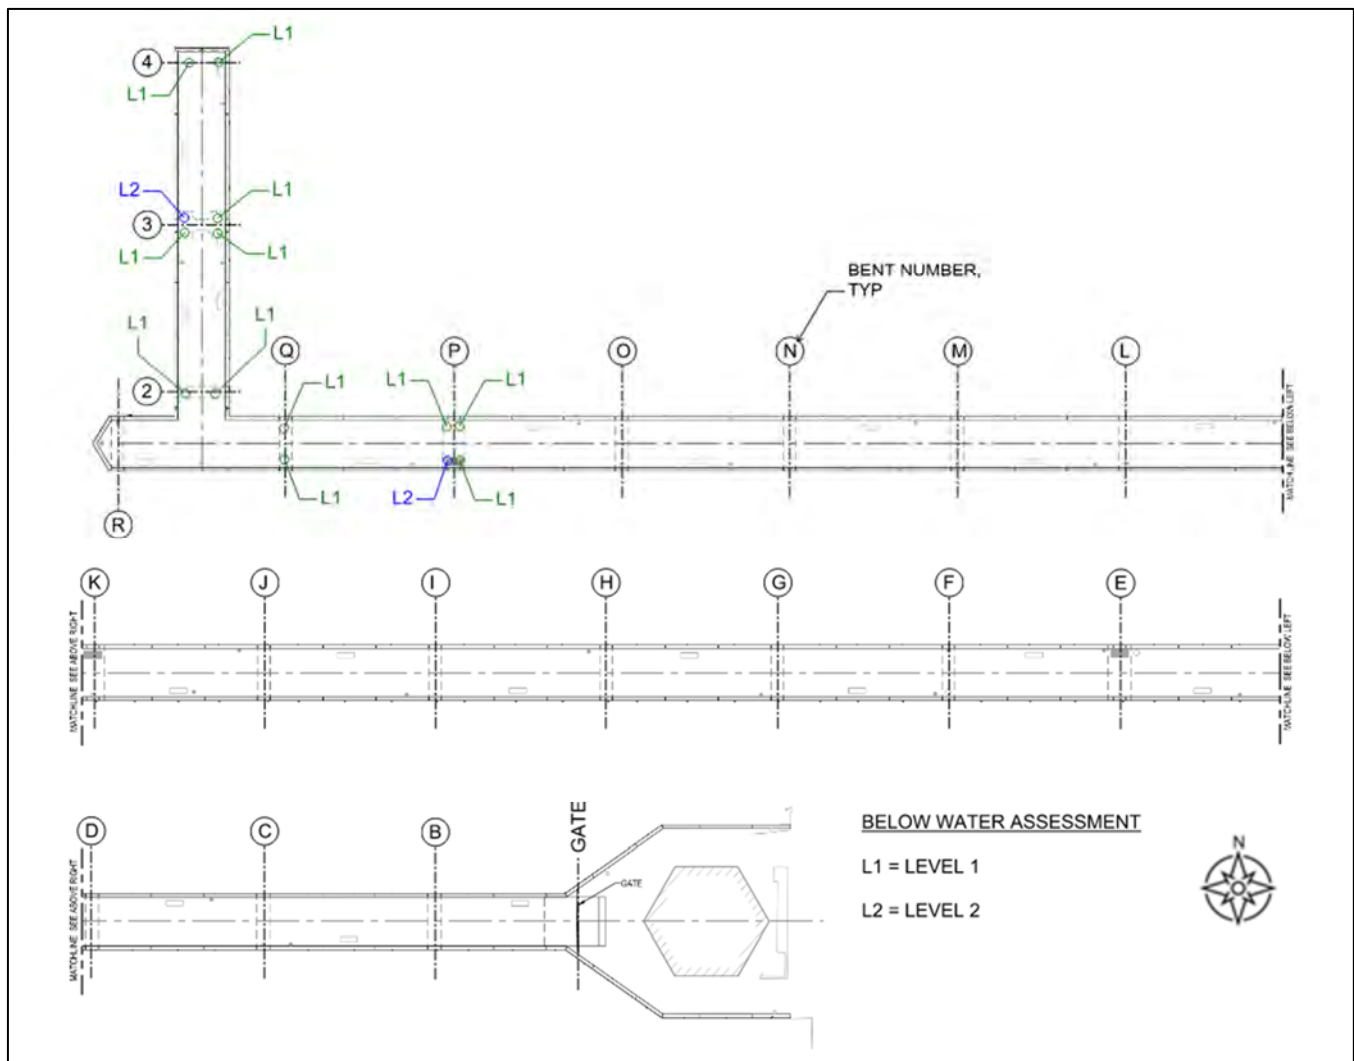
Figure 4.11 Underwater Pile Inspection Locations – Sea Engineering Report

All the piles inspected below the water line are noted in Figure 4.11. The piles showed no signs of damage below the MHW water line and minimal scouring was observed around the piles at seabed. The damage rating for the piles as noted in Figure 4.12 was governed by the conditions observed above the waterline.

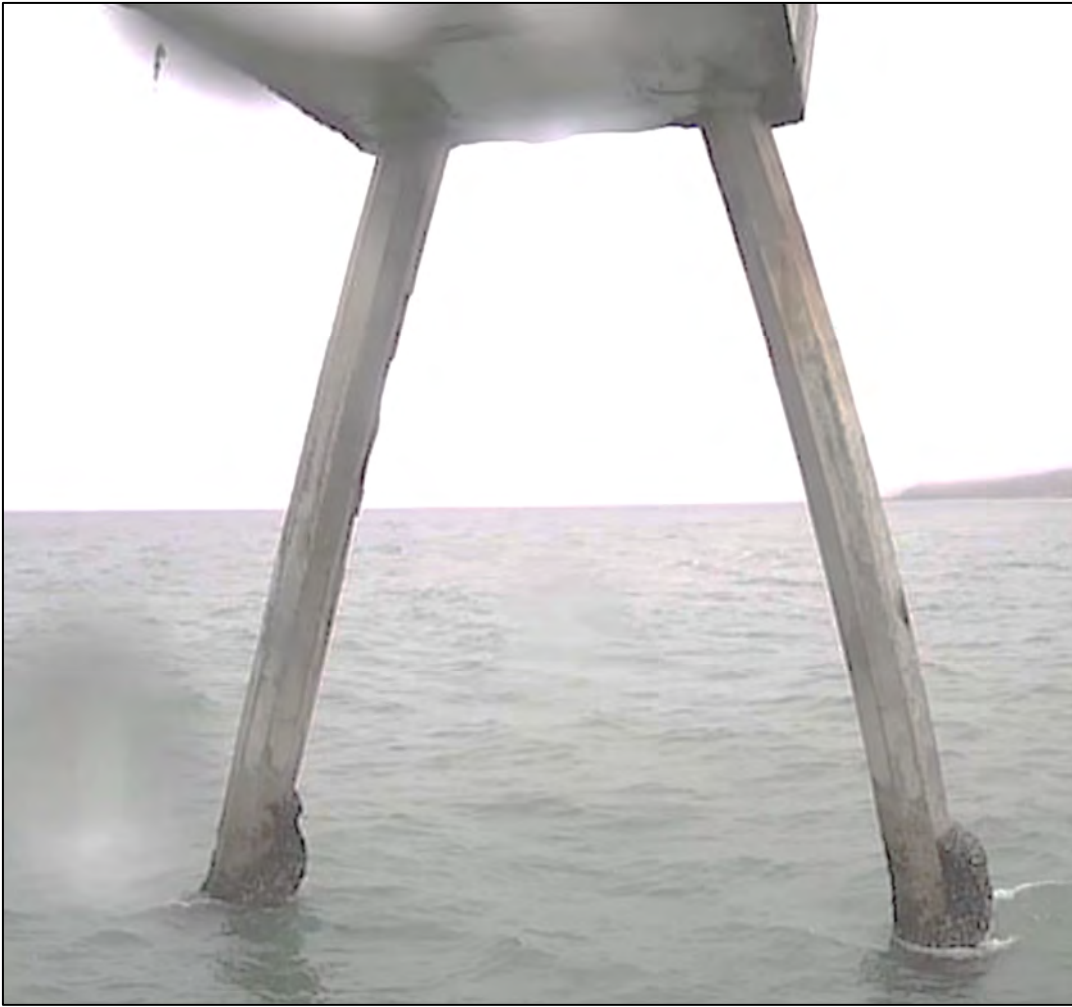
Figure 4.13 *Pier Extension - Bent 4 Piles*

- Marine growth around the shoreside of piles. The marine growth was most dense for approximately 8' along the pile.
- From mudline to +8' no marine growth was observed. From +8' to +18' above mudline marine growth was observed. Approximately 75% marine growth included a mixture of soft corals, sea stars, hard mussels, and barnacles. From 18ft above mudline to MHW marine growth was also observed. This marine growth included 100% of 6" thick barnacles and mussels with fishing line, ropes, and fishing tackle.
- No scour was observed. The seabed approximately 30' away from Bent 1P looked even.
- Concrete spall on sides exposed to most direct wind and waves. The spiral reinforcement is exposed to continued corrosion and impacts the load carrying capacity of the piles.
- Discoloration of concrete.
- No broken piles.

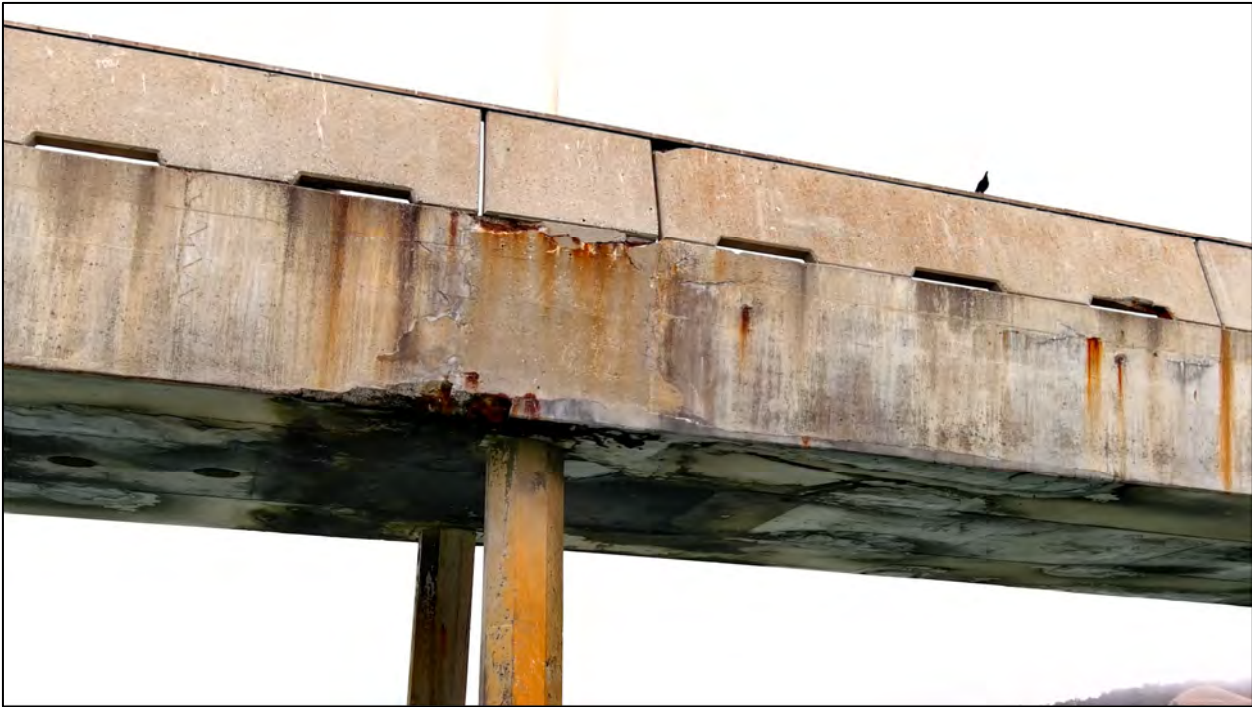
Figure 4.14 *Pile Damage Rating - Moderate (Bent 1G)*

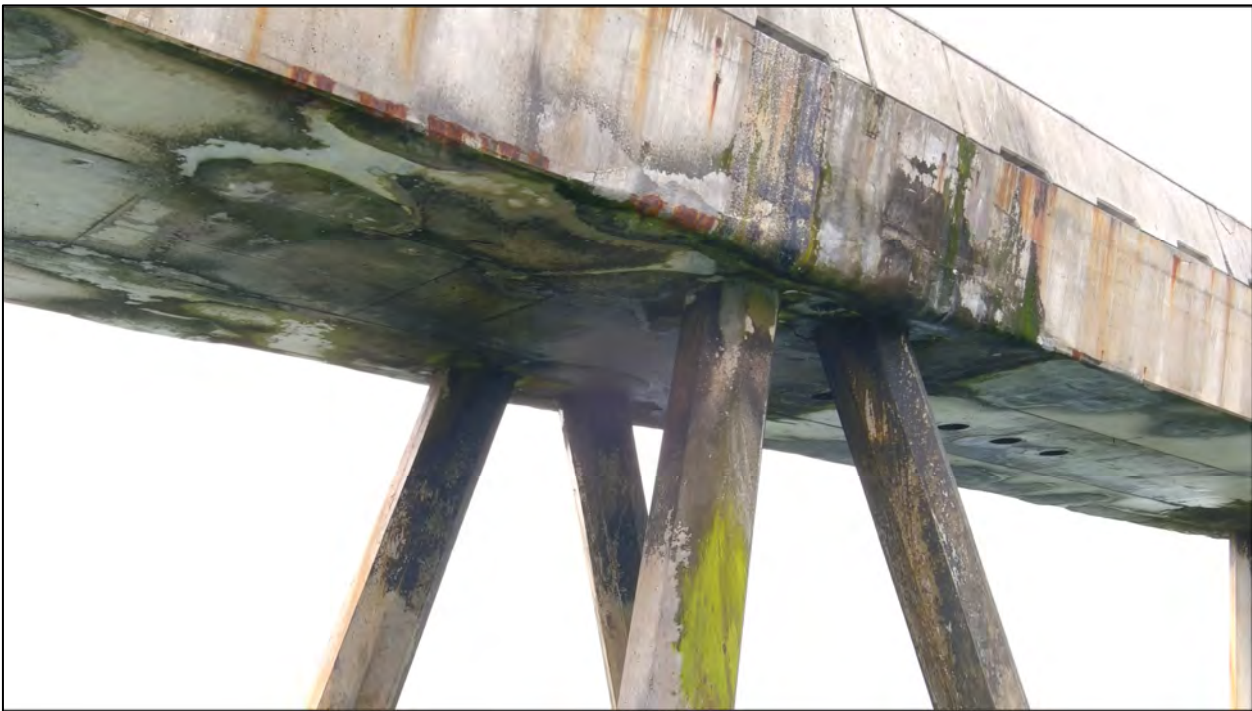
Figure 4.15 *Pile Damage Rating - Major (Bent 1K)*

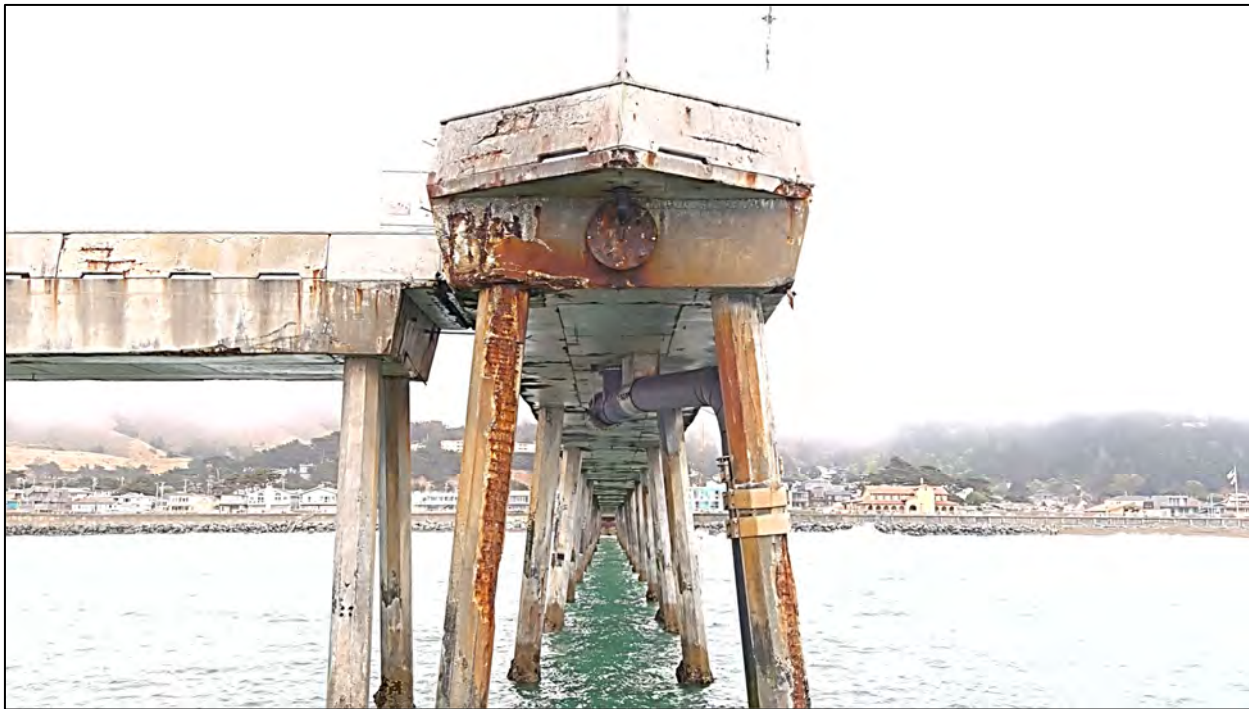
Figure 4.16 *Pile Damage Rating - Severe (Bent 1R)*

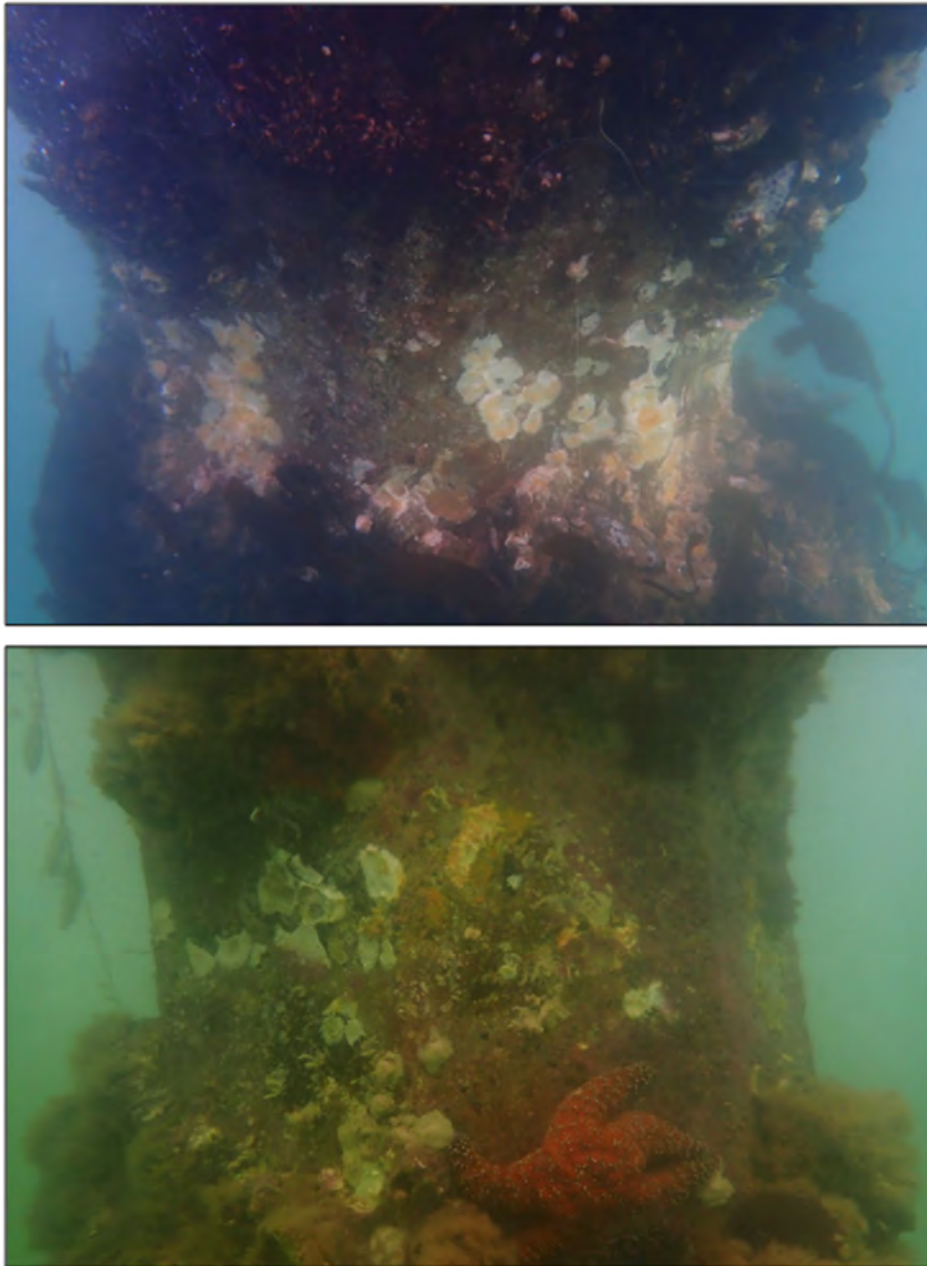
Figure 4.17 *Typical Pile Condition – Level II Inspection*

Overall Rating of Piles below MHW Level are Minor.

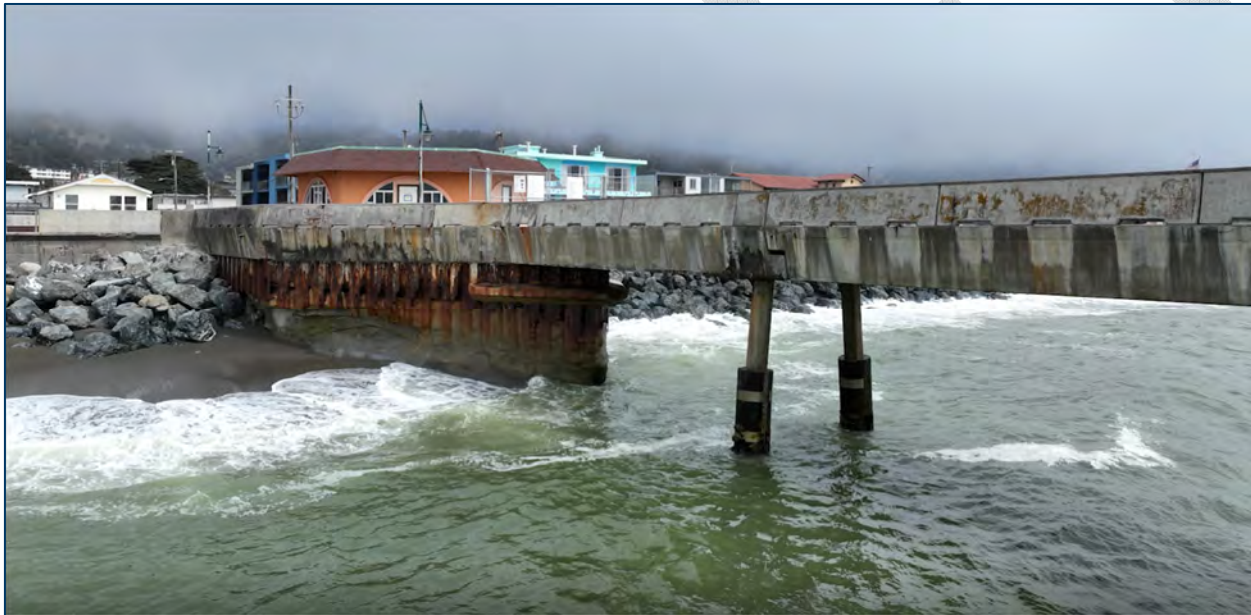
Figure A.3-1 Deck Exterior from Pier Abutment to Bent 1B – North Face

- Rust bleed stains around sheet pile/abutment concrete cap interface, abutment concrete cap and handrails connection
- Loss of steel sheet piles
- Minor to Moderate cracks on abutment concrete cap
- Minor to Moderate corrosion and structural spalls on abutment concrete cap
- Discoloration of concrete (black/green algae)
- Overall rating – Moderate

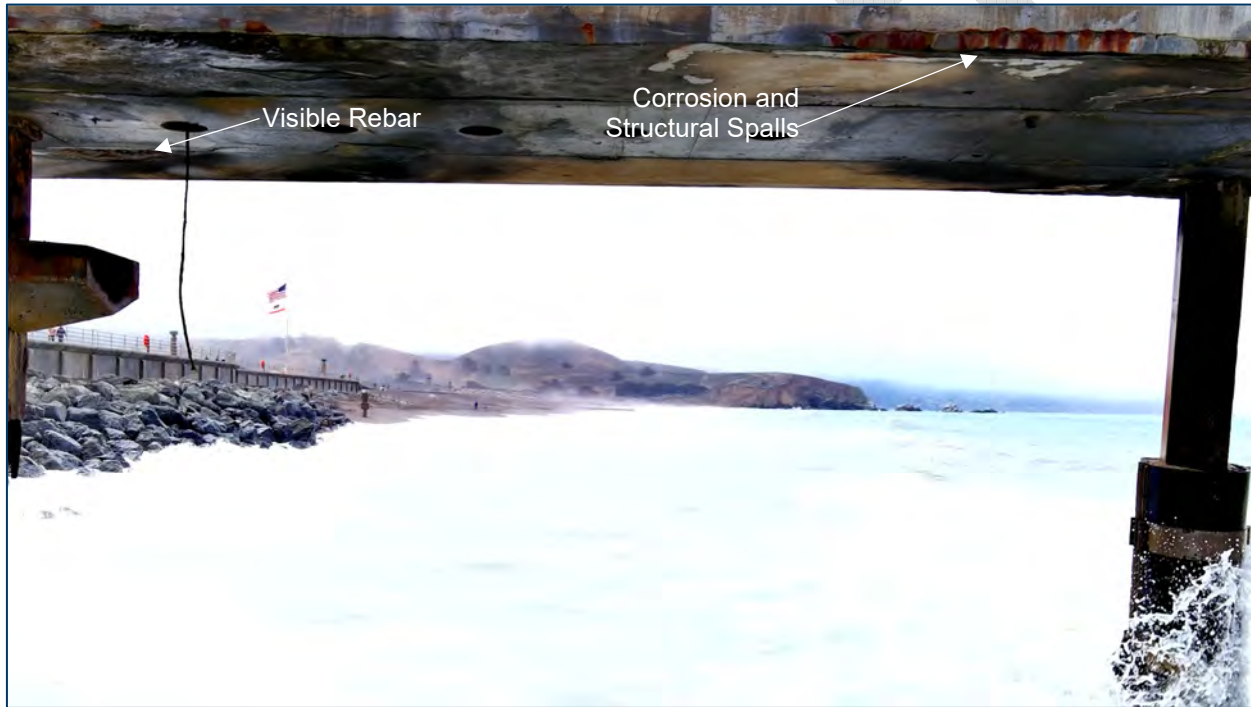
Figure A.3-5 Deck Exterior between Pier Abutment and Bent 1B – North Face

- Unattended broken wiring coming out of the deck underside.
- Discoloration of concrete (black/green algae)
- Rust bleed stains around deck and handrail connection
- Moderate to Severe corrosion and structural spalls with visible rebar
- Moderate to Major cracks and rust bleed stains around deck underside edges
- Overall rating of deck – Severe

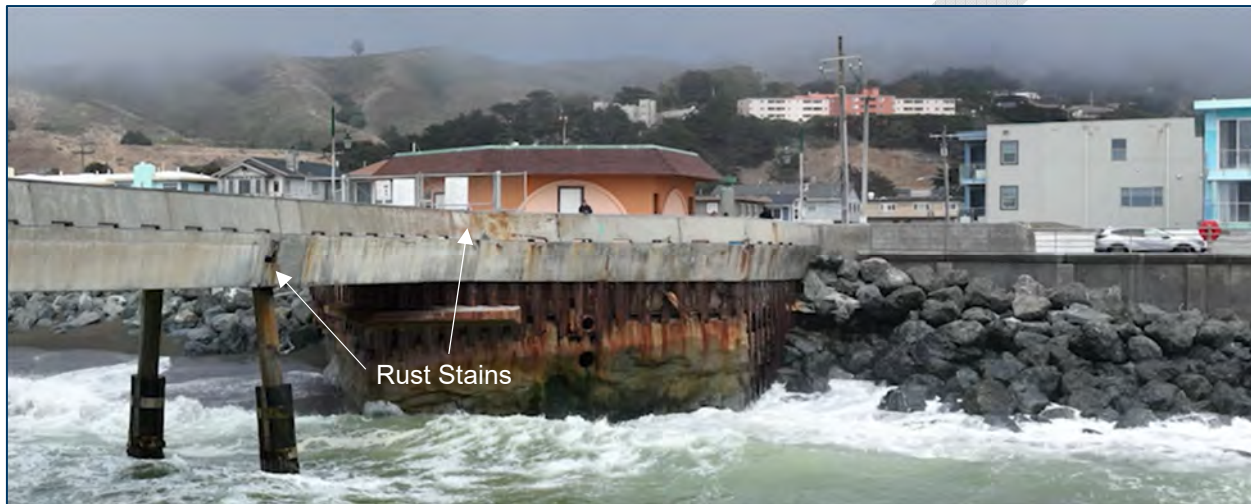
Figure A.3-9 Deck Exterior between Pier Abutment and Bent 1B – South Face

- Moderate to Major cracks and rust bleed stains around bent underside edges
- Rust stains and moderate cracks on piles
- Abrasion on piles
- Minor impact spalls on piles
- Overall rating for Bent – Major
- Overall rating for Pile - Moderate

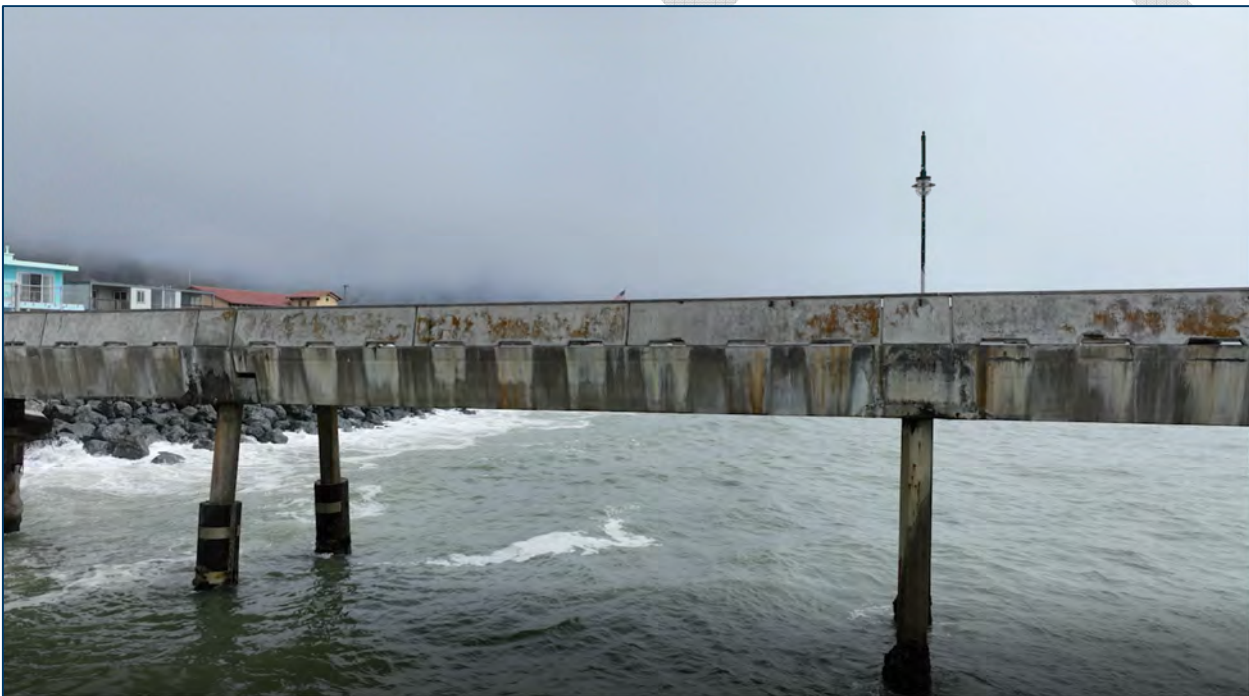
Figure A.3-11 Deck Exterior from Bent 1B to Bent 1C – North Face

- Discoloration of concrete (black/green algae)
- Rust bleed stains around deck and handrail connection at some places, deck, and bent connection
- Minor to Moderate corrosion and structural spalls on deck between Bent 1B and 1C
- Moderate to Major corrosion and structural spalls around and under Bent 1C
- Moderate to Major cracks around and under Bent 1C
- Minor to Moderate cracks on deck between Bent 1B and 1C
- Rust stains and moderate cracks on piles
- Abrasion on piles
- Minor impact spalls on piles
- Overall rating for Deck – Moderate
- Overall rating for Bent – Major
- Overall rating for Pile - Moderate

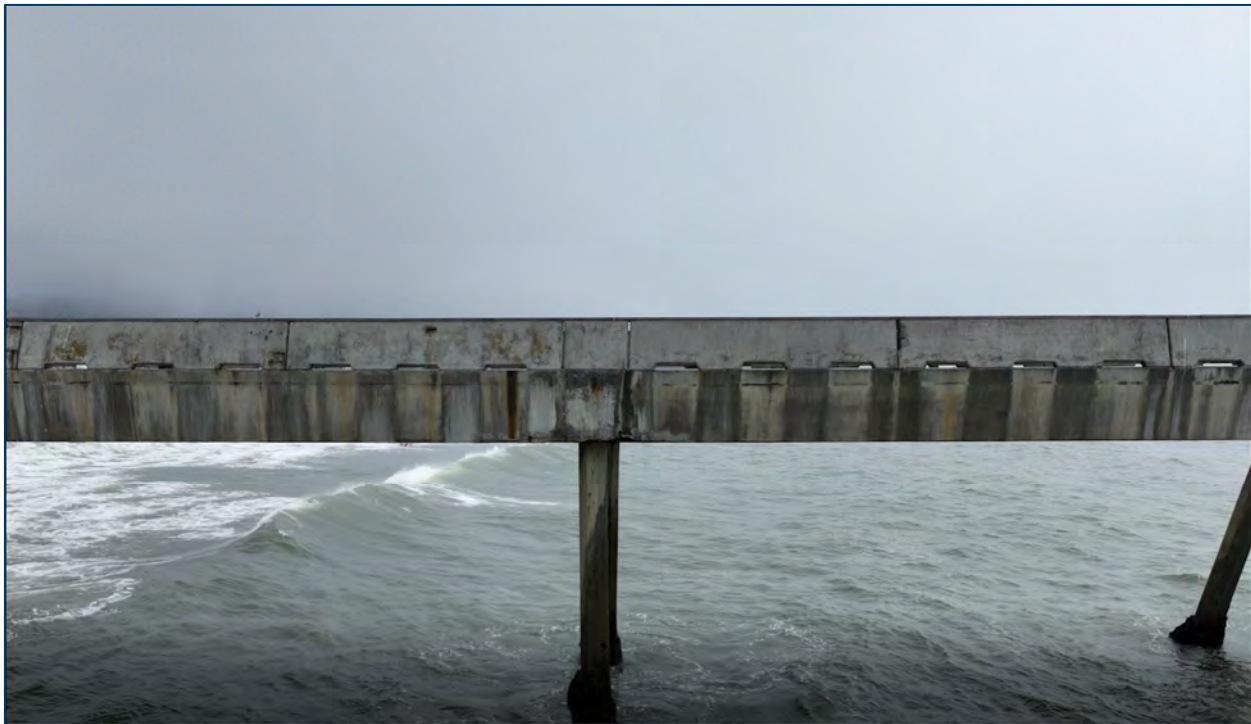
Figure A.3-15 *Deck Exterior around Bent 1D – North Face*

- Discoloration of concrete (black/green algae)
- Rust bleed stains around deck and handrail connection at some places, deck and bent connection
- Moderate to Severe corrosion and structural spalls on deck between Bent 1C and 1D – Visible rebar
- Moderate to Severe corrosion and structural spalls around Bent 1D
- Moderate to Major cracks around and under Bent 1D
- Moderate cracks between on deck Bent 1C and 1D
- Rust stains and moderate cracks on piles
- Abrasion on piles
- Minor impact spalls on piles
- Overall rating for Deck – Severe
- Overall rating for Bent - Severe
- Overall rating for Pile - Moderate

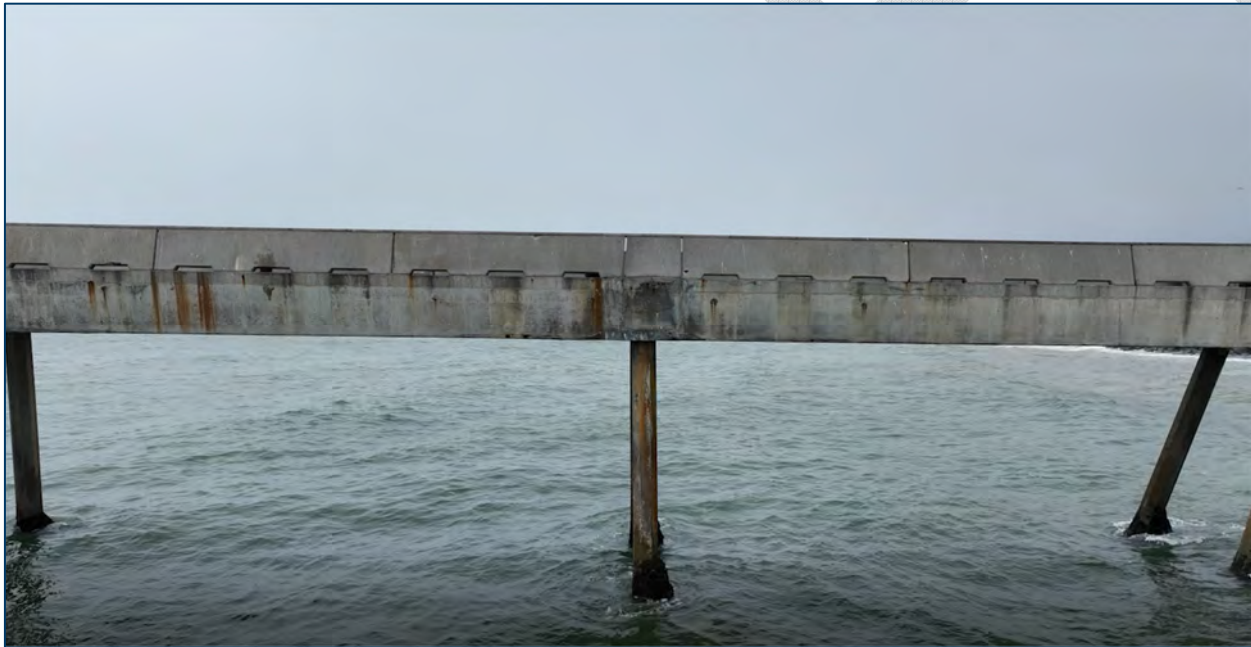
Figure A.3-27 Deck Exterior around Bent 1F – South Face

- Discoloration of concrete (black/green algae)
- Rust bleed stains around deck and handrail connection at some places, deck and bent connection
- Moderate to Major corrosion and structural spalls on deck between Bent 1E and 1F
- Moderate to Major corrosion and structural spalls around Bent 1F
- Moderate to Major cracks around and under Bent 1E
- Moderate to Major cracks between Bent 1E and 1F
- Rust stains and moderate cracks on piles
- Abrasion on piles
- Minor impact to Major corrosion/structural spalls on piles
- Overall rating for Deck – Major
- Overall rating for Bent - Major
- Overall rating for Pile – Bent F-N – Moderate, Bent F-S - Major

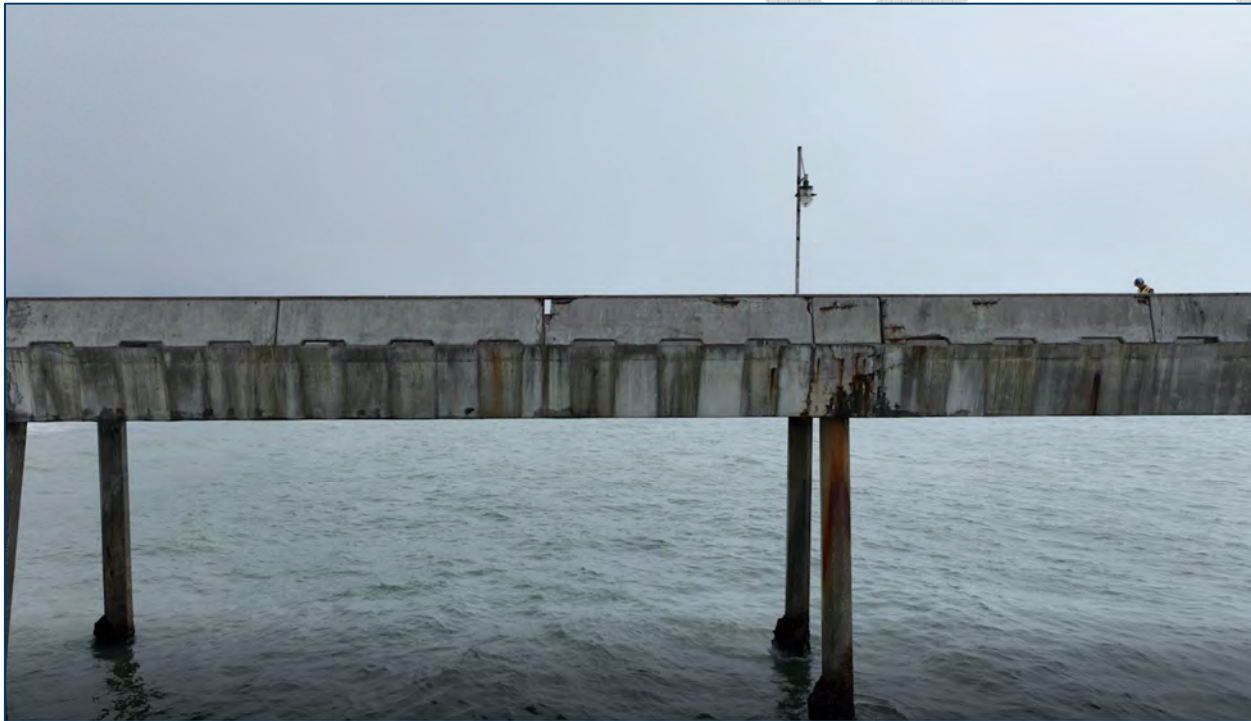
Figure A.3-30 Deck Exterior around Bent 1G – North Face

- Discoloration of concrete (black/green algae)
- Rust bleed stains around deck and handrail connection at some places, deck, and bent connection
- Moderate to Major corrosion and structural spalls on deck between Bent 1F and 1G
- Moderate to Severe corrosion and structural spalls around Bent 1G
- Moderate to Major cracks around and under Bent 1G
- Moderate to Major cracks between Bent 1F and 1G
- Rust stains and moderate cracks on piles
- Abrasion on piles
- Minor impact spalls on piles
- Overall rating for Deck – Major
- Overall rating for Bent - Severe
- Overall rating for Pile - Moderate

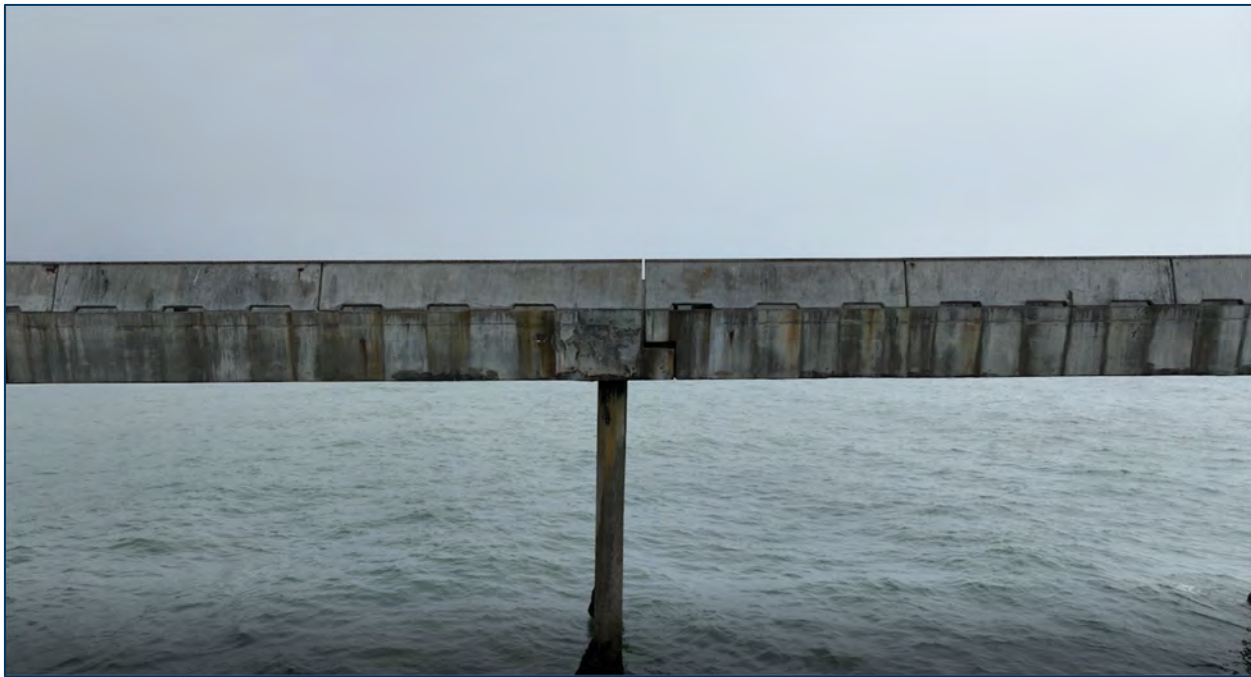
Figure A.3-34 Deck Exterior around Bent 1H – North Face

- Discoloration of concrete (black/green algae)
- Rust bleed stains around deck and handrail connection at some places, deck and bent connection (bearing plate connection)
- Moderate corrosion and structural spalls between Bent 1G and 1H
- Moderate corrosion and structural spalls around Bent 1H
- Moderate to Major cracks around and under Bent 1H
- Moderate to Major cracks between Bent 1G and 1H
- Rust stains and moderate cracks on piles
- Abrasion on piles
- Minor impact spalls on piles
- Overall rating for Deck – Major
- Overall rating for Bent - Major
- Overall rating for Pile - Moderate

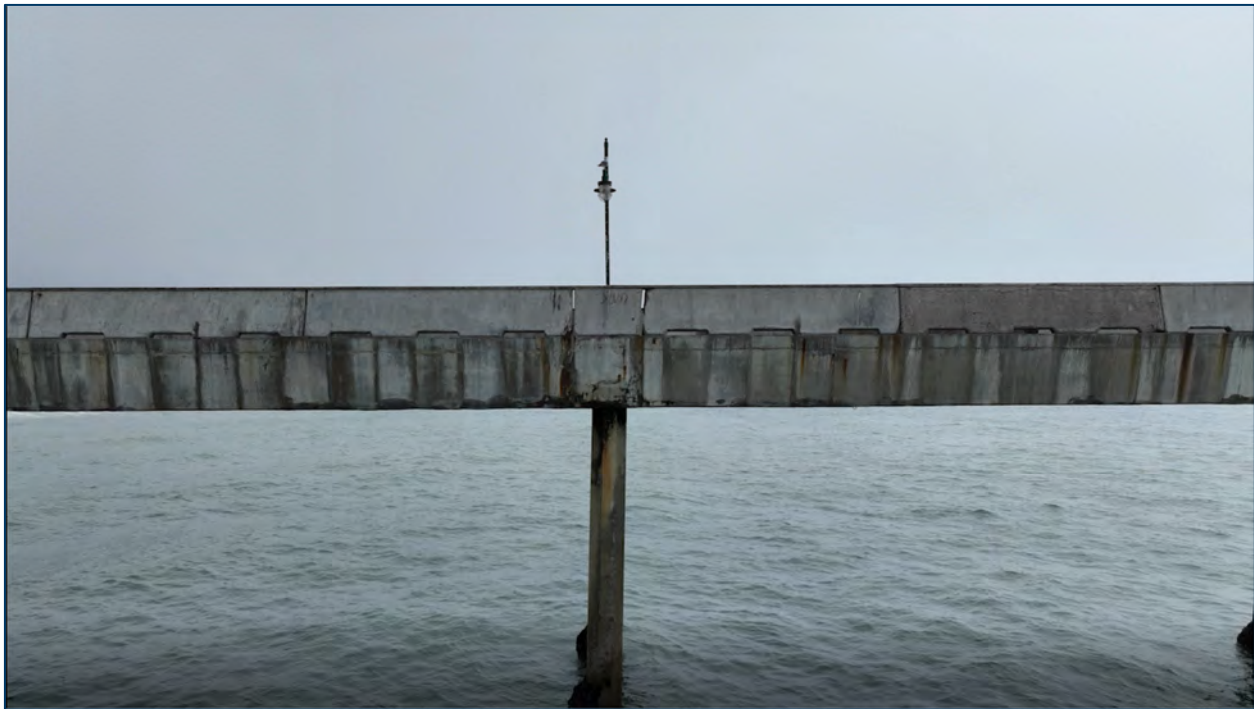
Figure A.3-37 Deck Exterior around Bent 1I – North Face

- Discoloration of concrete (black/green algae)
- Rust bleed stains around deck and handrail connection at some places, deck and bent connection (bearing plate connection)
- Minor impact spalls between Bent 1H and 1I
- Moderate to Major corrosion and structural spalls around Bent 1I
- Moderate to Major cracks around and under Bent 1I
- Minor to Moderate cracks between Bent 1H and 1I
- Rust stains and moderate cracks on piles
- Abrasion on piles
- Minor impact spalls on piles
- Overall rating for Deck – Moderate
- Overall rating for Bent - Major
- Overall rating for Pile - Moderate

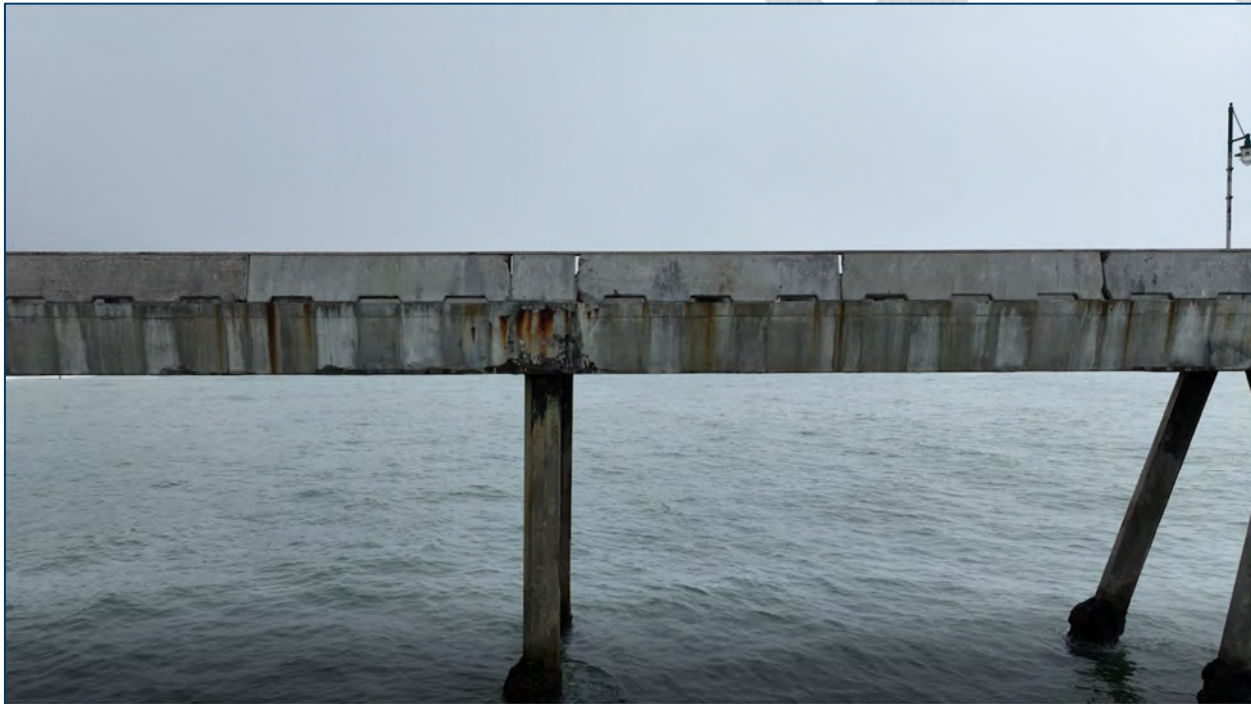
Figure A.3-41 Deck Exterior around Bent 1J - North Face

- Discoloration of concrete (black/green algae)
- Rust bleed stains around deck and handrail connection at some places, deck and bent connection
- Minor spalls between Bent 1I and 1J
- Moderate to Major corrosion and structural spalls around Bent 1J
- Moderate to Major cracks around and under Bent 1I
- Moderate to Major cracks between Bent 1I and 1J
- Rust stains and moderate cracks on piles
- Abrasion on piles
- Minor impact spalls on piles
- Overall rating for Deck – Major
- Overall rating for Bent - Major
- Overall rating for Pile – Moderate

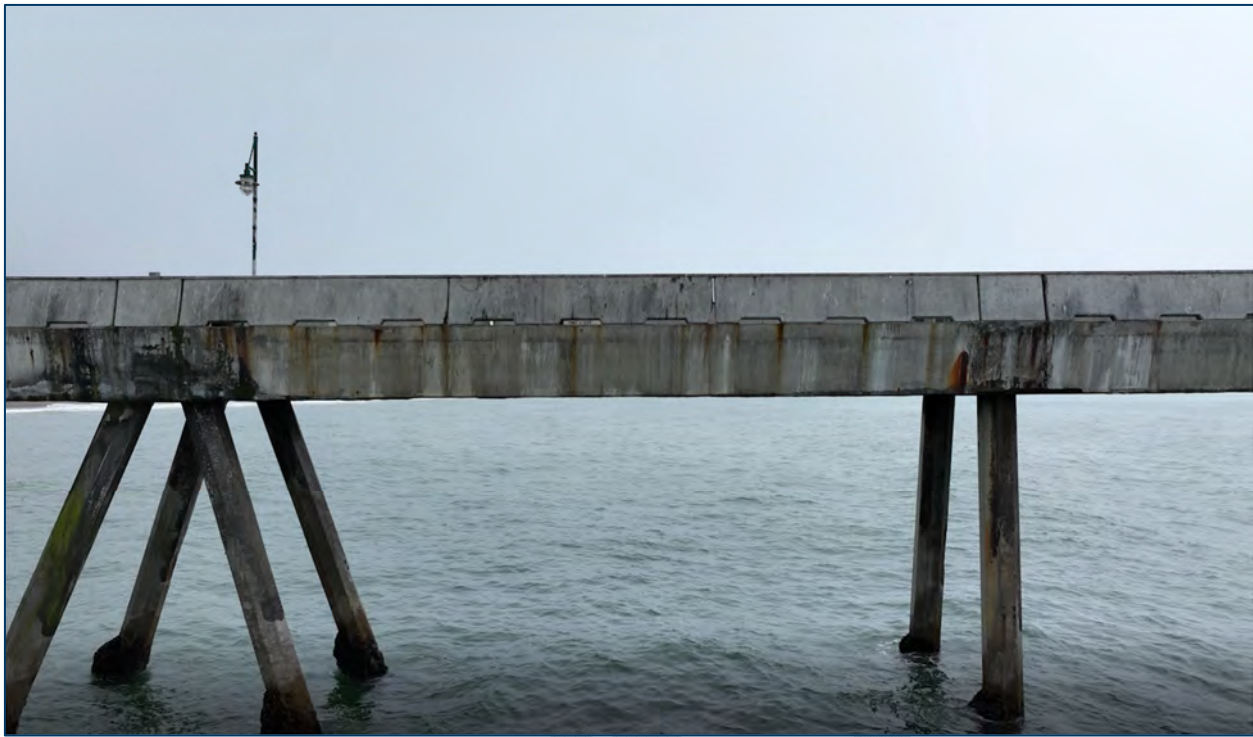
Figure A.3-45 Deck Exterior around Bent 1K and 1L- North Face

- Discoloration of concrete (black/green algae)
- Rust bleed stains around deck and handrail connection at some places, deck and bent connection
- Minor spalls between Bent 1J and 1K
- Moderate to Major corrosion and structural spalls around Bent 1K
- Moderate to Major cracks around and under Bent 1K
- Moderate to Major cracks between Bent 1J and 1K
- Rust stains and moderate cracks on piles
- Abrasion on piles
- Minor impact to Major corrosion/structural spalls on piles
- Overall rating for Deck – Major
- Overall rating for Bent - Major
- Overall rating for Pile – Bent K-NE - Moderate, Bent K-NW - Moderate, Bent K-SE - Major, Bent K-SW - Major

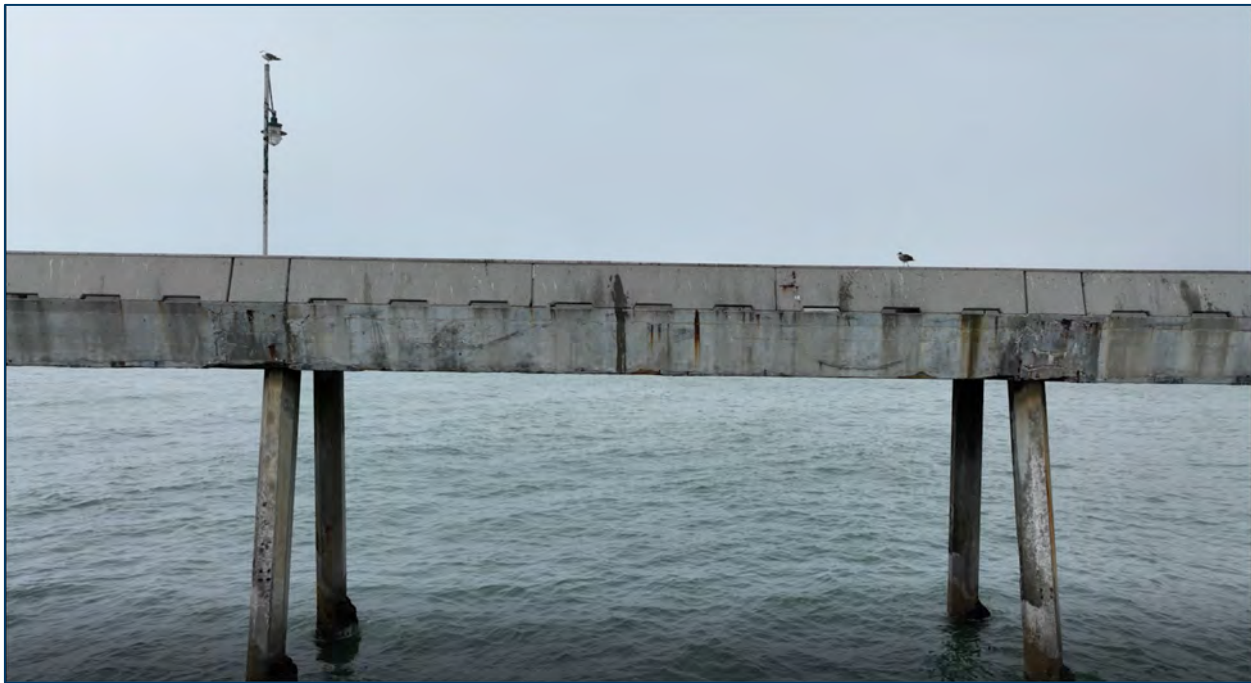
Figure A.3-48 *Deck Exterior between Bent 1M and 1L – South Face*

- Discoloration of concrete (black/green algae)
- Rust bleed stains around deck and handrail connection at some places, deck and bent connection
- Moderate to Major corrosion and structural spalls between Bent 1K and 1L
- Moderate to Severe corrosion and structural spalls around Bent 1L
- Moderate to Major cracks around and under Bent 1L
- Moderate to Major cracks between Bent 1K and 1L
- Rust stains and moderate cracks on piles
- Abrasion on piles
- Minor impact to Major corrosion/structural spalls on piles
- Overall rating for Deck – Major
- Overall rating for Bent - Severe
- Overall rating for Pile – Major

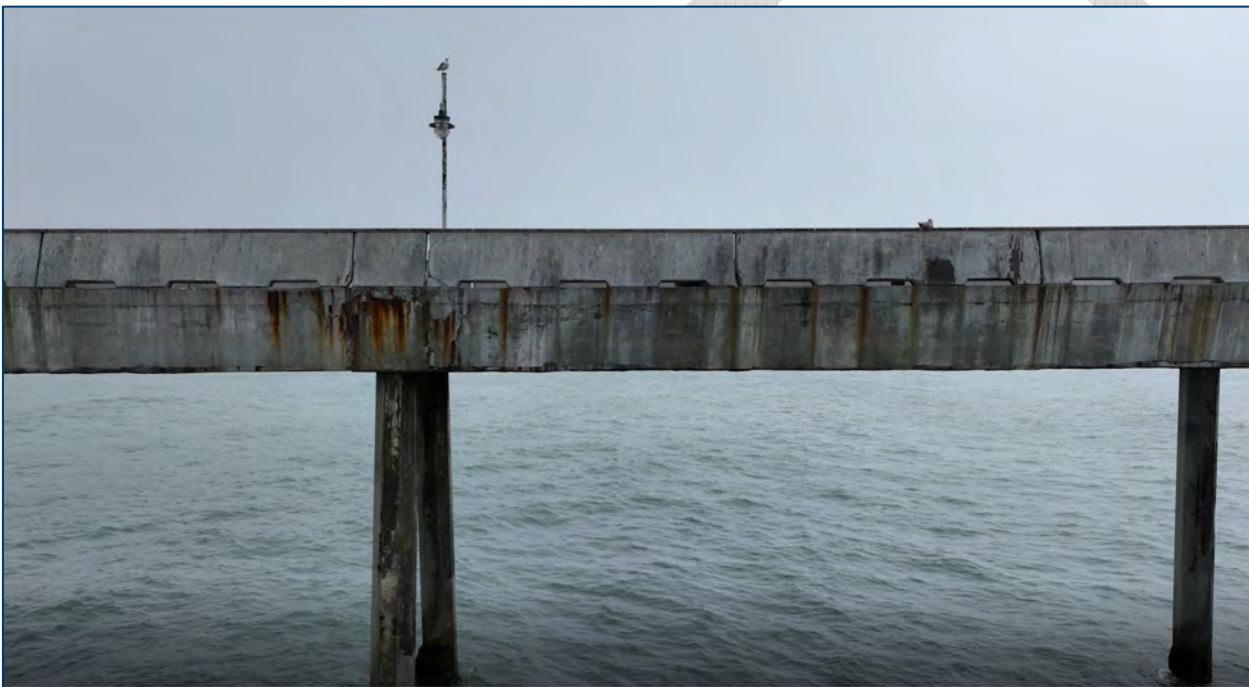
Figure A.3-51 Deck Exterior around Bent 1M – North Face

- Rust bleed stains around deck and handrail connection at some places, deck and bent connection
- Minor spalls between Bent 1L and 1M
- Moderate to Severe corrosion and structural spalls around Bent 1M – Visible Rebar
- Moderate to Major cracks around and under Bent 1M
- Moderate to Major cracks between Bent 1L and 1M
- Rust stains and moderate cracks on piles
- Abrasion on piles
- Minor impact to Major corrosion/structural spalls on piles
- Overall rating for Deck – Major
- Overall rating for Bent - Severe
- Overall rating for Pile – Bent M-N - Major, Bent M-S - Moderate
