Pacifica Municipal Fishing Pier

2023 Condition Assessment Report

City of Pacifica

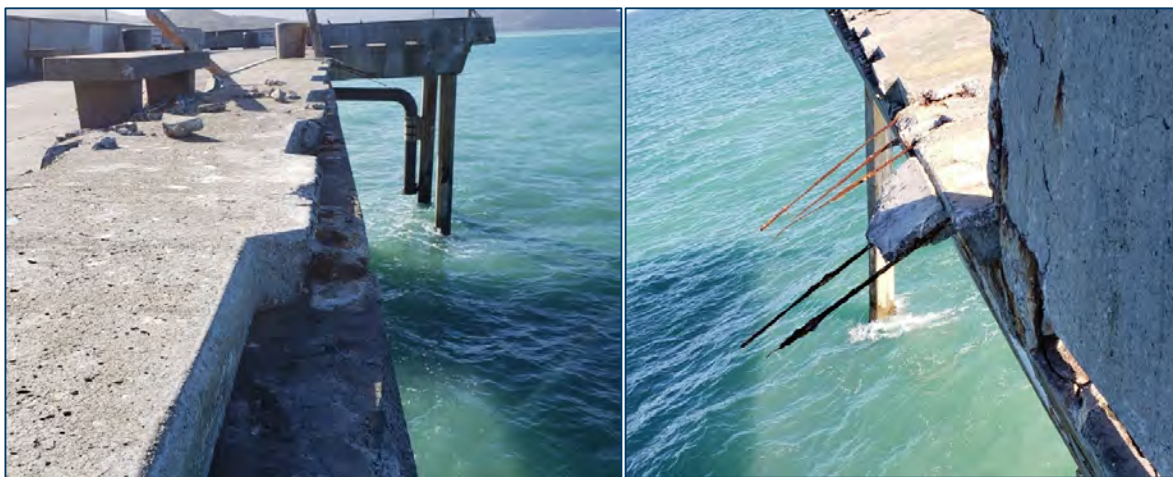
Figure 3.1 Collapsed Handrail, Photo 2021

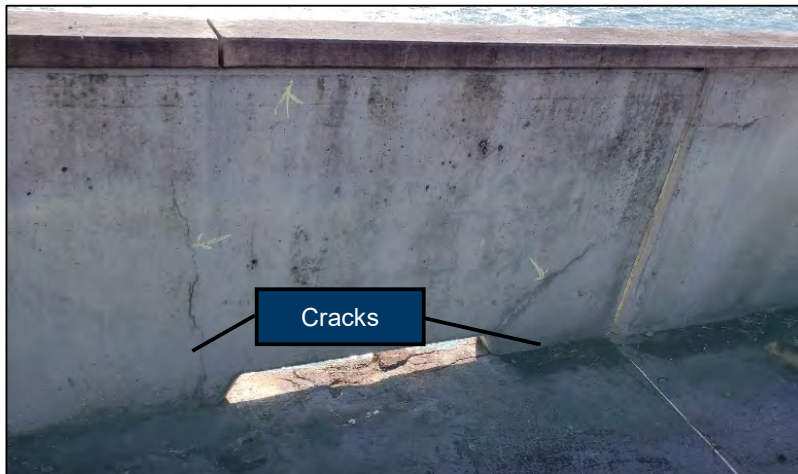
Figure 3.2: Typical Damage Rated Minor

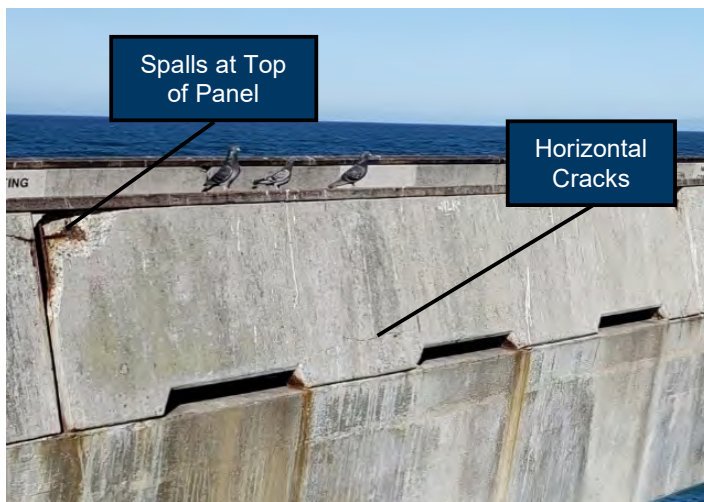
Figure 3.3: Typical Damage Rated Moderate

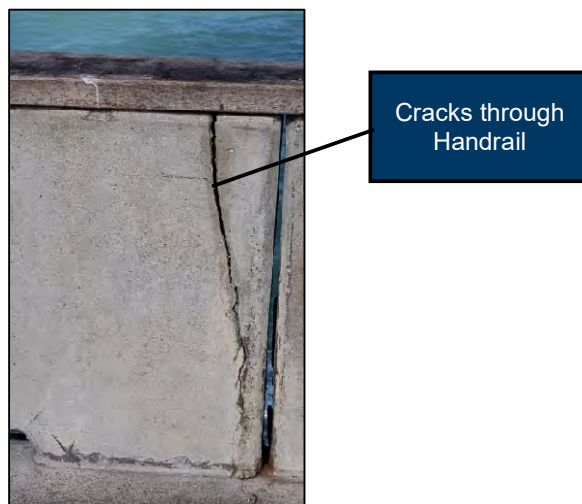
Figure 3.4: Typical Damage Rated Major

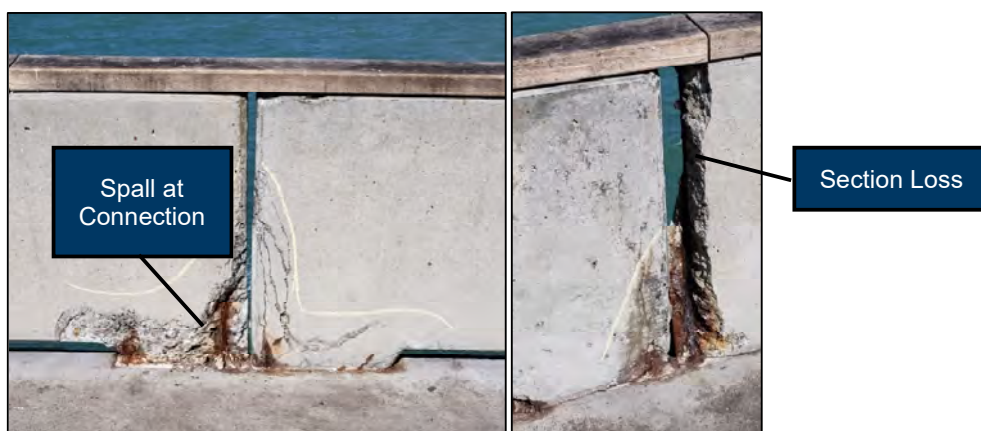
Figure 3.5: Typical Damage Rated Severe

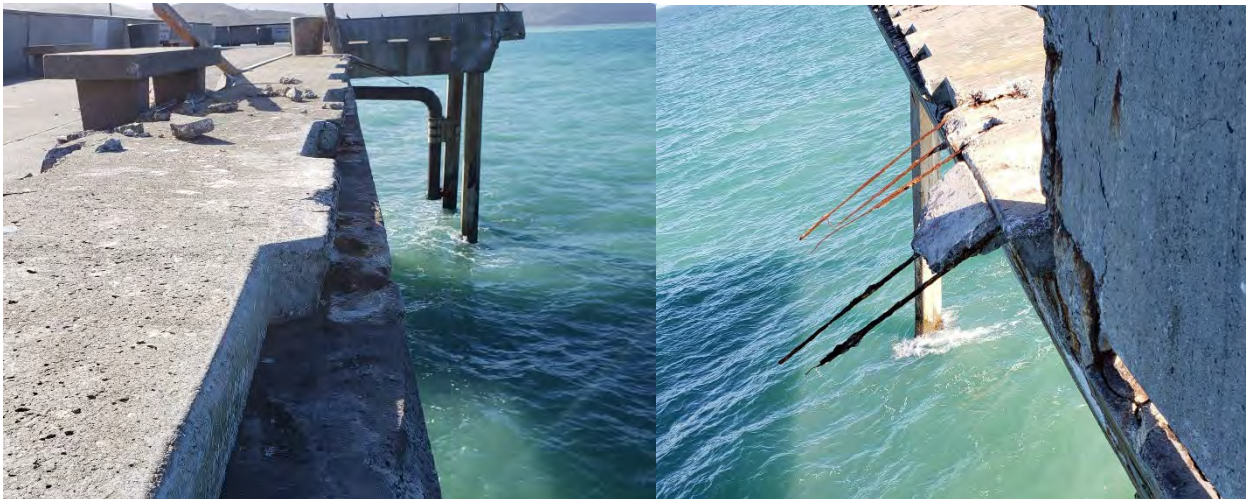
Figure 4: Photos of Collapsed Handrail

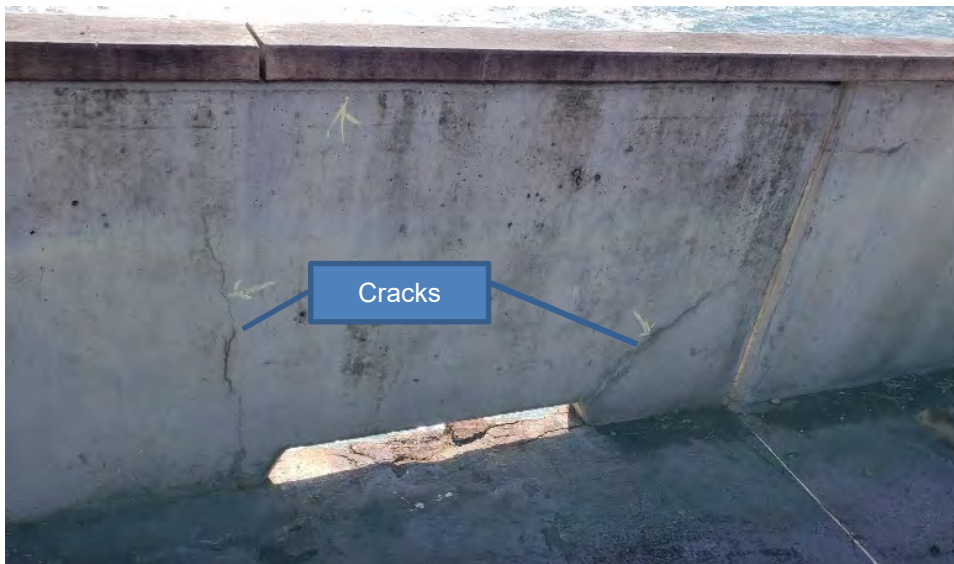
Figure 5: Typical Damage Rated Minor

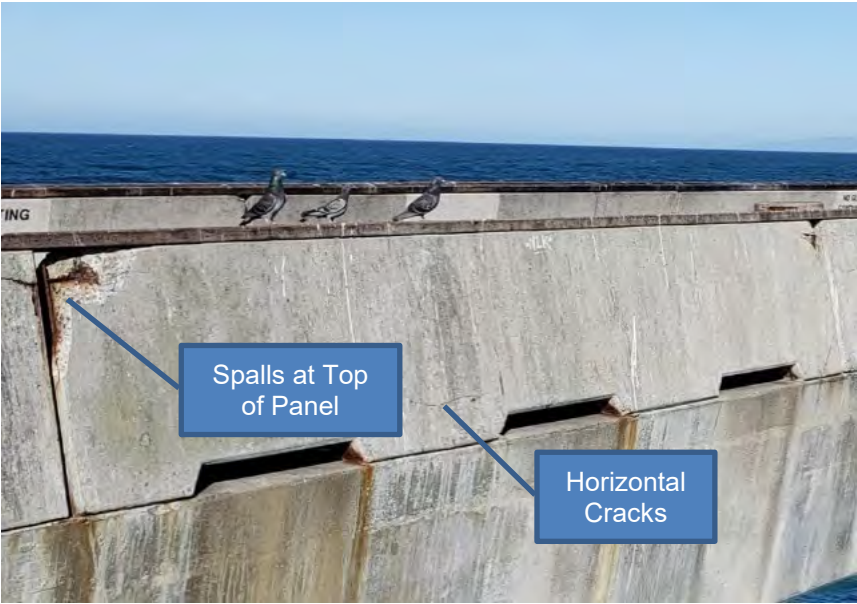
Figure 6: Typical Damage Rated Moderate

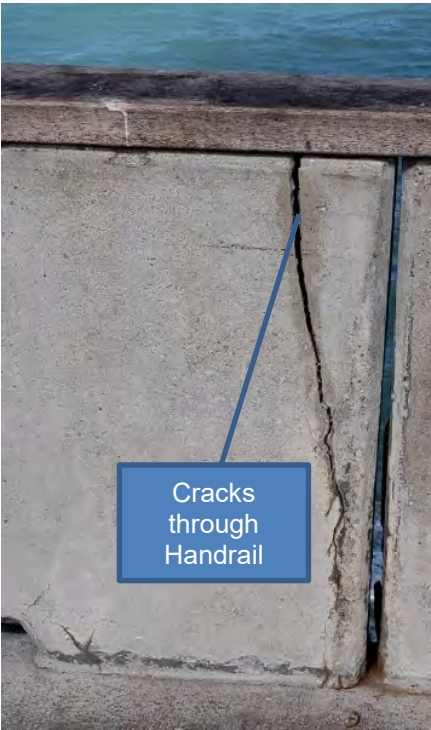
Figure 7: Typical Damage Rated Major

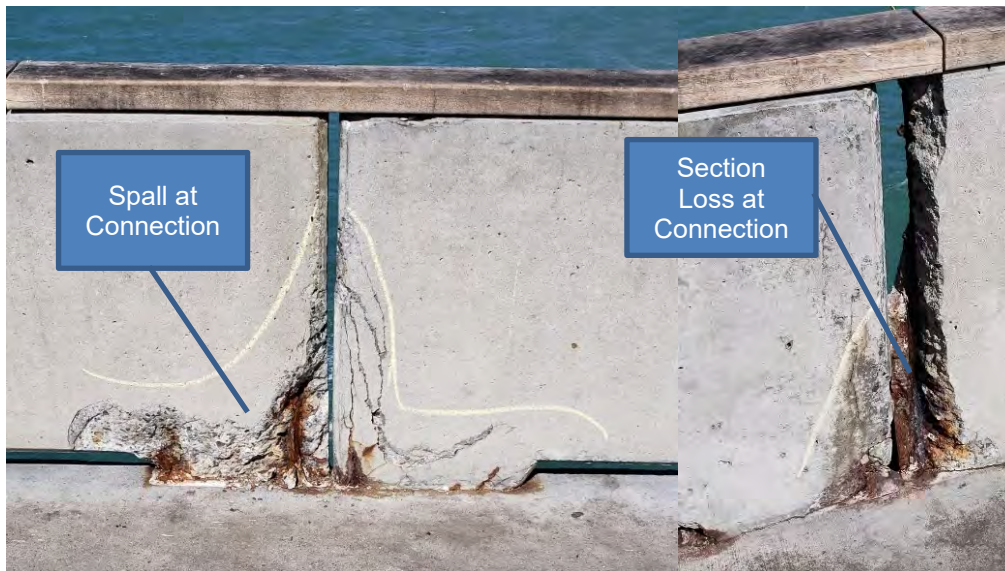
Figure 8: Typical Damage Rated Severe
