# Technical Memorandum

<b>To</b>	Roland Yip, City of Pacifica	<b>Contact No.</b>	925 849 1019
<b>Copy to</b>		<b>Email</b>	satish.chilka@ghd.com
<b>From</b>	Satish Chilka, PE	<b>Project No.</b>	12599413
<b>Project Name</b>	Pacifica Pier Condition Assessment		
<b>Subject</b>	Post Storm Condition Assessment – April 2024

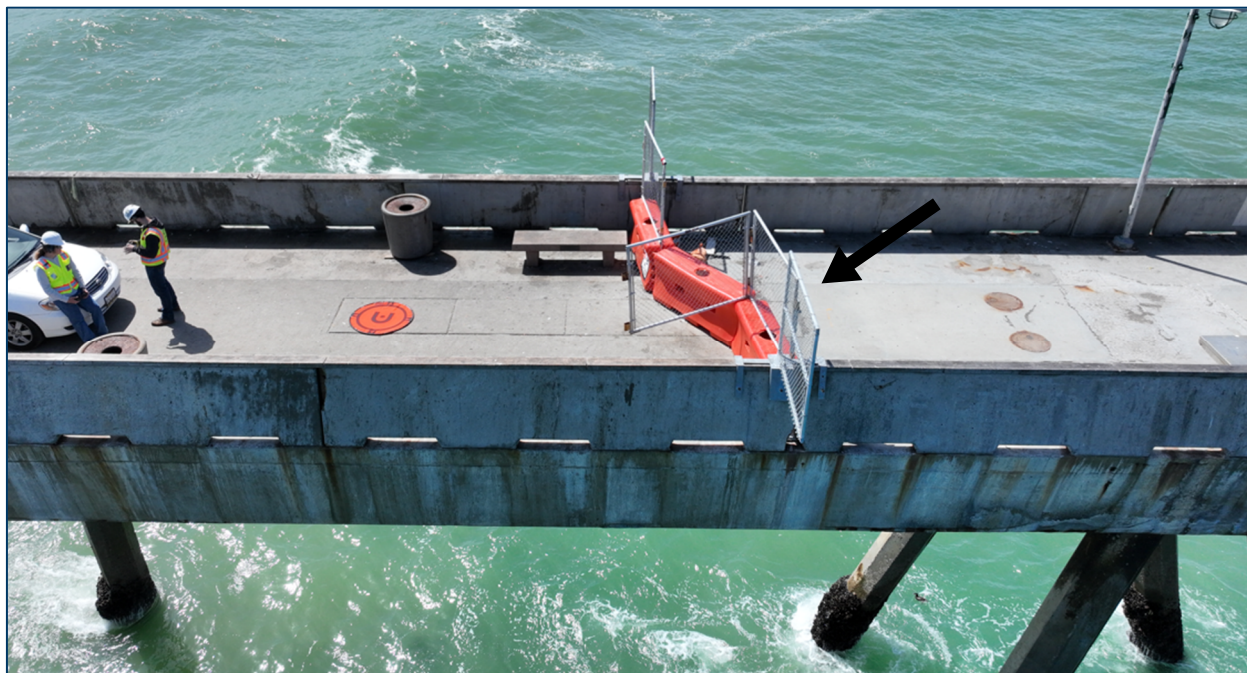
**Figure 1.2** Chain-link Fence on Main Pier near Bent K

It was also recommended to close the Pier before and during anticipated storm events that subject the piles to high winds, swells and large waves and conduct a post-event assessment to identify any critical damages before re-opening the Pier. The City of Pacifica had closed the Pier in December 2023 due to high winds and large swells. After a high-level assessment of the handrails in January 2024, the City re-opened portion of the Main Pier and installed chain-link fence preventing access beyond Bent J (Figure 1.2).

The City should continue to limit public access to the offshore end of the Main Pier and the Pier Extension until the piles, handrails and deck are repaired. Moving the current chain-link fence from Bent K to a location between Bent N and Bent P (last fish cleaning station) will be appropriate to prevent access to these areas. The large gaps in the handrails should be boarded to reduce risk of injury from exposed reinforcement and rough concrete surfaces.

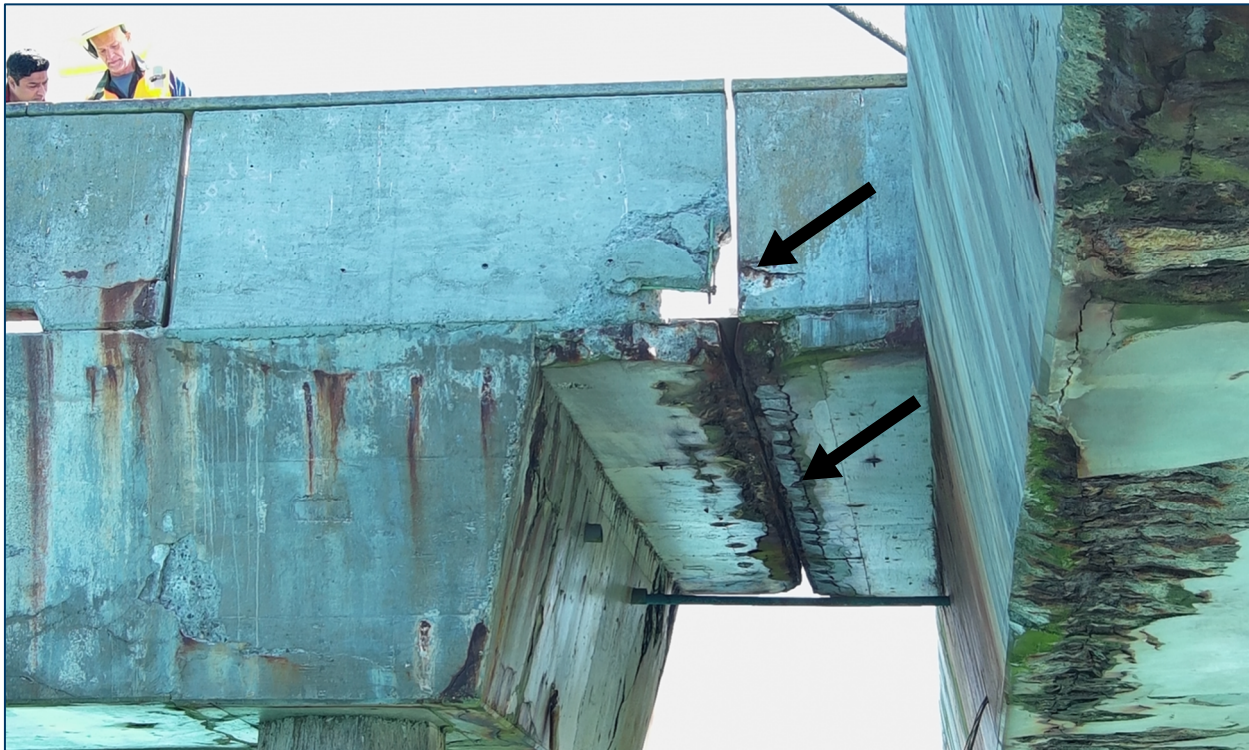
**Figure 3.1**      *Handrail and Deck Slab between Main Pier and Pier Extension, View toward East*

A few new damages were observed along the Pier after the seasonal storms between December 2023 and February 2024. The most notable damage occurred at the handrail between the Main Pier and Pier Extension as shown in Figure 3.1 and Figure 3.2.

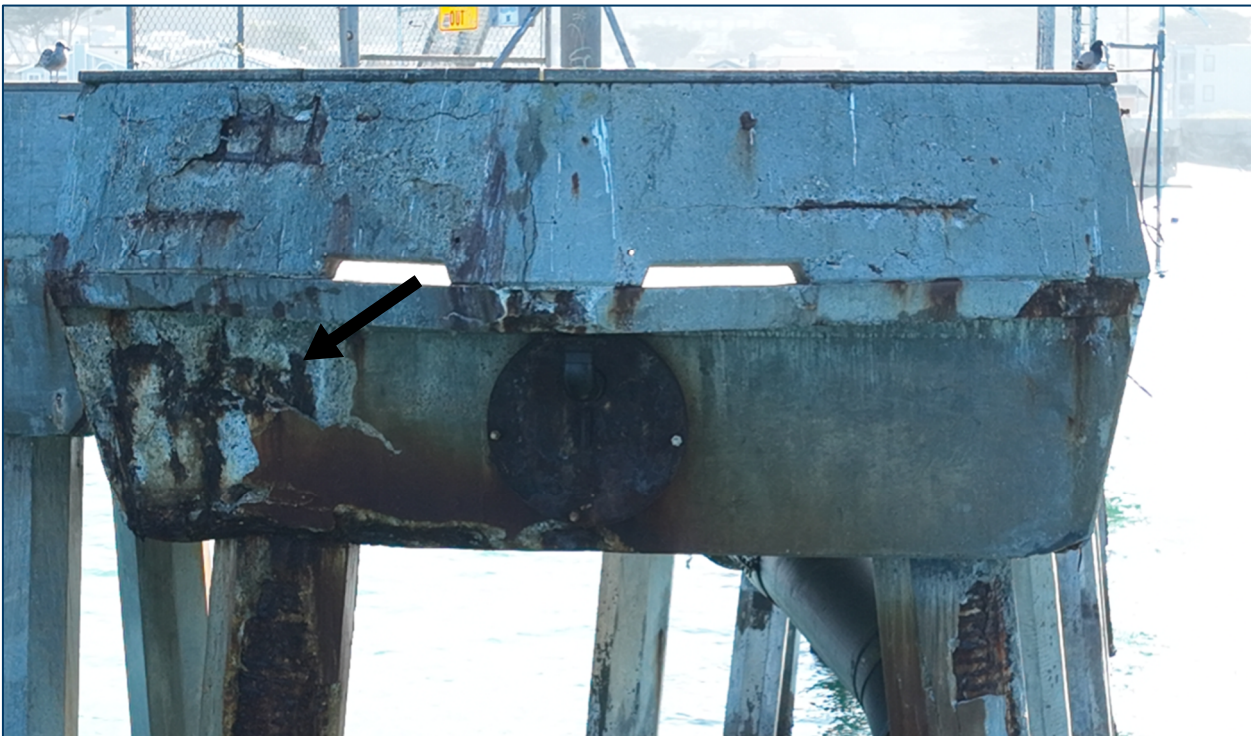
**Figure 3.3** Deck and Piles at Bent R, View toward East.

The end of the Pier deck and the piles at Bent R were previously noted to have cracks and spall damage. These damages have increased in size and have exposed the underlying corroded reinforcements (Figure 3.3 and Figure 3.4). A large section of the abandoned outfall pile that previously extended several feet toward the water along the southern pile of Bent R and the steel bracket connecting to the pile were missing (Figure 3.4 and Figure 3.5).

The offshore end of the Main Pier and the Pier Extension are exposed to most severe impacts from the storm events. The damaged piles along Bent R, Bent 3 and Bent 4 are recommended for repairs in the near term. The open spalls on these piles have increased in size and exposed more of the underlying corroded reinforcement. Although the piles and deck are not subject to heavy loads during non-storm season, these conditions will worsen over time and pose a significant risk to the stability of the structure.

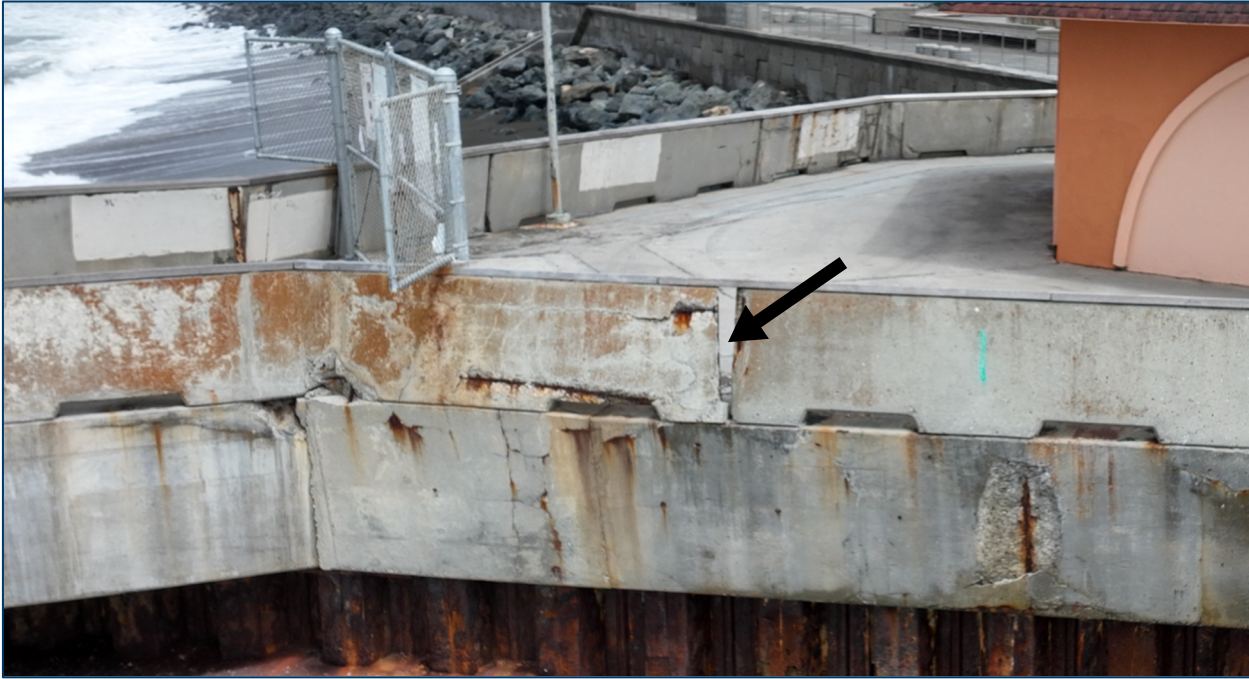
**Figure 3.6**      *Handrail near Gate on South side of Pier*

A few large openings were noted along the handrails as shown in Figure 3.6 through Figure 3.11. These openings have resulted from loss of previously spalled concrete. These damages are not anticipated to impact the functionality of the handrails but the open spall, exposed reinforcement and size of the openings greater than 4-inches pose a hazardous condition.

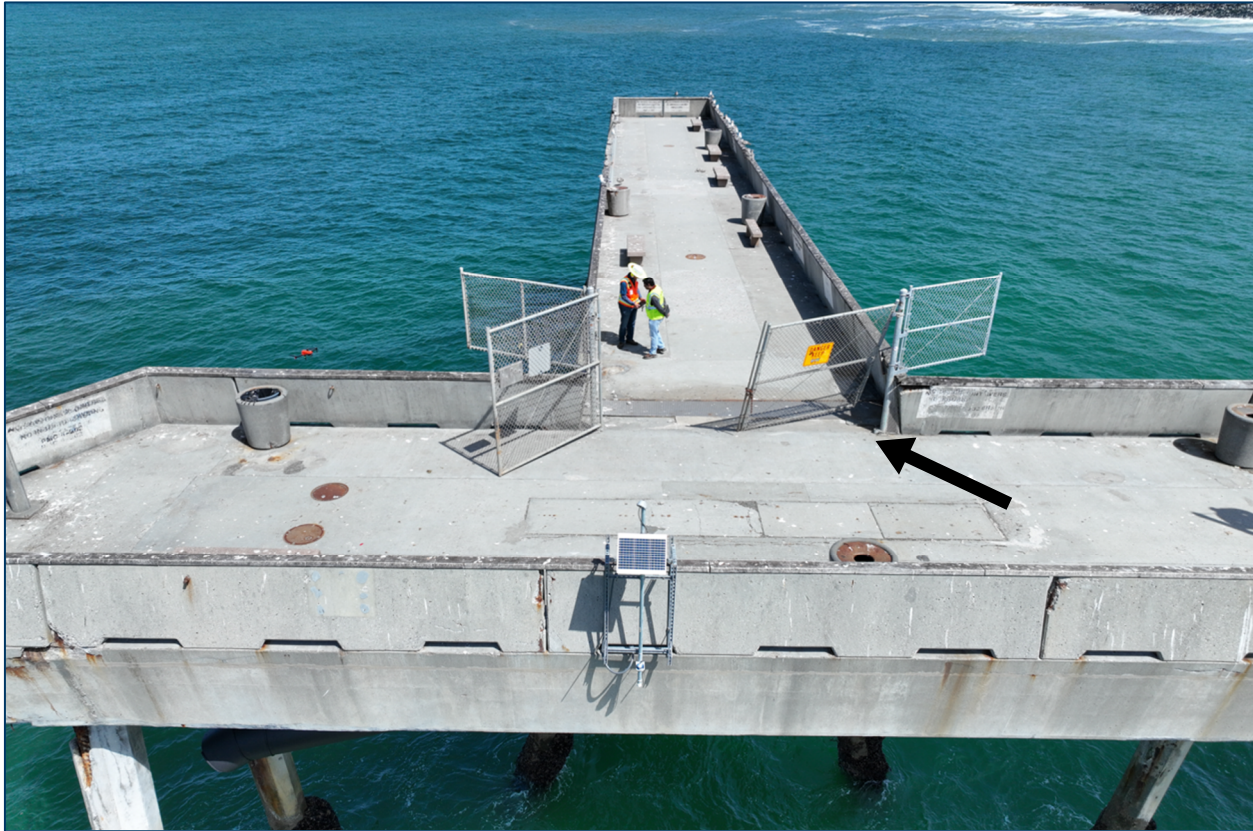
**Figure 3.12** Chain-link Fence between Main Pier and Pier Extension

The City had installed a chain-link fence to close access to the Pier Extension. The bottom of the fence panel was noted to have come off the connection.

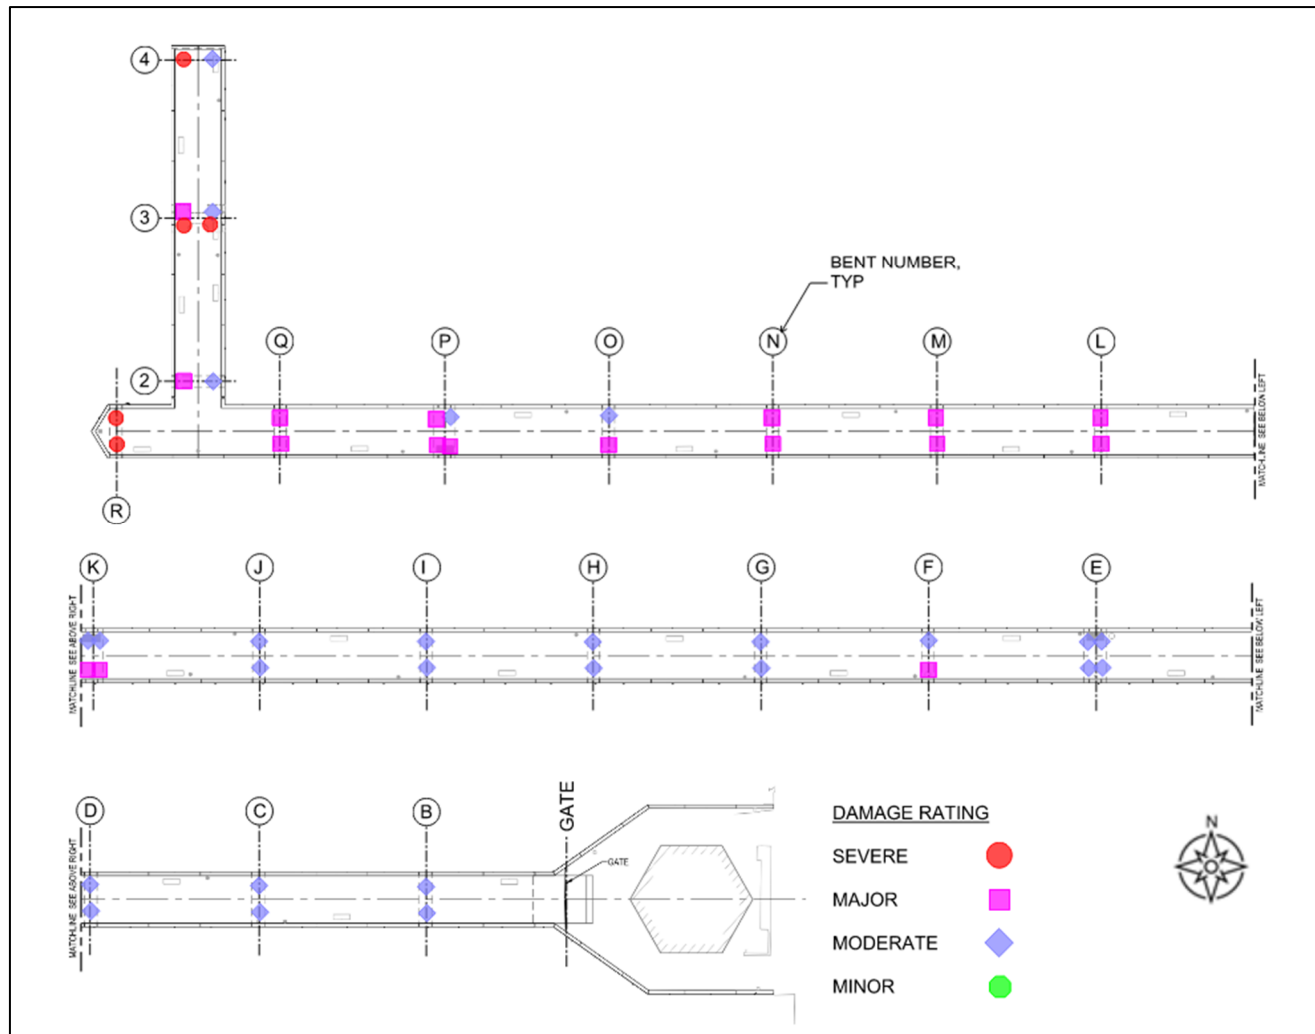
Figure 3.13 Damage Ratings – Piles, Above Water Observations 2024

Although the extent of spalling has increased on some of the piles along Bent R and under the Pier Extension, these piles were previously assigned a Severe damage rating. The damage ratings have not changed. A summary of the pile damage ratings is shown in Figure 3.13.
