November 23, 2020 Pacifica City Council Meeting Agenda Item #10

Additional Meeting Materials Agenda Item # 10

Kielty Arborist Services LLC

Site: 24 - 30 Salada Avenue, Pacifica CA

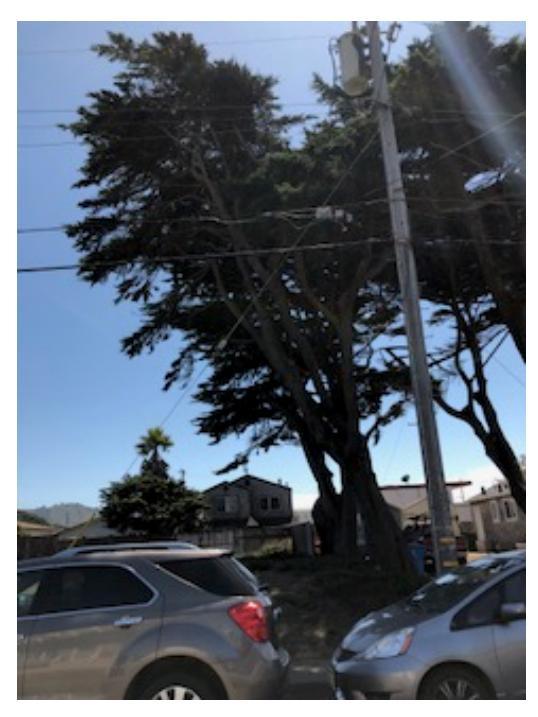
Five cypress trees at 24-30 Salada Ave. The trees have PGE electric power lines wired throughout and beneath.

The current conditions have most of the foliage and leaning trunks over the vacant lot with some overhanging limbs on the developed property side. High voltage utility lines and other electrical lines are within the tree canopies. Many of the limbs are heavy lateral limbs and are subjected to failure. Utility interruption and potential fire danger is at high risk as even a small limb failure can interrupt the utility service. Pruning the cypress trees for line clearance will remove a large portion of the canopies and would likely be beyond the tolerance of the trees. Pruning the cypress trees and their canopies for balance would be extremely difficult and maybe not possible as a large portion of the canopies should be removed which would likely be beyond the tolerance of the trees. Tree decline would be expected if more than 25% of the canopies were to be removed.

Pruning cypress trees #5 for line clearance would leave heavy lateral limbs over the rear residence. This would create an off-balanced canopy with the remaining canopy heavy over the residence. The rear residence would be a high value target of trees #4 and #5. Limb failure is the most likely part of the trees to fail as a history of limb loss in the canopies was observed.

The tree pruning needed for line clearance and to reduce risk of limb failure likely exceeds ANSI Standards. Pruning more than 25% of the tree canopies would weaken the trees and roots. Tree decline would be imminent.

Replacement of all five (5) cypress tree is the only method that eliminates all hazards and liabilities associated with the trees.

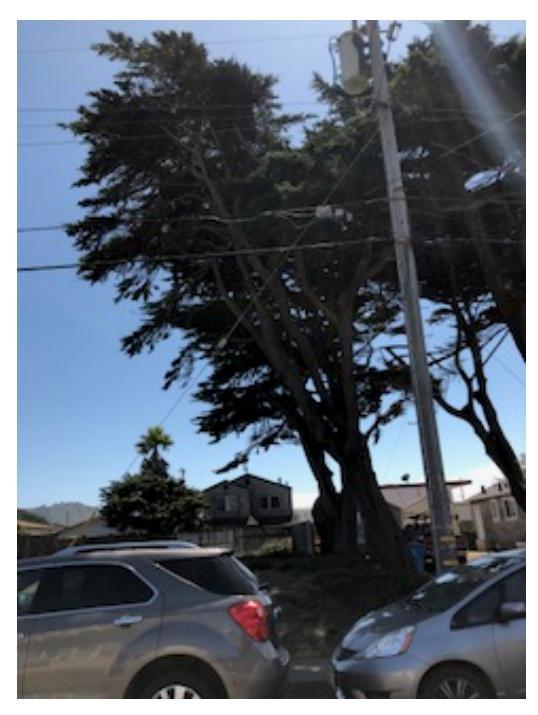
Five cypress trees at 24-30 Salada Ave. The trees have PGE electric power lines wired throughout and beneath.

The current conditions have most of the foliage and leaning trunks over the vacant lot with some overhanging limbs on the developed property side. High voltage utility lines and other electrical lines are within the tree canopies. Many of the limbs are heavy lateral limbs and are subjected to failure. Utility interruption and potential fire danger is at high risk as even a small limb failure can interrupt the utility service. Pruning the cypress trees for line clearance will remove a large portion of the canopies and would likely be beyond the tolerance of the trees. Pruning the cypress trees and their canopies for balance would be extremely difficult and maybe not possible as a large portion of the canopies should be removed which would likely be beyond the tolerance of the trees. Tree decline would be expected if more than 25% of the canopies were to be removed.

Pruning cypress trees #5 for line clearance would leave heavy lateral limbs over the rear residence. This would create an off-balanced canopy with the remaining canopy heavy over the residence. The rear residence would be a high value target of trees #4 and #5. Limb failure is the most likely part of the trees to fail as a history of limb loss in the canopies was observed.

The tree pruning needed for line clearance and to reduce risk of limb failure likely exceeds ANSI Standards. Pruning more than 25% of the tree canopies would weaken the trees and roots. Tree decline would be imminent.

Replacement of all five (5) cypress tree is the only method that eliminates all hazards and liabilities associated with the trees.
