SEA LEVEL RISE VULNERABILITY ASSESSMENT

Pacifica, CA

Prepared for
The City of Pacifica

January 2018

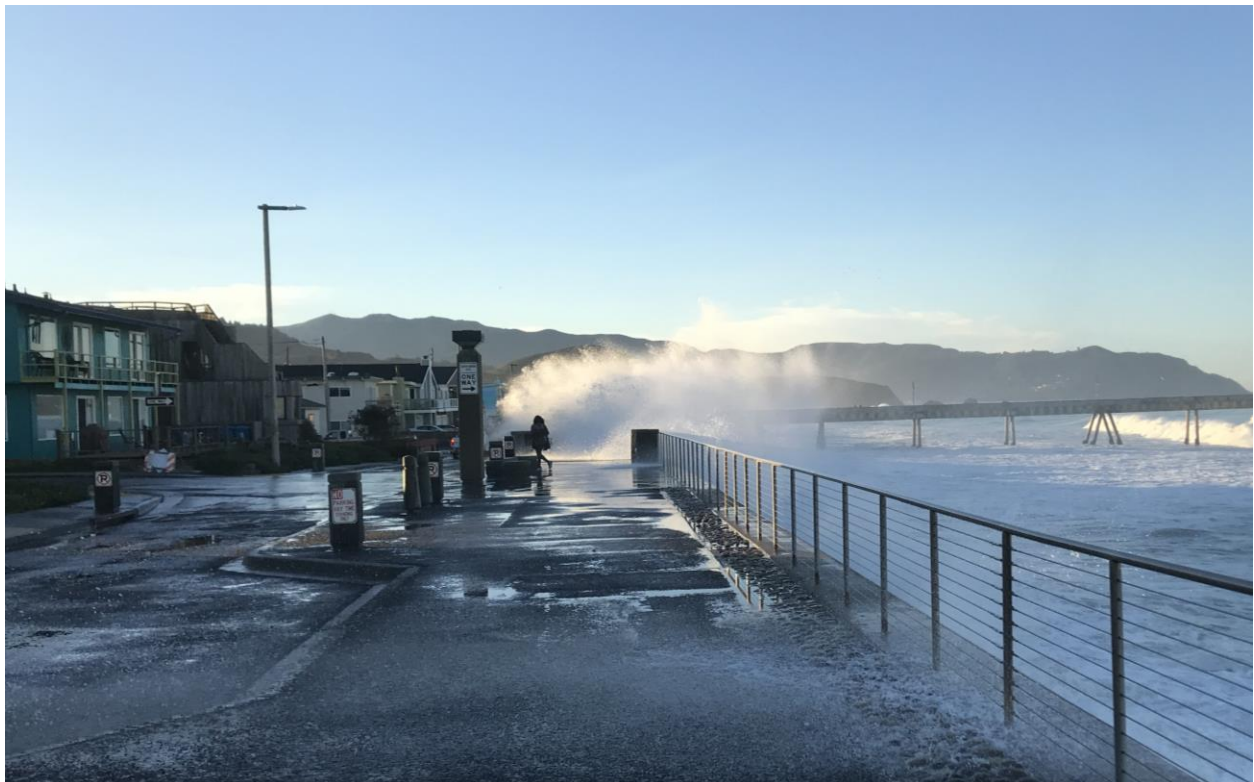
Near-king tides and high surf at Beach Boulevard on November 30, 2017 (J. Jackson)

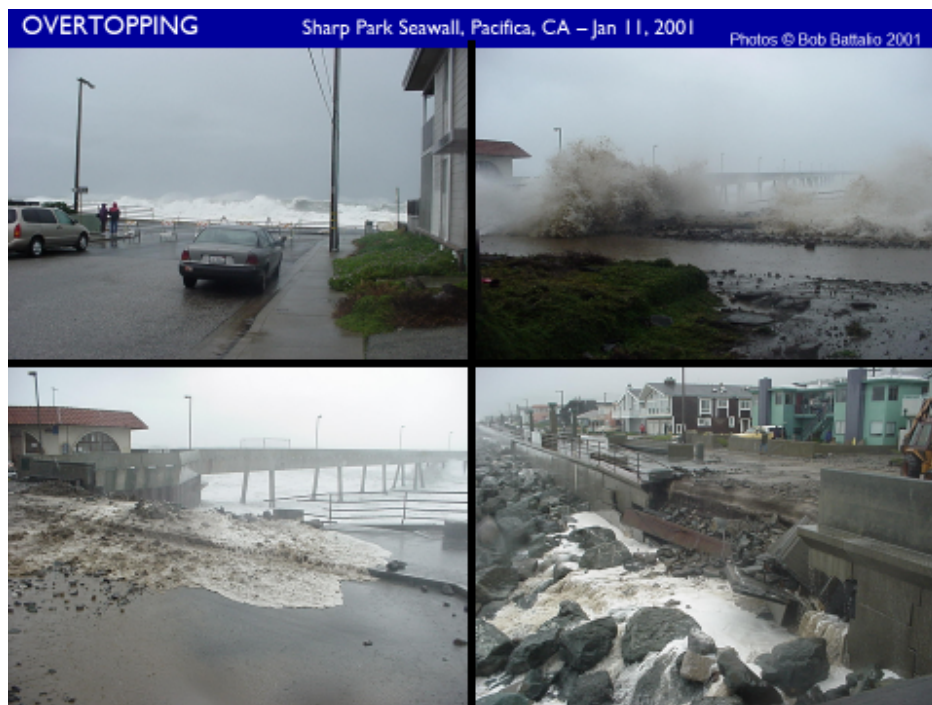
Figure 2
Observed flooding and erosion along Beach Blvd on January 11, 2001

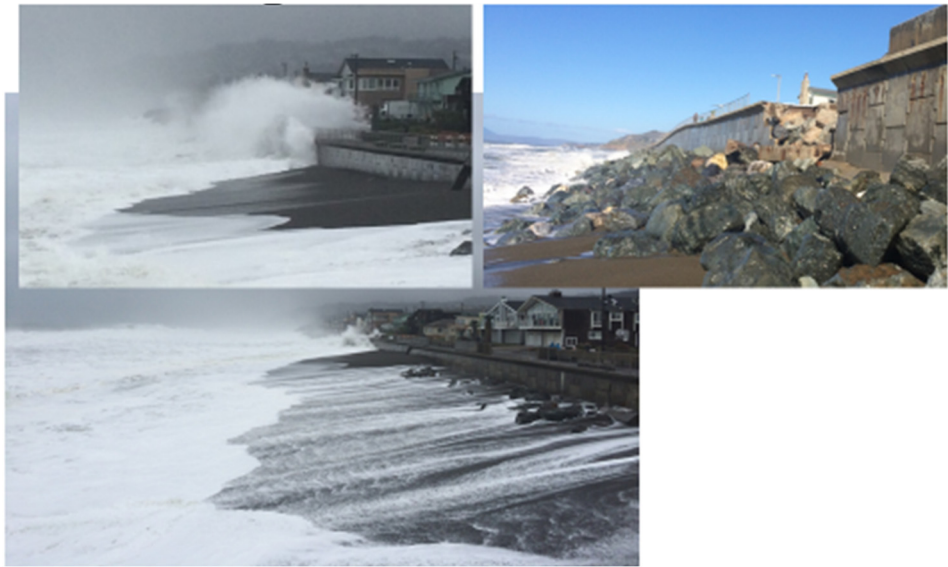
Figure 3
Observed flooding and erosion events at Pacifica on January 22, 2016

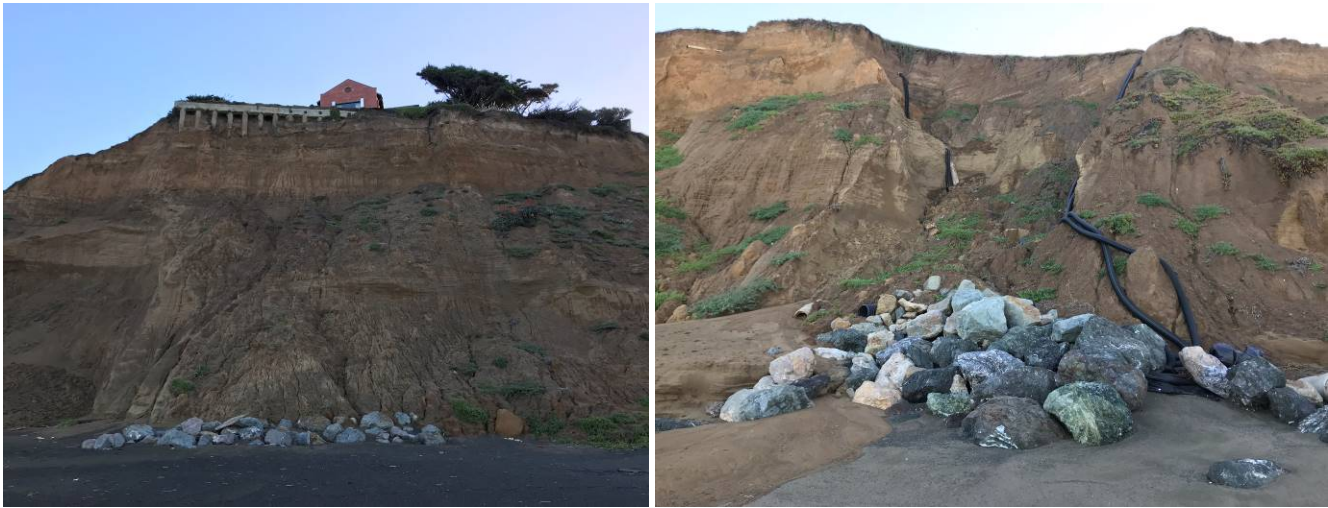
Figure 6
 Dollaradio Station with rock at toe and Piles at top of bluff (Left)
 Drainage pipes and terrestrial erosion of bluff south of Dollar Radio (Right)

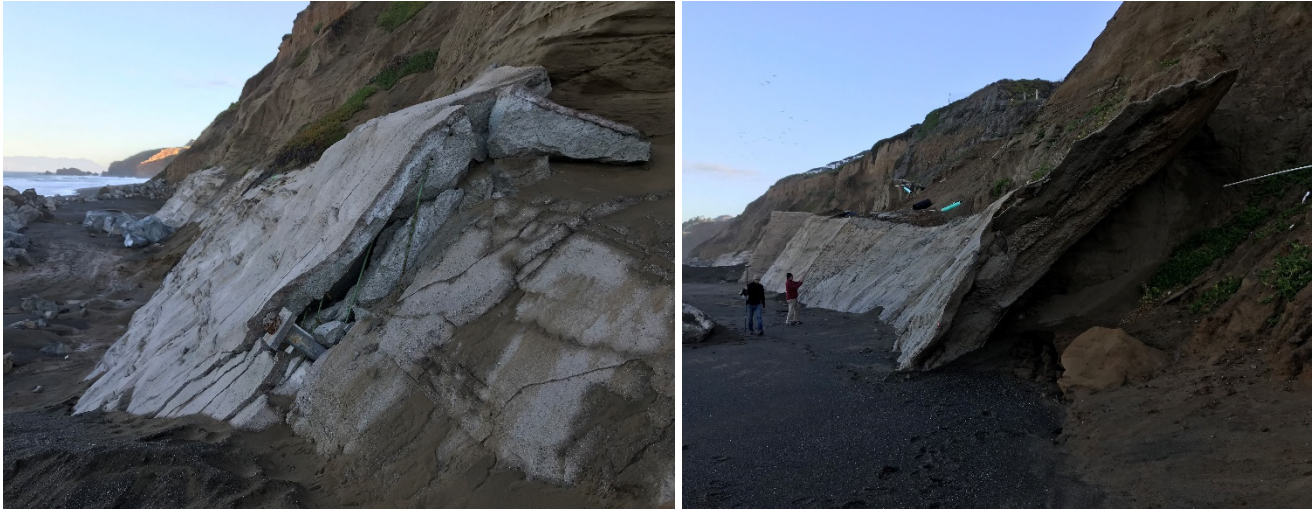
Failure of seawall caused by erosion behind structure and partial collapse

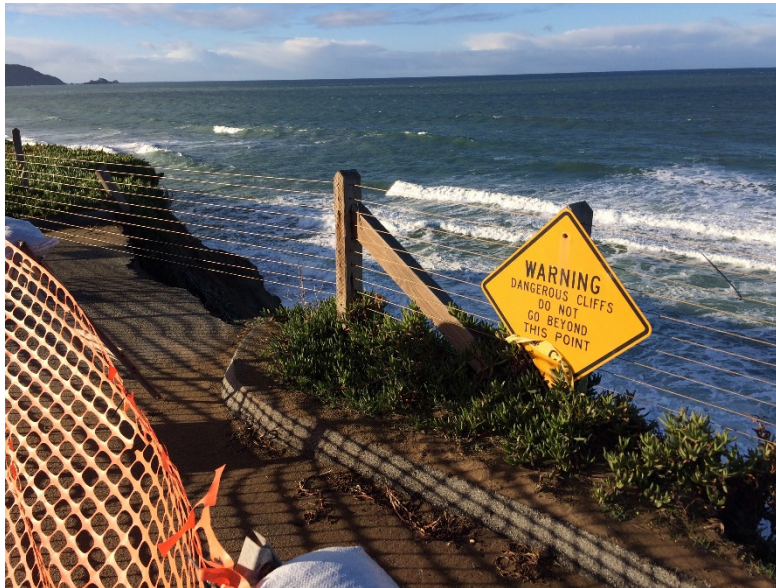
Figure 10
Bluff top trail at Esplanade Ave at risk of erosion (photograph Dec 20 2017)

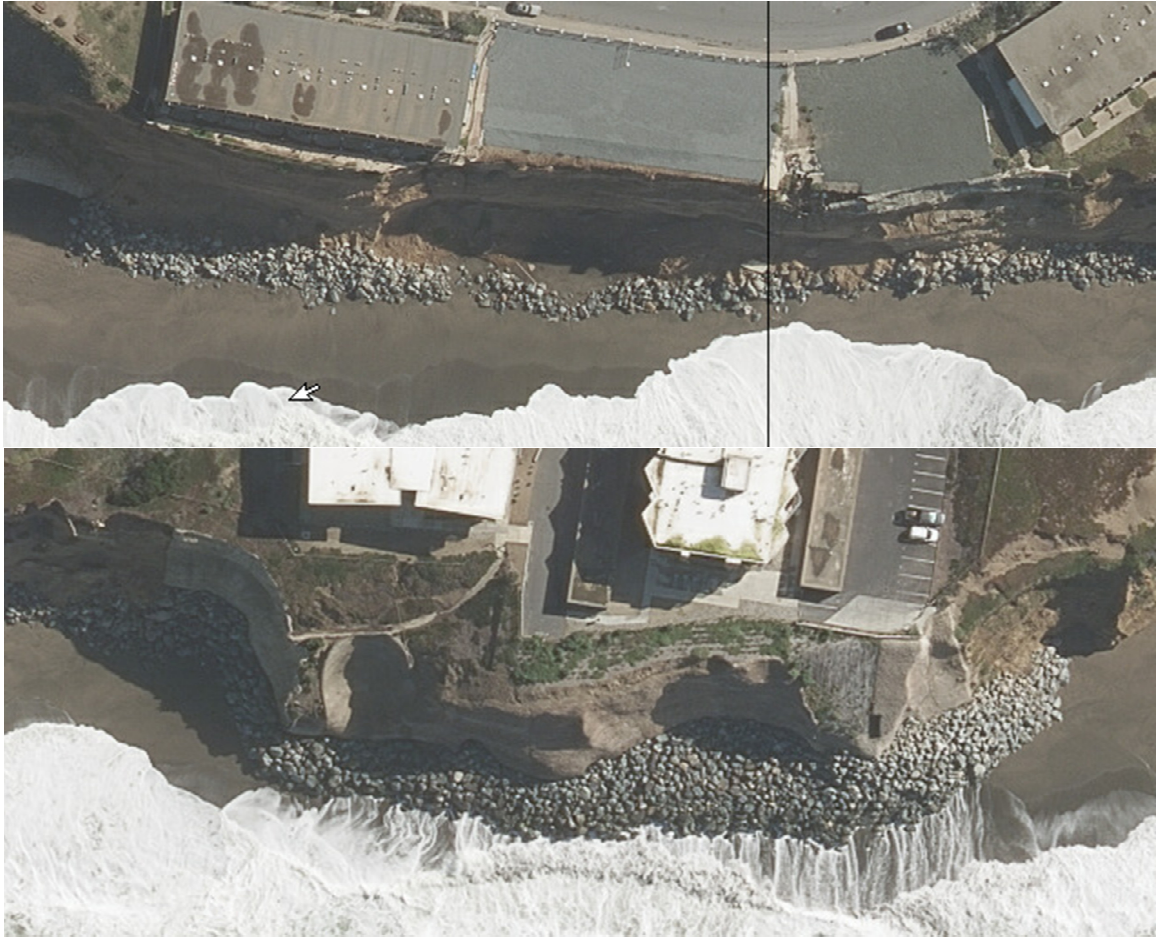
Figure 11
Bluff toe armorment and erosion at Esplanade blufftop apartments (top)
Bluff toe and face armorment at The Bluffs apartments (bottom)

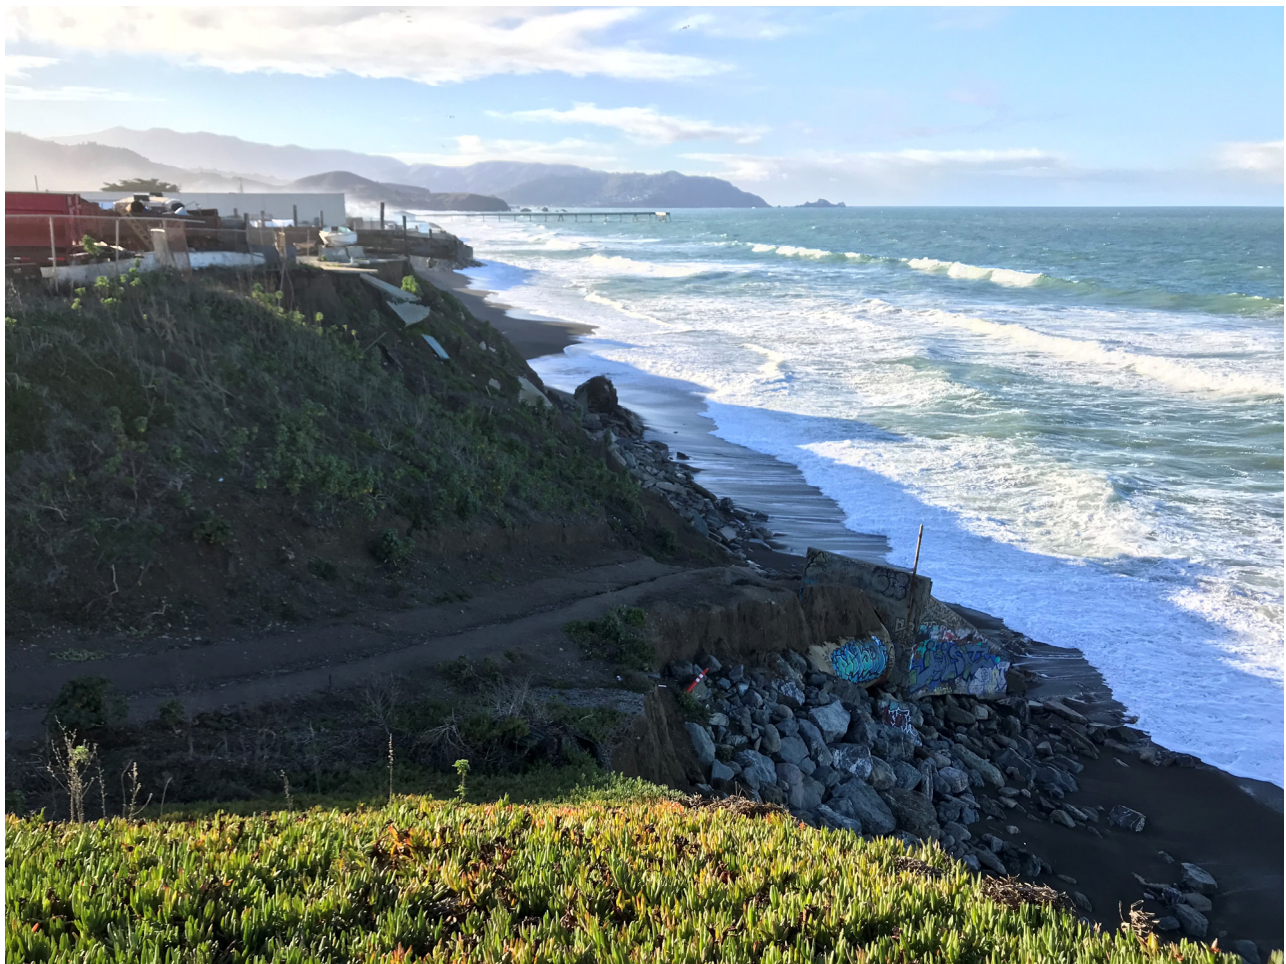
Figure 13
 Damaged stormwater outfall in foreground, landfill and eroded rubble on narrow beach beyond
