Utility Cut Impact Assessment and Fee Development Final Report

NCE Project No. 1004.05.55
Jan 2022

City of Pacifica

Utility Cut Impact Assessment and Fee Development

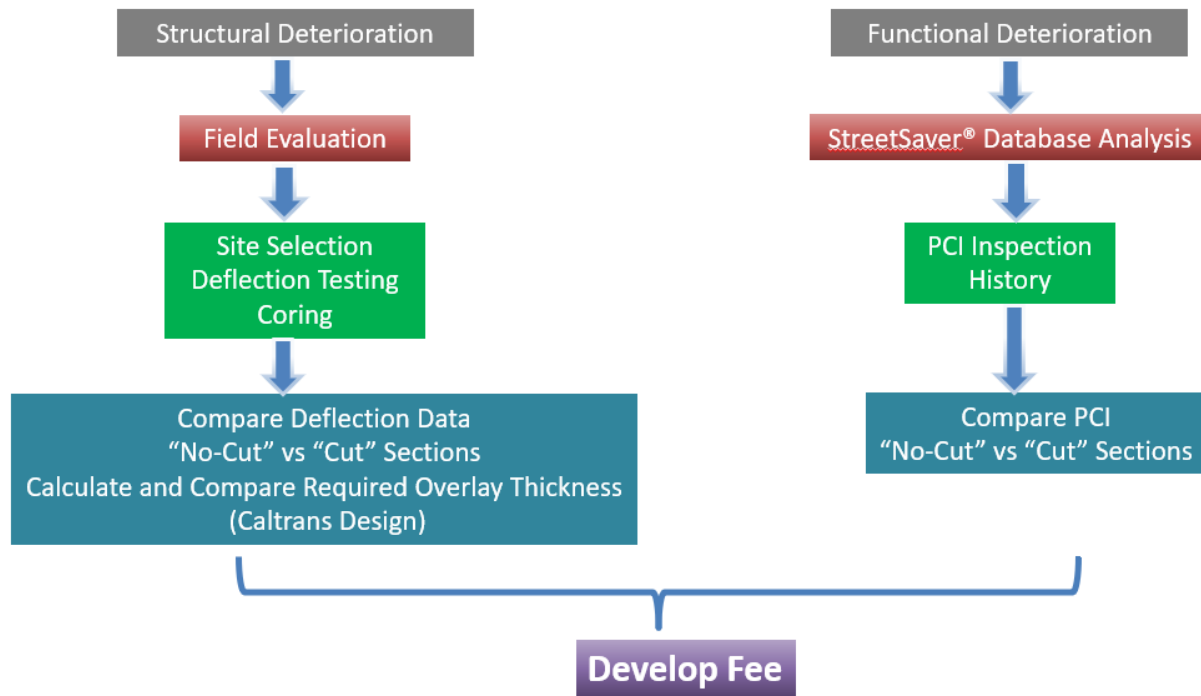
Figure 2. Technical Approach

The flowchart shown in Figure 2 presents the methodology for this study where both structural and functional deterioration approaches were used to evaluate the pavement damage due to the cuts. As shown, the functional deterioration approach was conducted using distress data from the StreetSaver[®] database and field testing was used to estimate loss in structural capacity due to cuts (structural deterioration approach).

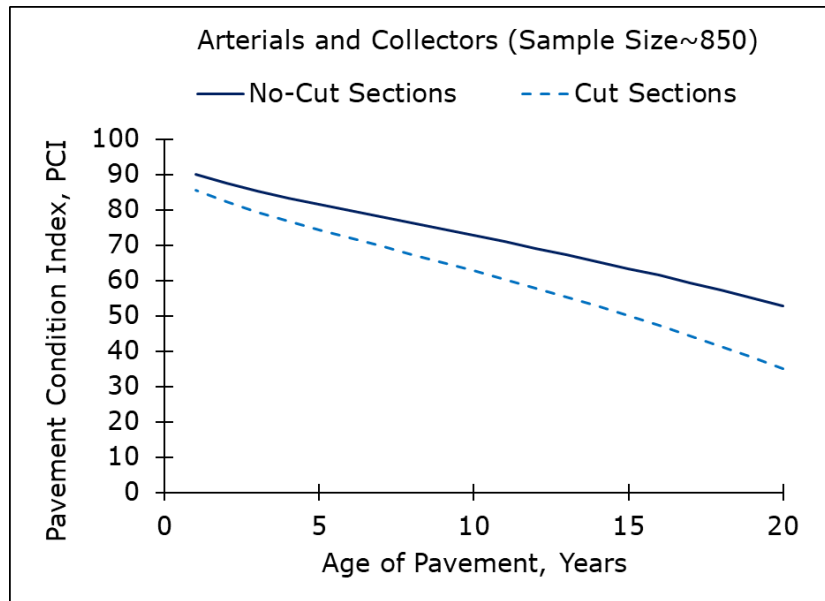
Figure 5. Pavement Deterioration Curve for Cut and No-Cut Sections – Arterials and Collectors

Pavement deterioration curves of cut and no-cut sections for arterials/collectors and residential were developed using the historical data from the City's database. These curves are shown in Figures 5 and 6.

- For arterials/collectors, overall sections with cuts deteriorate more rapidly than sections without cuts within all age groups.
- For residential, the above observation is true for pavements less than 15 years old. Some streets more than 15 years did not exhibit this trend due to the existing distresses present.

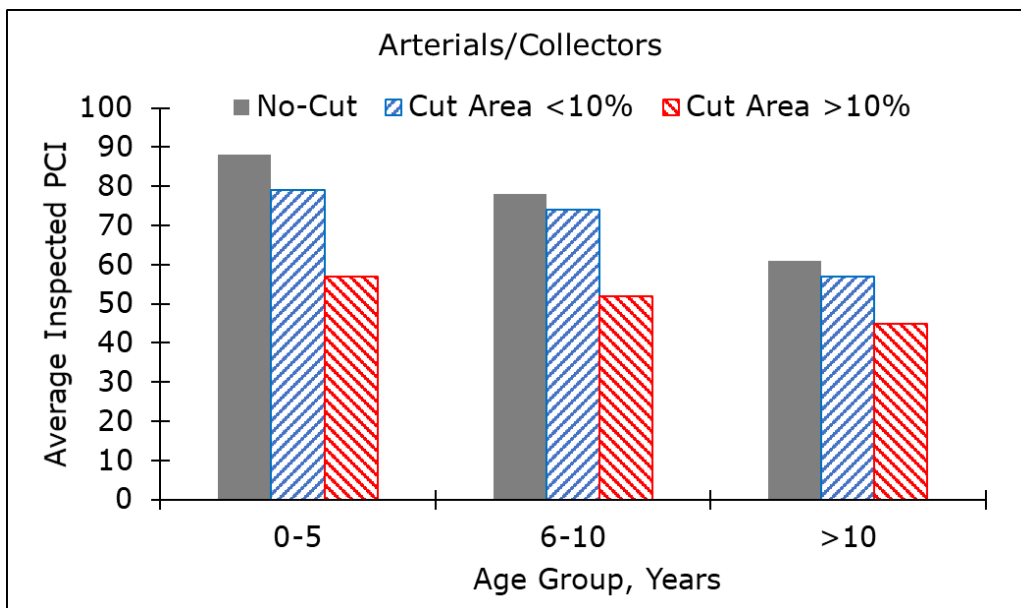
Figure 7. PCI Comparison by Functional Class, Age Group and Cut Size – Arterials/Collectors

- Overall PCI decreases with pavement age.
- The PCI decreases as the cut size increases.

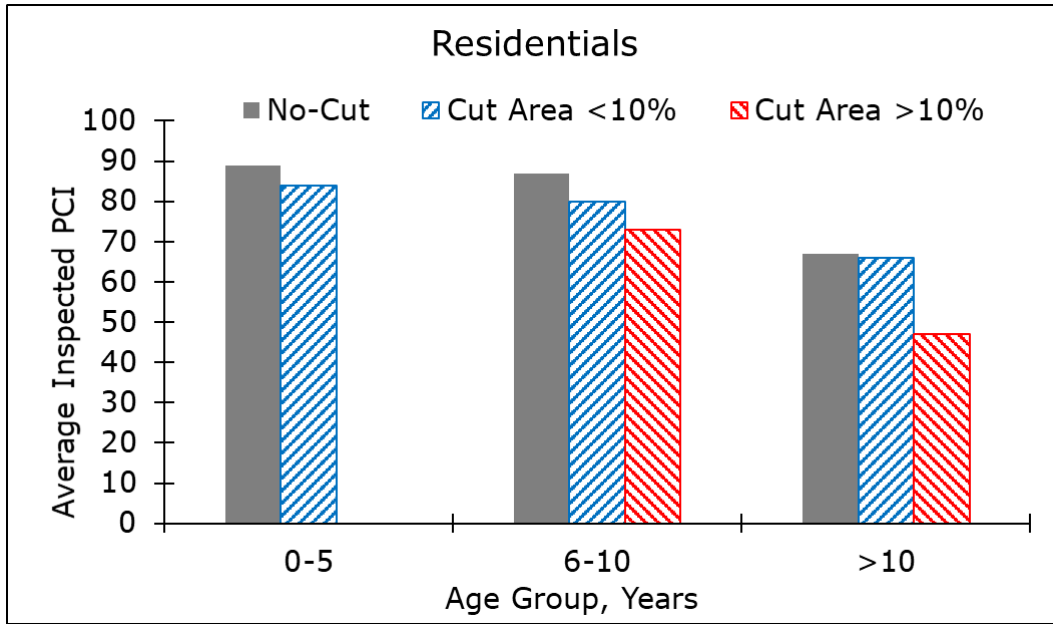
Figure 8. PCI Comparison by Functional Class, Age Group and Cut Size – Residential

Note that data points for newer residential streets with large cuts were not available.

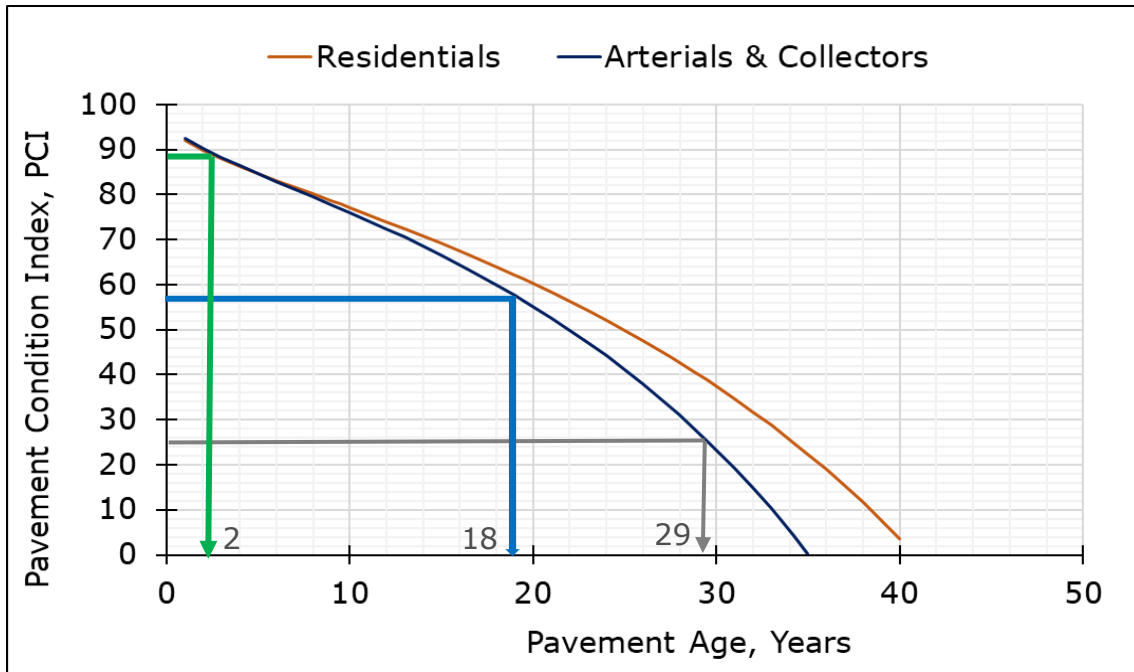
Figure 10. Example of Percent Reduction in Life

For example (see Figure 10), an arterial/collector (aged 0-to-5 years) with no cut has a PCI of 89. Based on the analysis in the previous section, a cut area greater than 10% of the section area would drop the PCI to 57. A PCI of 89 for arterials/collectors corresponds to an equivalent service life of approximately 2 years, whereas a PCI of 57 corresponds to an equivalent service life of 19 years. Consequently, the cut in this example reduces the pavement service life by 17 years, or 58% of its 29.5-year service life.

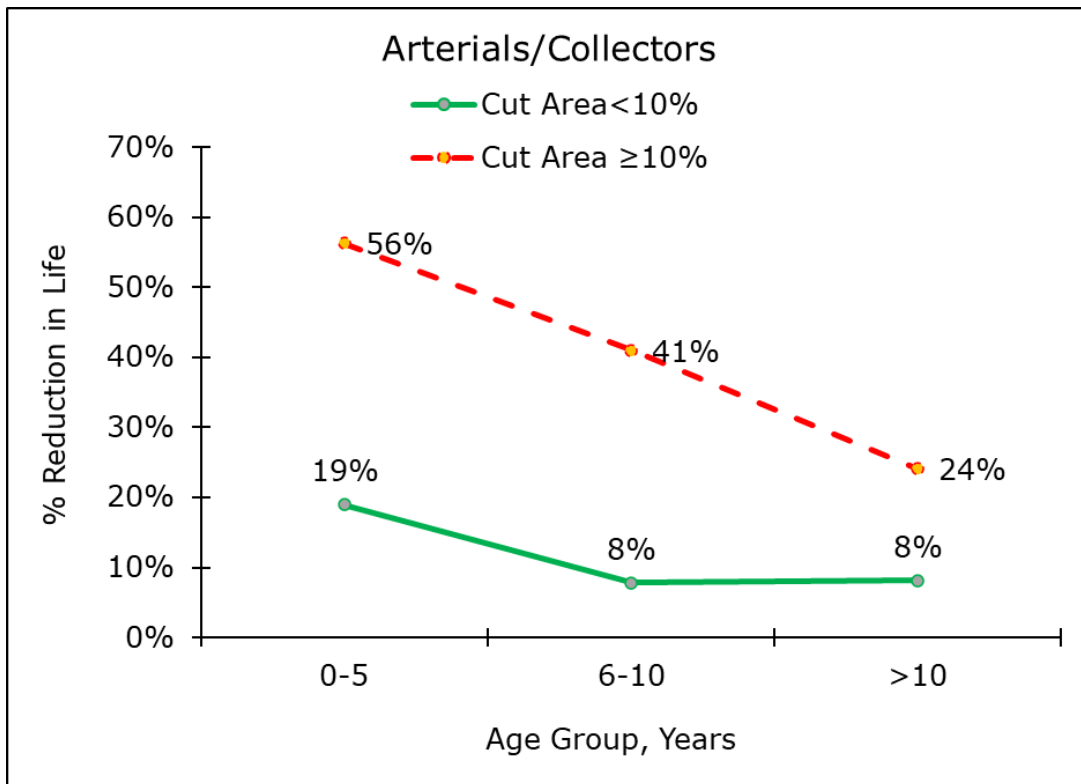
Figure 11. Percent Reduction in Pavement Service Life -Arterials/Collectors

The above calculation was performed for both functional classes in all age groups and for all cut sizes to estimate the percent reduction in pavement service life and illustrated in the Figures 11 and 12.

Figures 11 and 12 indicate the following:

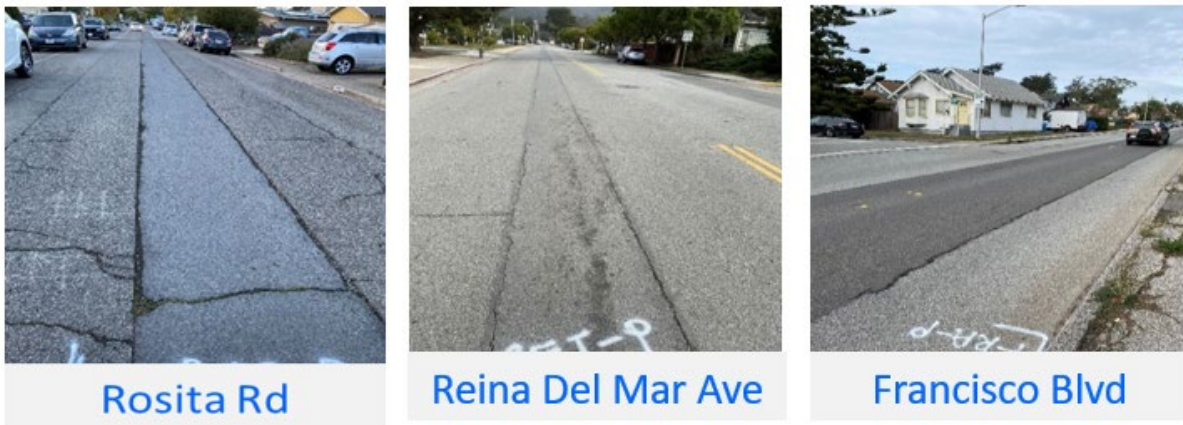
Figure 16 Typical Full Block Trench Cut in Pacifica

For large cuts, we observed many full-block longitudinal trench cuts (Figure 16). A cut of this type would be equal to or greater than 10% of the section area and thus \$3.00/SF would be charged for the full recovery.
