Pacifica Municipal Fishing Pier

2023 Condition Assessment Report

City of Pacifica

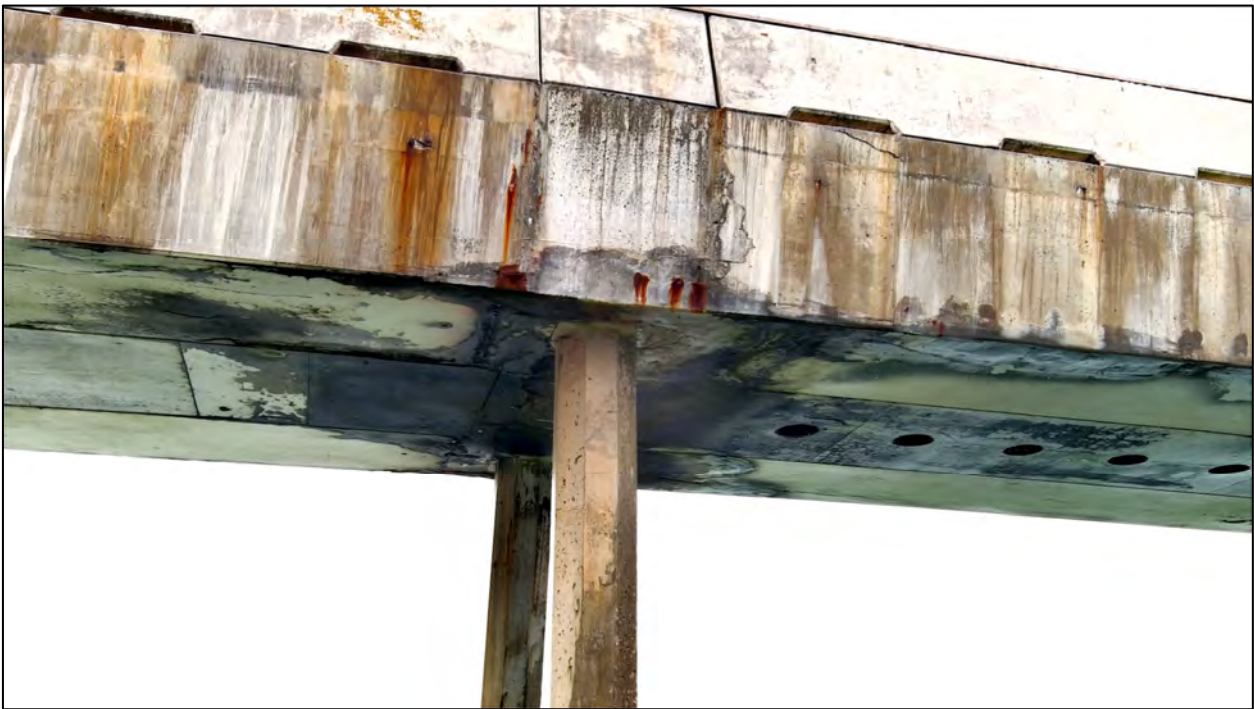
Figure 4.7 **Deck Major Rating (Bent 1F)**

The condition of the Pier exterior sides and soffits were assessed from the images captured by the drone. The images were reviewed by GHD's engineers to identify damages such as discoloration from algae growth, rust stains, cracks, and spalls. Typical damages on the sides and soffits of the deck and bent caps are shown in Figure 4.6 through

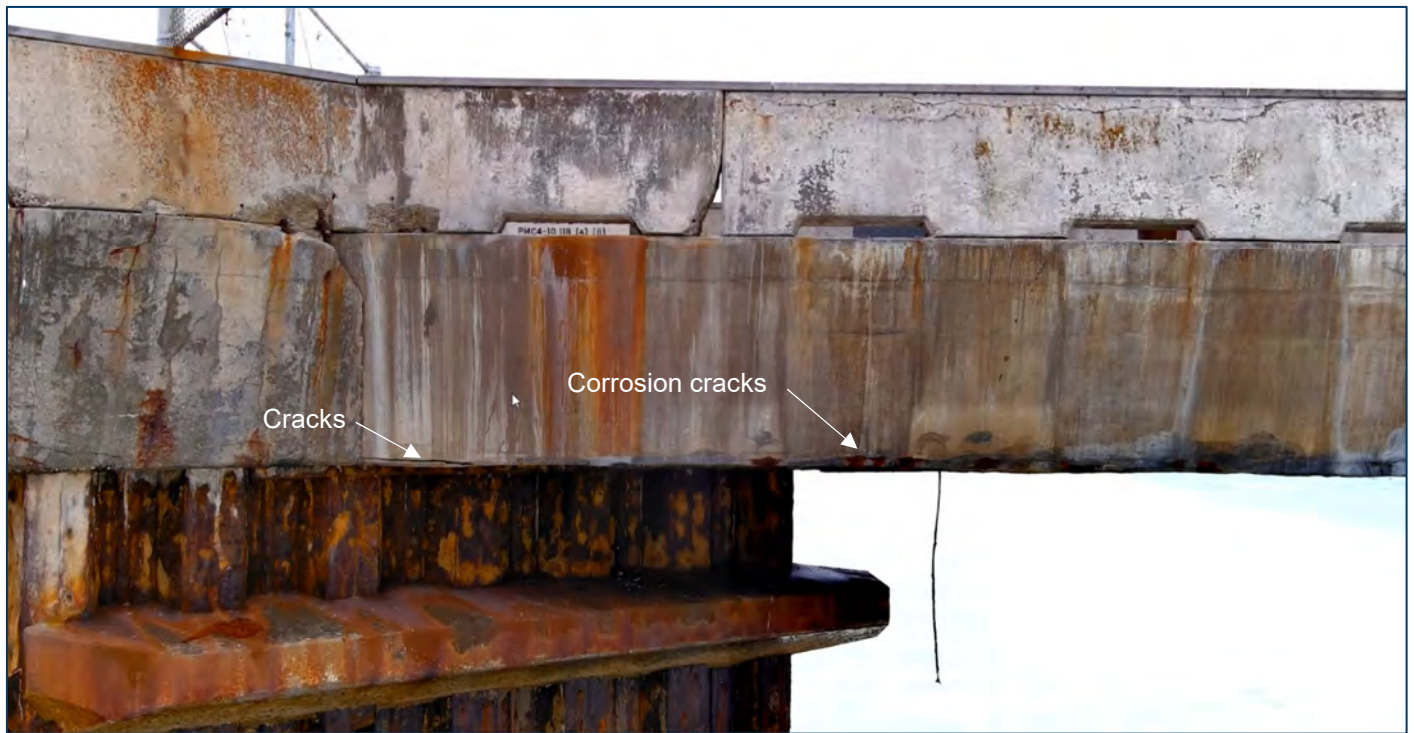
Figure A.3-7 Deck Exterior between Pier Abutment and Bent 1B – North Face

- Unattended broken wiring coming out of the deck underside.
- Discoloration of concrete (black/green algae)
- Rust bleed stains around deck and handrail connection
- Moderate to Severe corrosion and structural spalls with visible rebar
- Moderate to Major cracks and rust bleed stains around deck underside edges
- Overall rating of deck – Severe

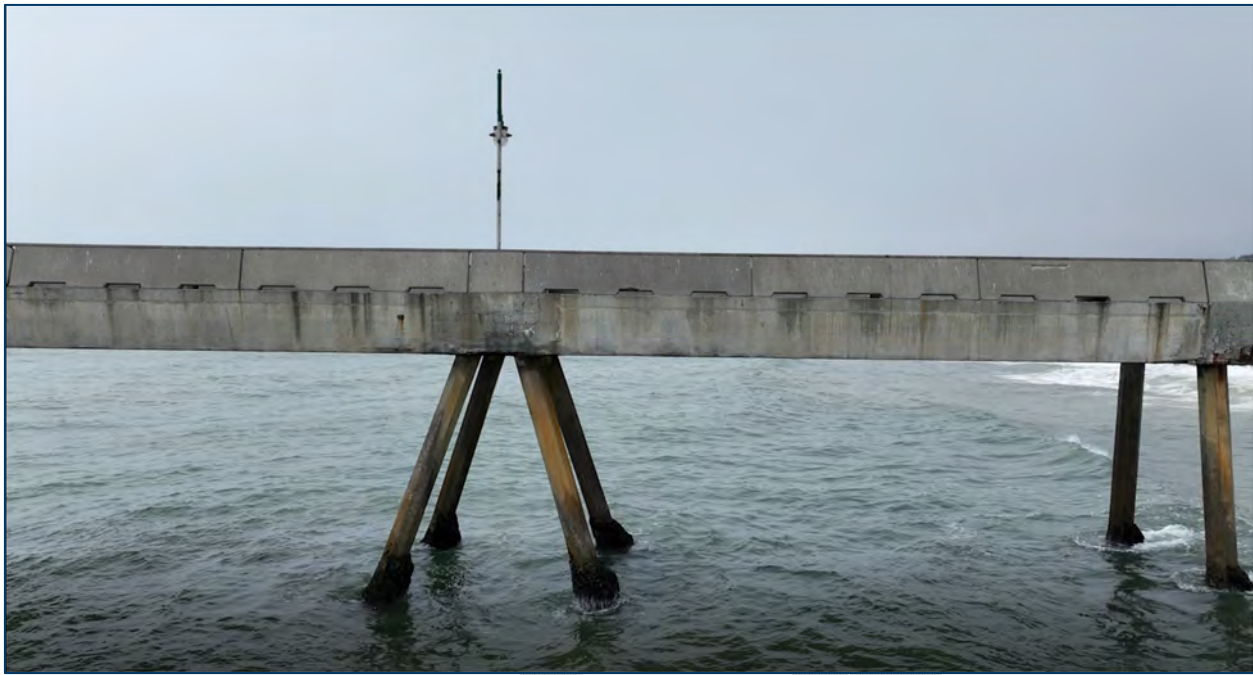
Figure A.3-22 Deck Exterior around Bent 1E – South Face

- Rust bleed stains around deck and handrail connection at some places, deck and bent connection
- Moderate to Severe corrosion and structural spalls on deck between Bent 1D and 1E – Visible rebar
- Moderate to Major cracks around and under Bent 1E
- Moderate cracks on deck between Bent 1D and 1E
- Rust stains and moderate cracks on piles
- Abrasion on piles
- Minor impact spalls on piles
- Overall rating for Deck – Severe
- Overall rating for Bent - Major

Overall rating for Pile - Moderate

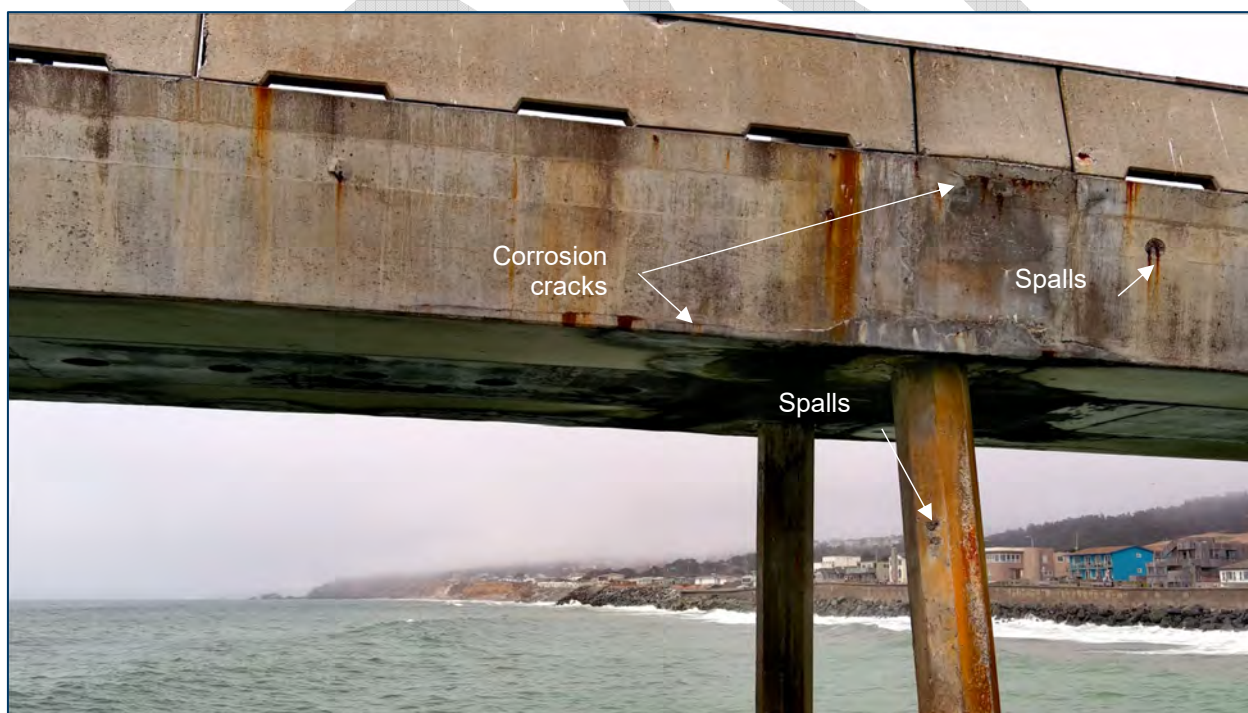
Figure A.3-29 Deck Exterior at Bent 1F – South Face

- Discoloration of concrete (black/green algae)
- Rust bleed stains around deck and handrail connection at some places, deck and bent connection
- Moderate to Major corrosion and structural spalls on deck between Bent 1E and 1F
- Moderate to Major corrosion and structural spalls around Bent 1F
- Moderate to Major cracks around and under Bent 1E
- Moderate to Major cracks between Bent 1E and 1F
- Rust stains and moderate cracks on piles
- Abrasion on piles
- Minor impact to Major corrosion/structural spalls on piles
- Overall rating for Deck – Major
- Overall rating for Bent - Major
- Overall rating for Pile – Bent F-N – Moderate, Bent F-S - Major

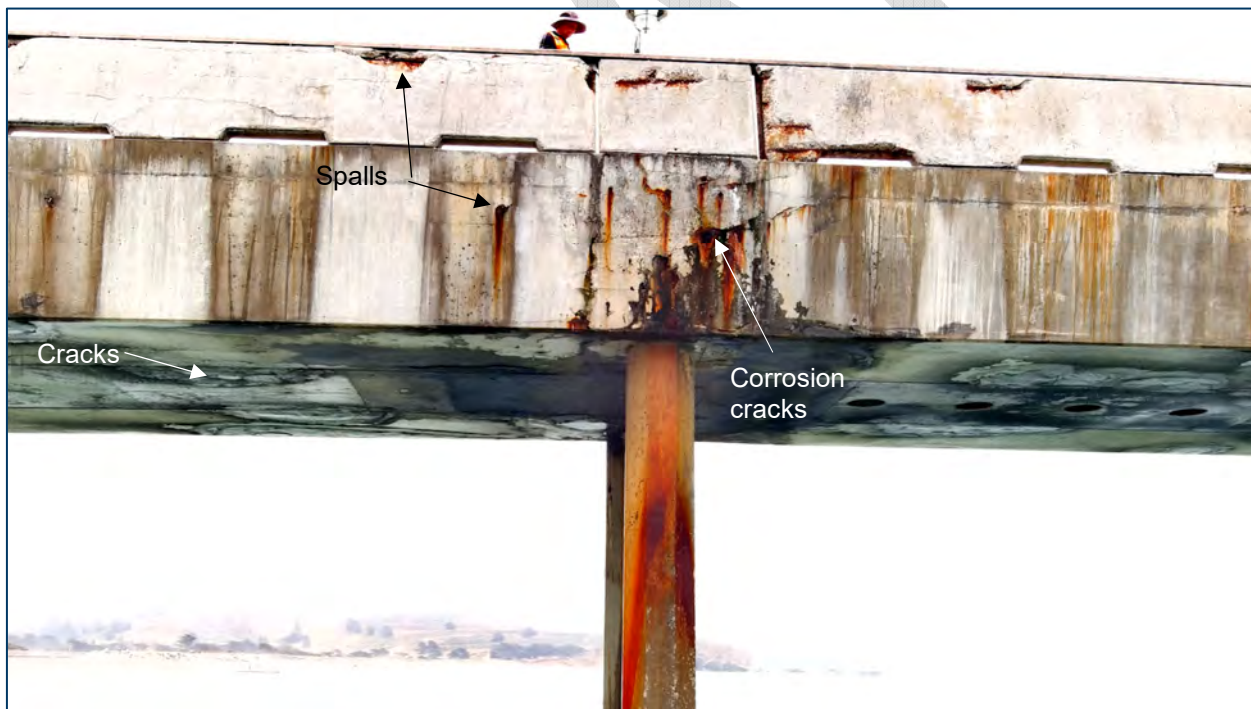
Figure A.3-32 Deck Exterior at Bent 1G – North Face

- Discoloration of concrete (black/green algae)
- Rust bleed stains around deck and handrail connection at some places, deck, and bent connection
- Moderate to Major corrosion and structural spalls on deck between Bent 1F and 1G
- Moderate to Severe corrosion and structural spalls around Bent 1G
- Moderate to Major cracks around and under Bent 1G
- Moderate to Major cracks between Bent 1F and 1G
- Rust stains and moderate cracks on piles
- Abrasion on piles
- Minor impact spalls on piles
- Overall rating for Deck – Major
- Overall rating for Bent - Severe
- Overall rating for Pile - Moderate

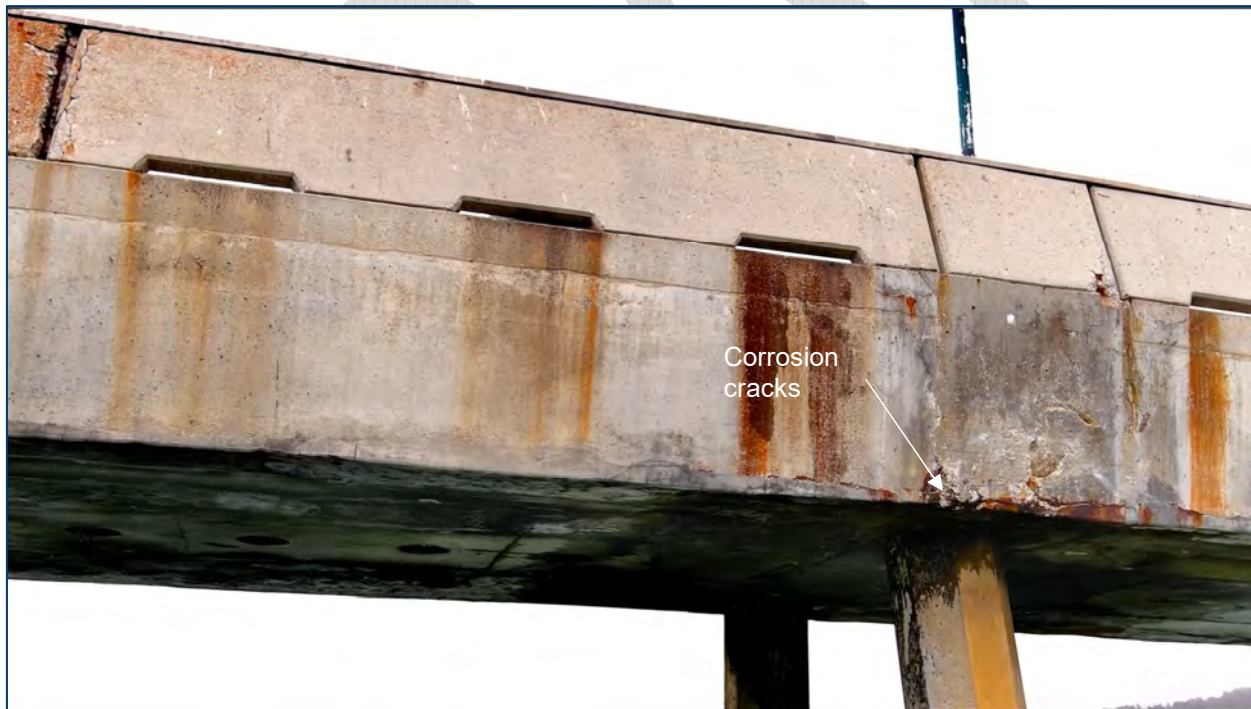
Figure A.3-40 Deck Exterior at Bent 1I – South Face

- Discoloration of concrete (black/green algae)
- Rust bleed stains around deck and handrail connection at some places, deck and bent connection (bearing plate connection)
- Minor impact spalls between Bent 1H and 1I
- Moderate to Major corrosion and structural spalls around Bent 1I
- Moderate to Major cracks around and under Bent 1I
- Minor to Moderate cracks between Bent 1H and 1I
- Rust stains and moderate cracks on piles
- Abrasion on piles
- Minor impact spalls on piles
- Overall rating for Deck – Moderate
- Overall rating for Bent - Major
- Overall rating for Pile - Moderate

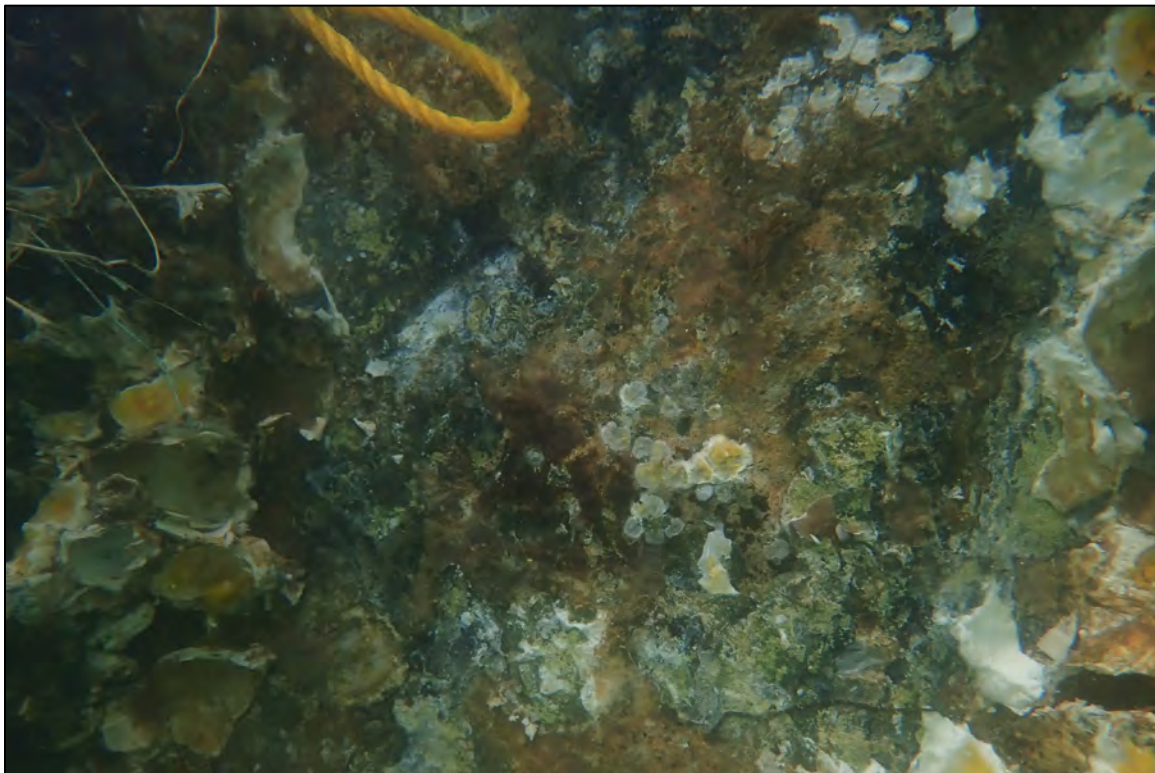
PHOTOGRAPH 10: Pile K-SW Level II tidal zone closeup

The underwater portions of the inspected Pacifica Municipal Pier prestressed concrete piles are in **Good** condition, with no damage observed. However, it should be noted that the overall condition of the piles is downgraded when considering damage above MHW and outside of the underwater inspection. Numerous open spalls with exposed reinforcement, closed spalls, cracks, and evidence of corrosion exist above MHW (out of scope). Two piles have above-water cracks that extend to the top of the marine growth; however, underwater, no evidence of the crack could be found. One of these cracks is located on Pile K-SW, where a Level II

underwater inspection cleaning was done. No evidence of the crack was found on the cleaned portion of the pile below water.
