SEA LEVEL RISE VULNERABILITY ASSESSMENT

Pacifica, CA

Prepared for
The City of Pacifica

January 2018

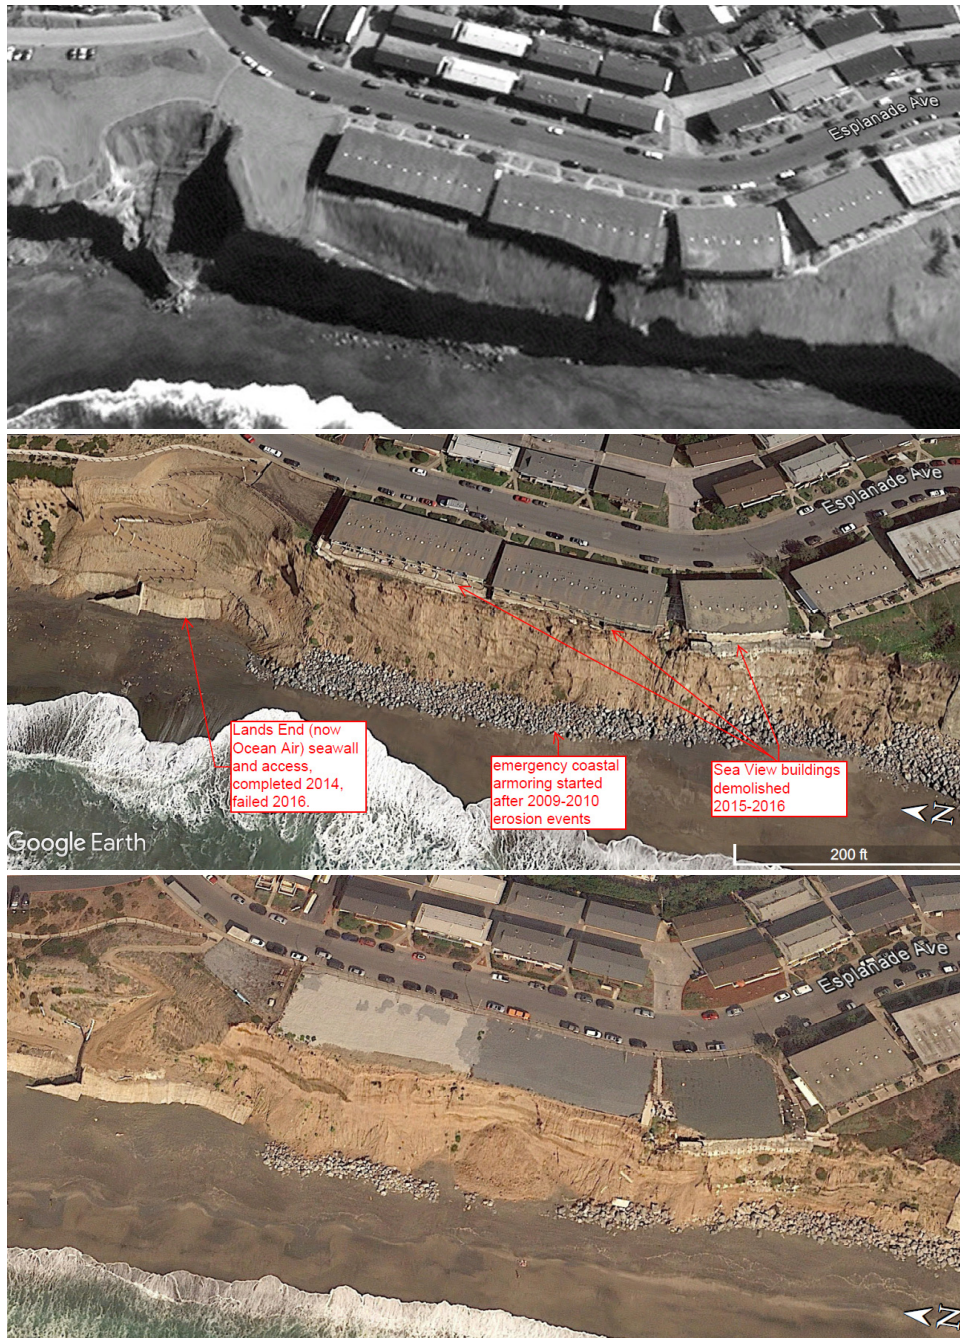
Failure of seawall caused by erosion behind structure and partial collapse

Immediately south, erosion of the bluff face has led to the removal of three multi-unit apartment buildings on Esplanade Avenue since 2015 (310, 320, 330 Esplanade Avenue) despite the presence of a rock revetment at the bluff toe. Existing coastal structures were upgraded since 2015 and expanded in the last to cover the entire bluff face at The Bluffs apartments (380 Esplanade Avenue). Erosion in northern Pacifica 2009-2016 led to a substantial expansion of coastal armoring as well as demolition of three apartment buildings and loss of public access to the beach. Figure 9 compares the progression and impacts of erosion along Esplanade Avenue in three aerial photographs taken in 2009, 2014, and 2016.

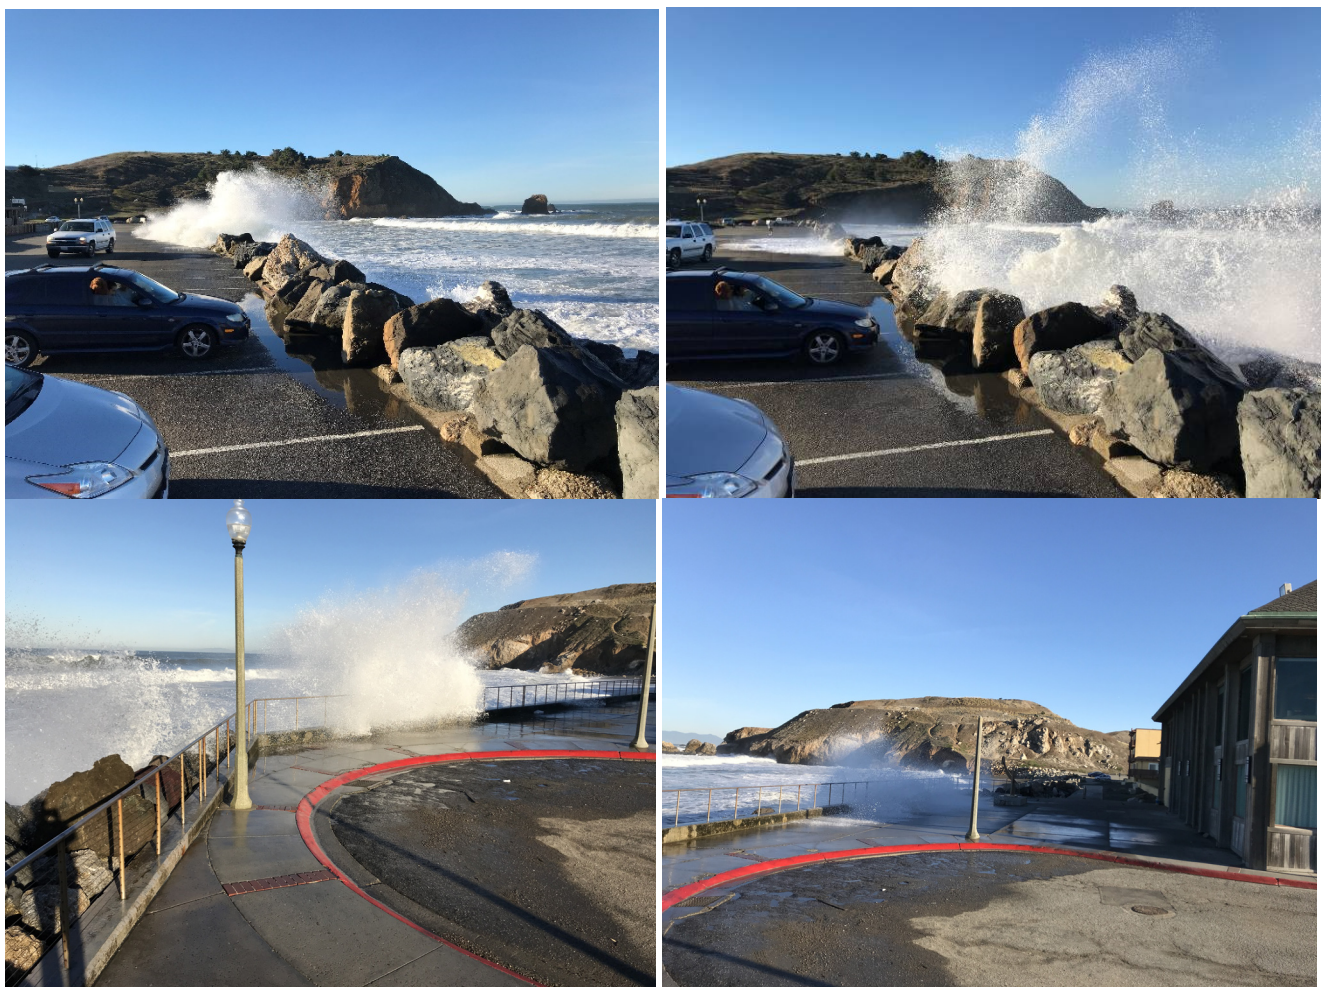
Rockaway Beach are generally 24 feet NAVD at the north and south ends of the beach and 32 feet NAVD within the parking lot in front of the Sea Breeze motel (100 Rockaway Beach Avenue). The BFE is 49 feet NAVD seaward of the revetment protecting Sea Breeze motel. It is not clear why this VE-zone steps down so dramatically landward of the rock revetment. The FEMA maps show overtopping of the backshore. In January of 2017, severe wave overtopping broke through the windows and damaged the building interior of Moonraker Restaurant (105 Rockaway Beach Avenue), shown bottom right photo of Figure 18 above. The Headlands (Figure 17), south of Rockaway Beach, is an undeveloped promontory that separates Rockaway Beach from Pacifica State Beach further south and is crossed by a scenic trail. Along these high bluffs, the FEMA BFEs are around 20 to 24 feet NAVD.

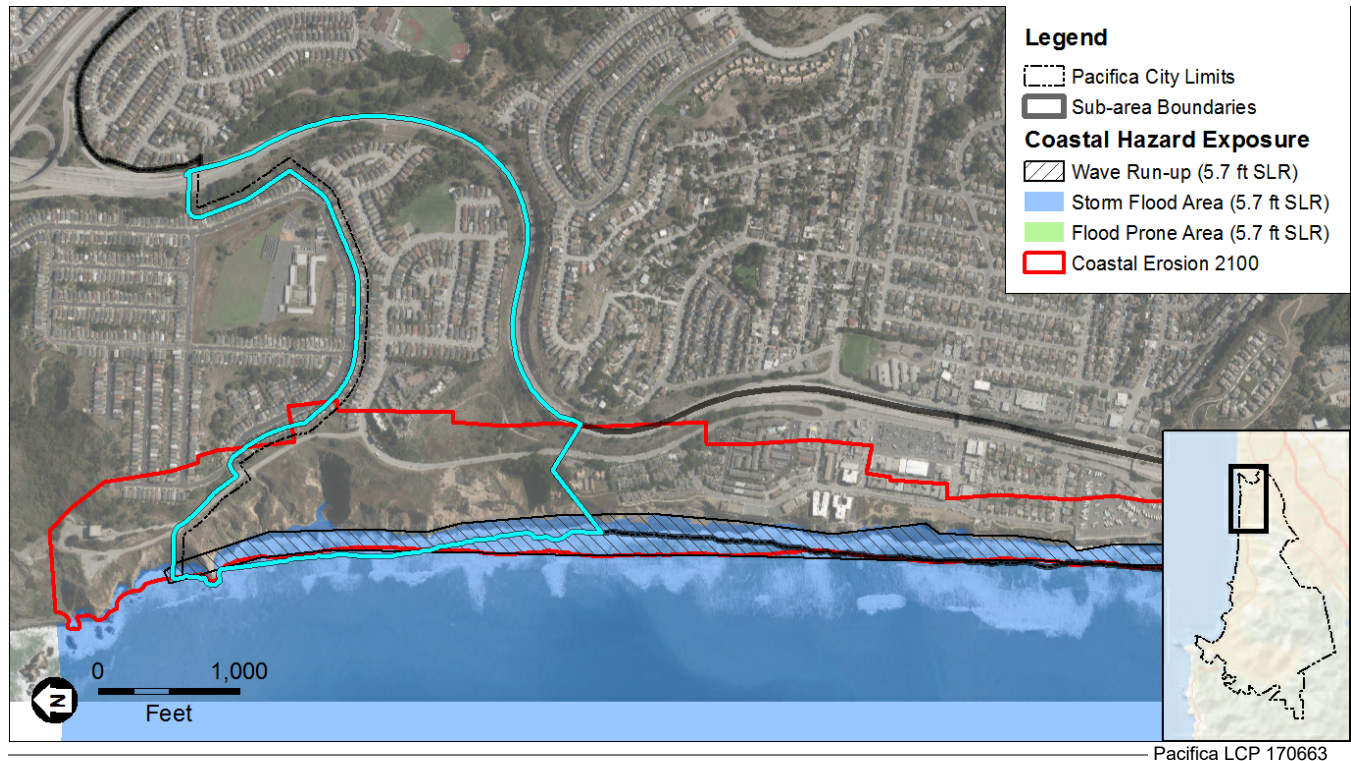
Figure 23
Fairmont West Sub-area – Coastal Hazards at 2100

Due to the high bluffs in the Fairmont West sub-area, few assets are exposed to flooding alone (sub-area shown in teal on Figure 23, Table 3). Coastal flooding and erosion exposure to coastal armoring structures, stormwater and wastewater infrastructure, essential/emergency services, and hazardous materials are shown in Appendix B-1. Exposure to existing land use, City-owned parcels, landmarks, local streets, utilities, senior centers, affordable rentals and other community assets are shown in Appendix C-1. Exposure to parks and trails, habitats and sensitive species are shown in Appendix D-1. Public access data such as vertical/lateral coastal access and views, etc. will be added to Appendix D in the Final Vulnerability Assessment.

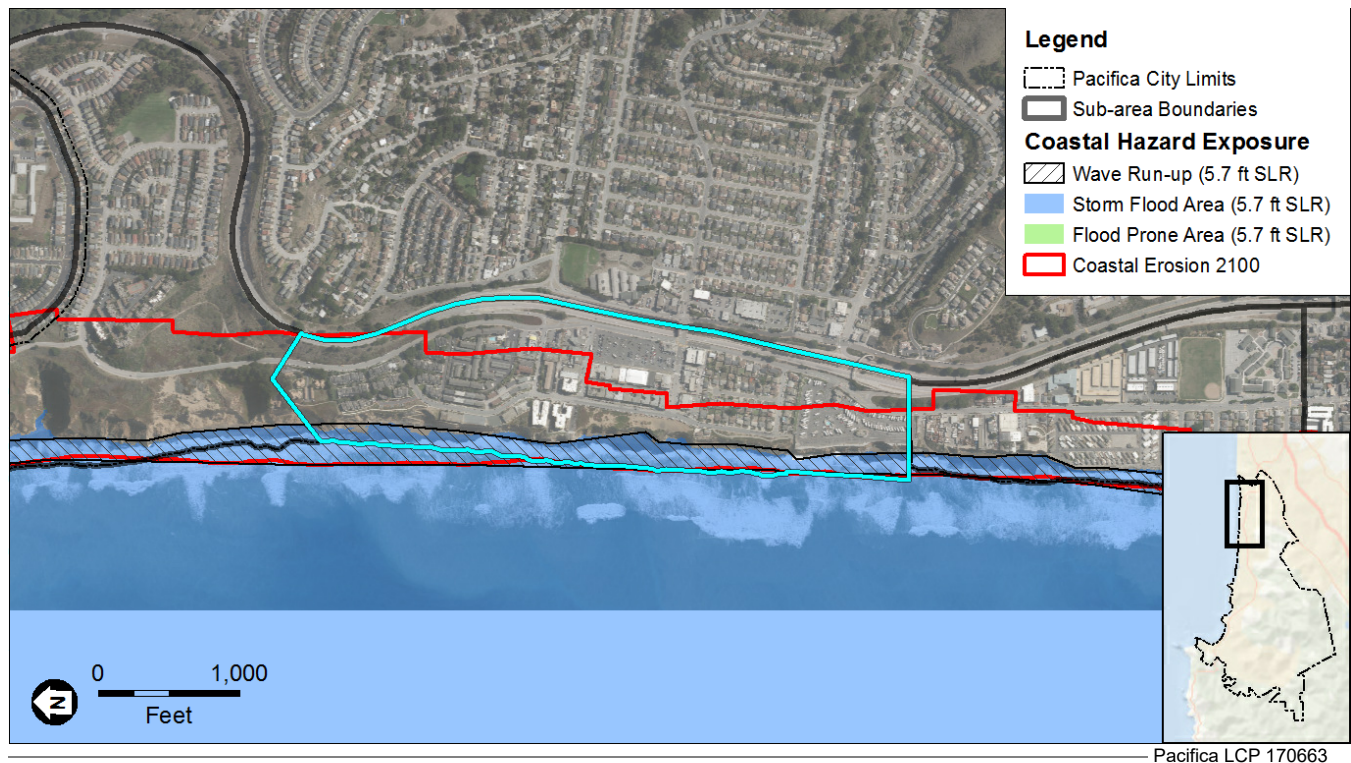
Figure 24
West Edgemar and Pacific Manor Sub-area – Coastal Hazards at 2100

Similar to Fairmont West, bluffs in the West Edgemar and Pacific Manor sub-area are high enough so that blufftop assets are not exposed to flooding, but are vulnerable to erosion in the future (sub-area shown in teal on Figure 24, Table 4). Coastal flooding and erosion exposure to coastal armoring structures, stormwater and wastewater infrastructure, essential/emergency services, and hazardous materials are shown in Appendix B-2. Exposure to existing land use, City-owned parcels, landmarks, local streets, utilities, senior centers, affordable rentals and other community assets are shown in Appendix C-2. Exposure to parks and trails, habitats and sensitive species are shown in Appendix D-2. Public access data such as vertical/lateral coastal access and views, etc. will be added to Appendix D in the Final Vulnerability Assessment.

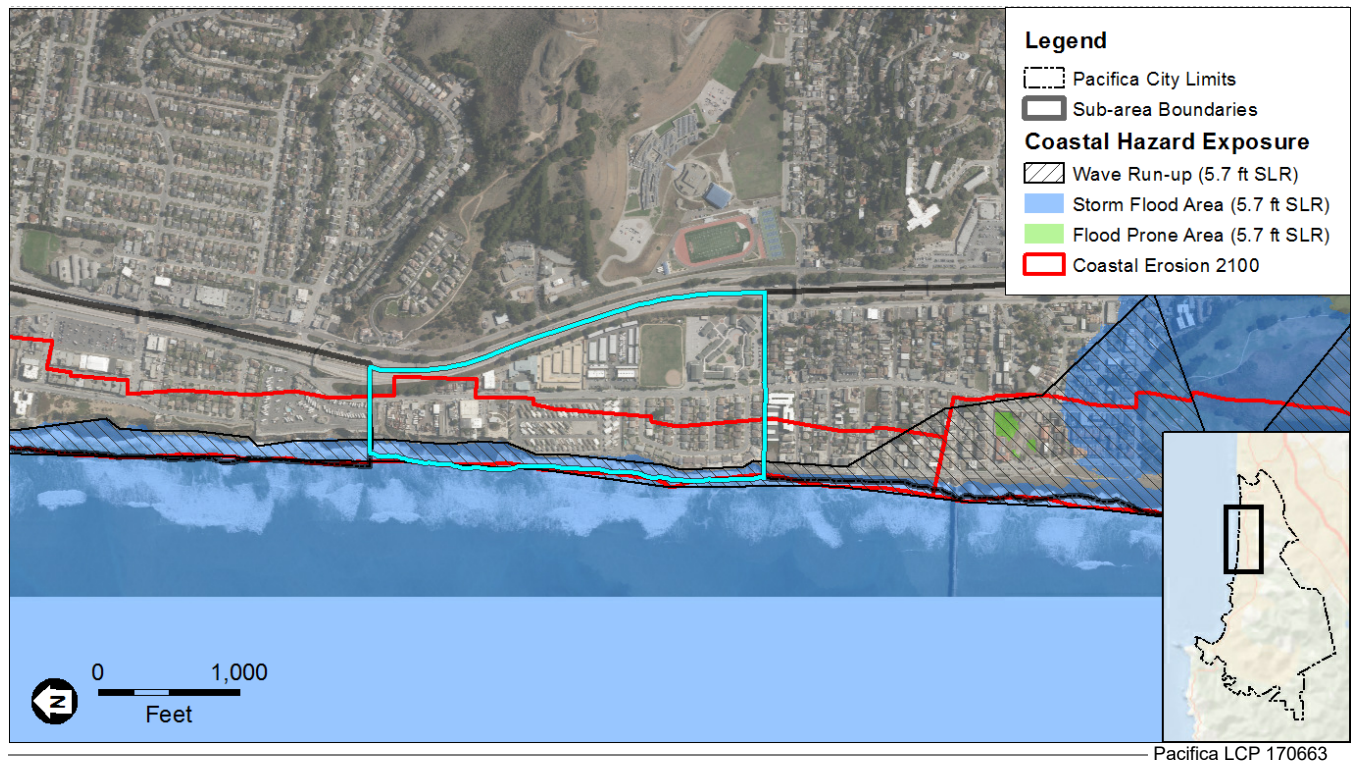
Figure 25
Northwest Sharp Park Sub-area – Coastal Hazards at 2100

Lower bluffs in the Northwest Sharp Park sub-area lead to higher asset vulnerabilities from coastal flooding (sub-area shown in teal on Figure 25, Table 5). Coastal flooding and erosion exposure to coastal armoring structures, stormwater and wastewater infrastructure, essential/emergency services, and hazardous materials are shown in Appendix B-2. Exposure to existing land use, City-owned parcels, landmarks, local streets, utilities, senior centers, affordable rentals and other community assets are shown in Appendix C-2. Exposure to parks and trails, habitats and sensitive species are shown in Appendix D-2. Public access data such as vertical/lateral coastal access and views, etc. will be added to Appendix D in the Final Vulnerability Assessment.

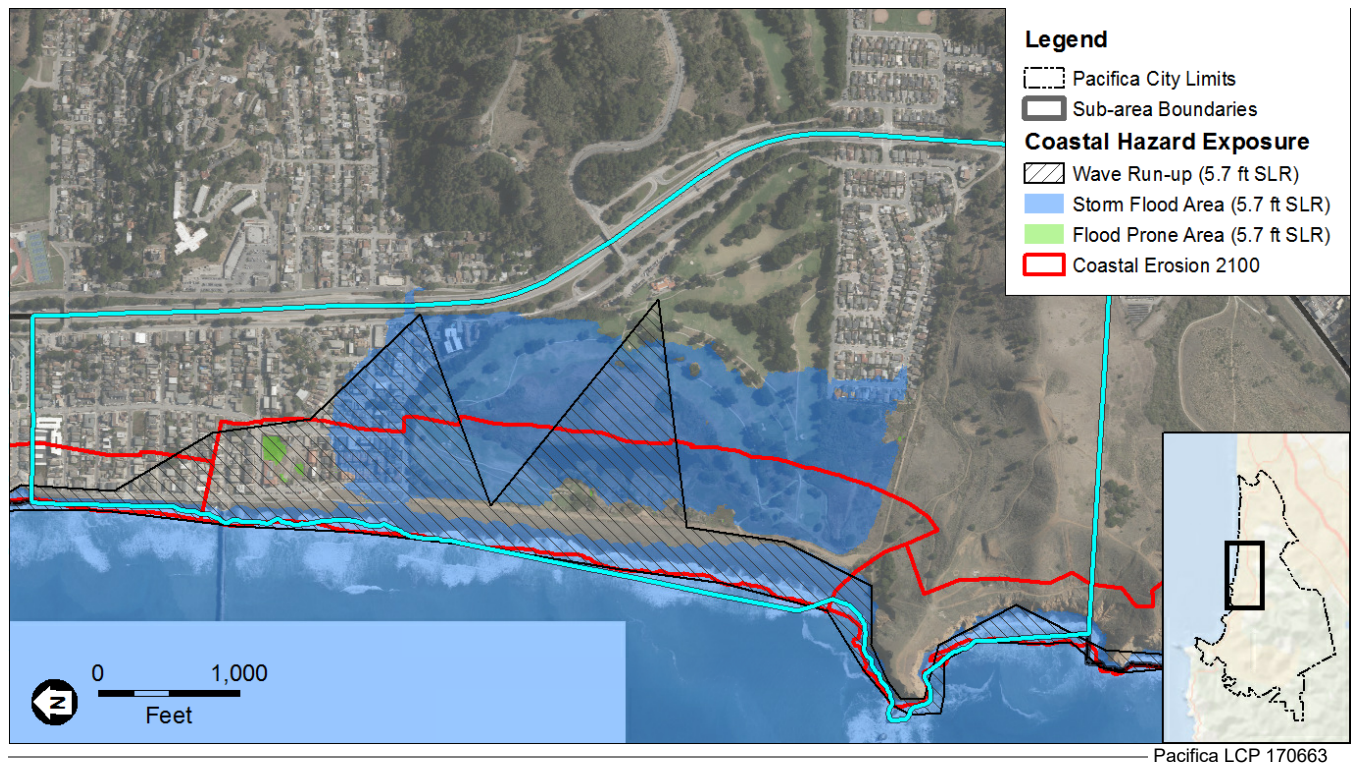
Figure 26
Sharp Park, West Fairway Park and Mori Point Sub-area – Coastal Hazards at 2100

Inundation and flooding will have a significant impact on the Sharp Park, West Fairway Park and Mori Point sub-area (sub-area shown in teal on Figure 26, Table 6) with SLR. Coastal flooding and erosion exposure to coastal armoring structures, stormwater and wastewater infrastructure, essential/emergency services, and hazardous materials are shown in Appendix B-3. Exposure to existing land use, City-owned parcels, landmarks, local streets, utilities, senior centers, affordable rentals and other community assets are shown in Appendix C-3. Exposure to parks and trails, habitats and sensitive species are shown in Appendix D-3. Public access data such as vertical/lateral coastal access and views, etc. will be added to Appendix D in the Final Vulnerability Assessment.

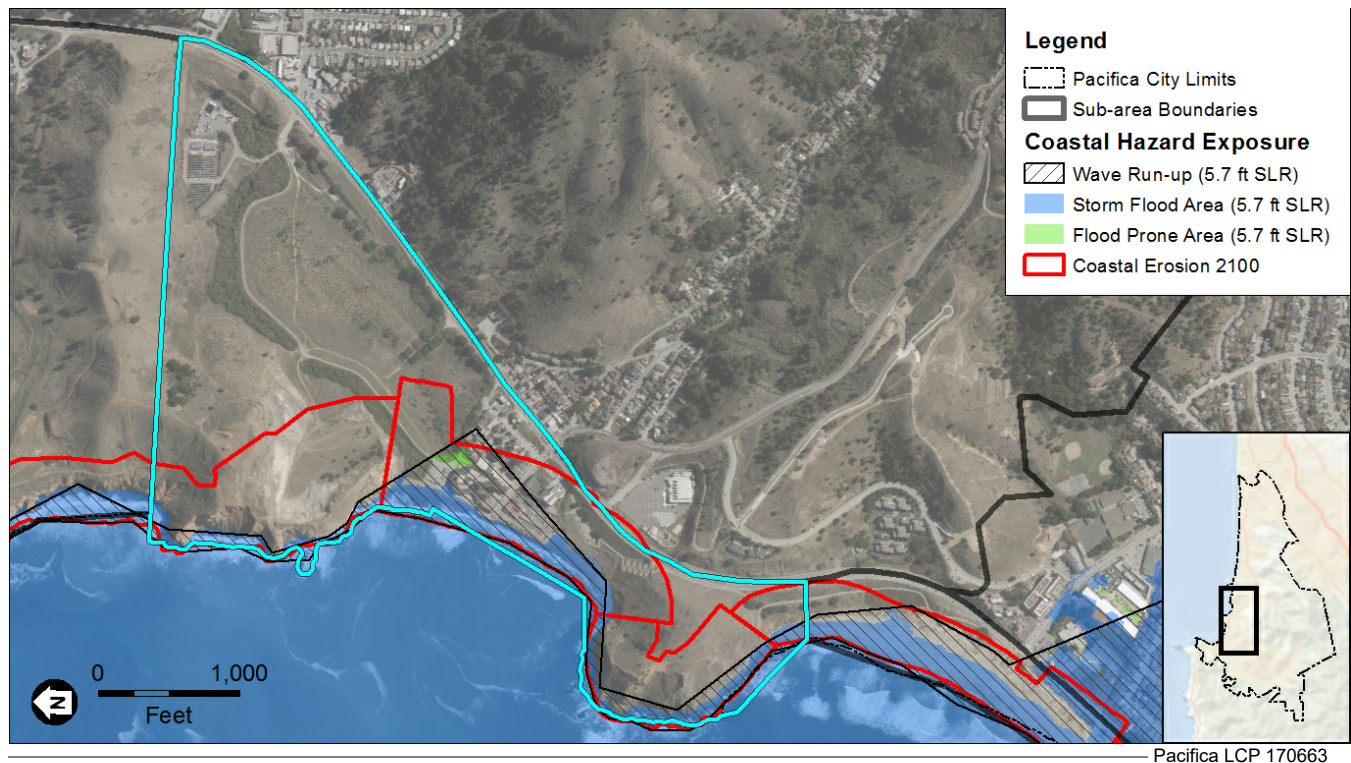
Figure 27
Rockaway Beach, Quarry and Headlands Sub-area – Coastal Hazards at 2100

The Rockaway sub-area asset vulnerabilities are concentrated at Rockaway Beach where the low backshore is more densely developed than the higher open space at the Quarry and Headlands (sub-area shown in teal on Figure 27, Table 7). Coastal flooding and erosion exposure to coastal armoring structures, stormwater and wastewater infrastructure, essential/emergency services, and hazardous materials are shown in Appendix B-4. Exposure to existing land use, City-owned parcels, landmarks, local streets, utilities, senior centers, affordable rentals and other community assets are shown in Appendix C-4. Exposure to parks and trails, habitats and sensitive species are shown in Appendix D-4. Public access data such as vertical/lateral coastal access and views, etc. will be added to Appendix D in the Final Vulnerability Assessment.

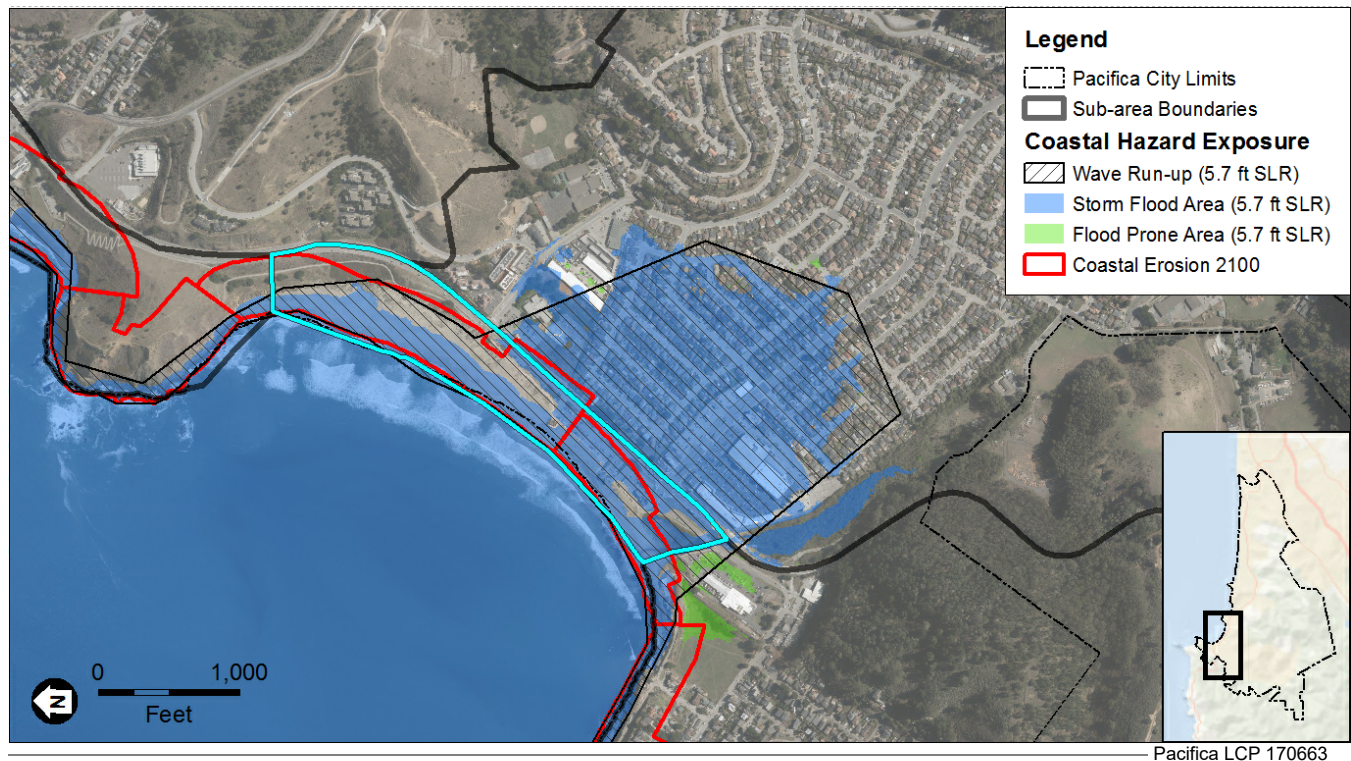
Figure 28
Pacifica State Beach Sub-area – Coastal Hazards at 2100

While the Pacifica State Beach sub-area is mostly beach, there are a number of key assets that are vulnerable (sub-area shown in teal on Figure 28, Table 8). Coastal flooding and erosion exposure to coastal armoring structures, stormwater and wastewater infrastructure, essential/emergency services, and hazardous materials are shown in Appendix B-5. Exposure to existing land use, City-owned parcels, landmarks, local streets, utilities, senior centers, affordable rentals and other community assets are shown in Appendix C-5. Exposure to parks and trails, habitats and sensitive species are shown in Appendix D-5. Public access data such as vertical/lateral coastal access and views, etc. will be added to Appendix D in the Final Vulnerability Assessment.

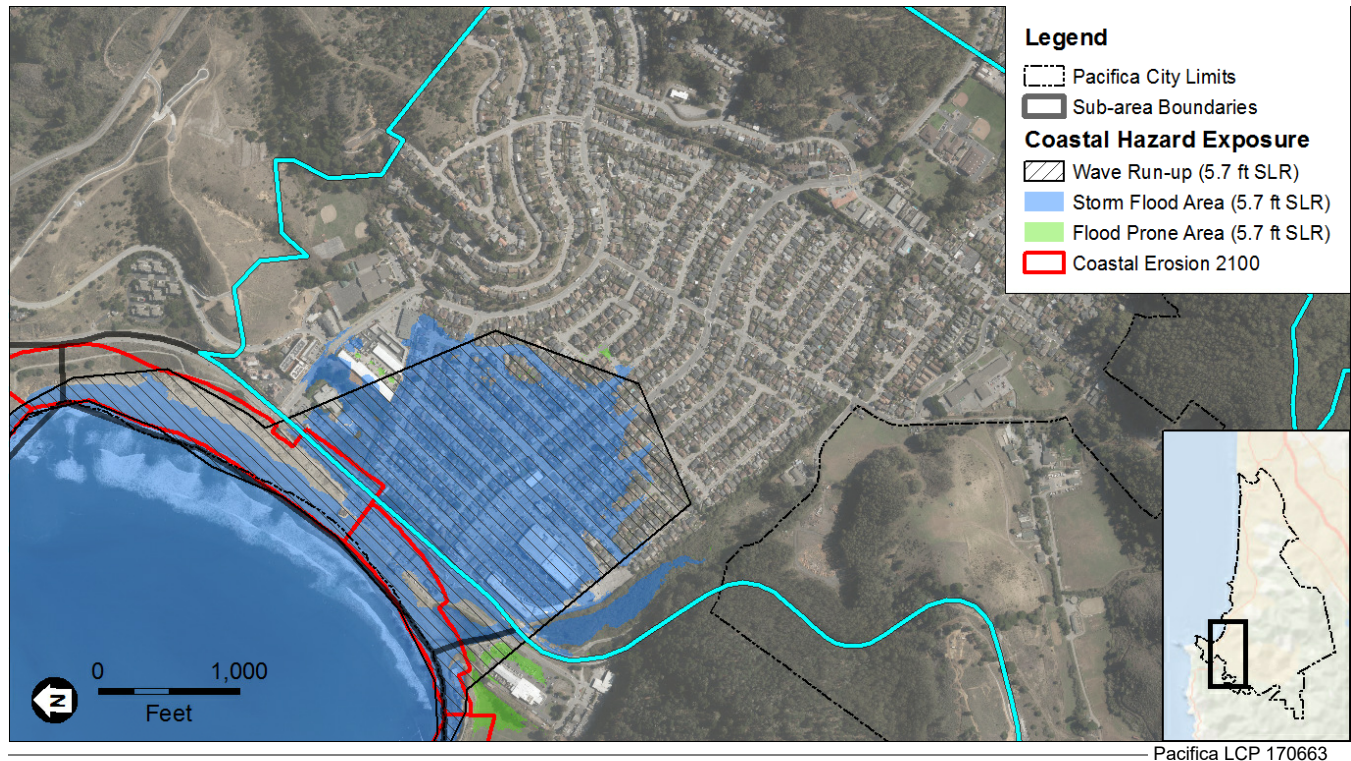
Figure 29
West Linda Mar Sub-area – Coastal Hazards at 2100

The coastal hazards posed to West Linda Mar are shown in Figure 29 (sub-area shown in teal), asset vulnerabilities are listed in Table 9. Coastal flooding and erosion exposure to coastal armoring structures, stormwater and wastewater infrastructure, essential/emergency services, and hazardous materials are shown in Appendix B-5. Exposure to existing land use, City-owned parcels, landmarks, local streets, utilities, senior centers, affordable rentals and other community assets are shown in Appendix C-5. Exposure to parks and trails, habitats and sensitive species are shown in Appendix D-5. Public access data such as vertical/lateral coastal access and views, etc. will be added to Appendix D in the Final Vulnerability Assessment.
