Public Comments Agenda Item 5

Written Comments Received By 12pm on 3/28/2022

Subject: Talbot lot up for rezoning

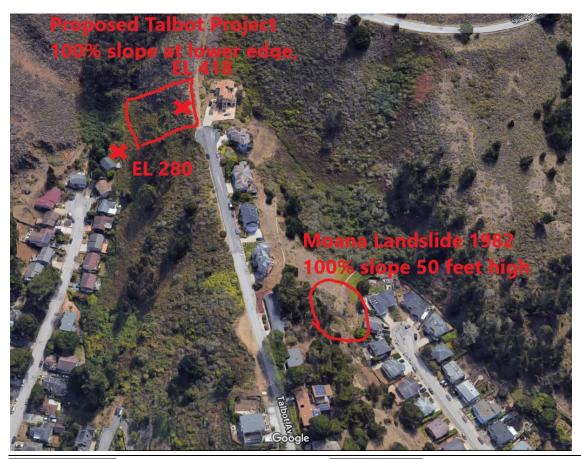
I took a Google Earth image along Talbot that shows both the proposed property and the location of the Moana slide. See below. Except for the proposed driveway and upper section of the home, the slopes are identical at 1:1 or 100% slope.

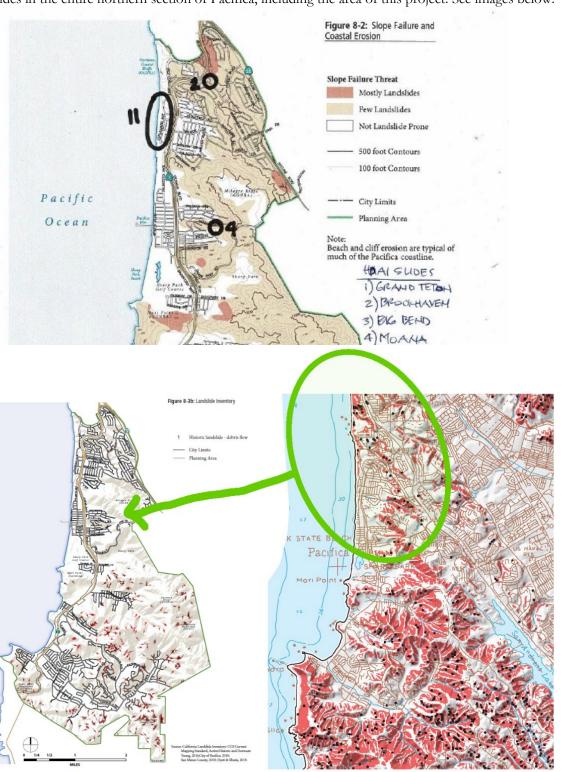
United States Geological Survey Map

(Red indicates debris flow risk areas, black dots indicate past landslides)

You might recall that I have informed the Planning Department and City Council on numerous occasions that our current General Plan Landslide Maps are inaccurate as the HDAI report called for new landslide maps to be drawn in 1983, but this work was never done. In my 2022 Draft General Plan/DEIR Comment Letter #2, dated 2/7/22, I also pointed out that the new landslide maps were inaccurate as they left out the historic debris flow landslides in the entire northern section of Pacifica, including the area of this project. See images below.

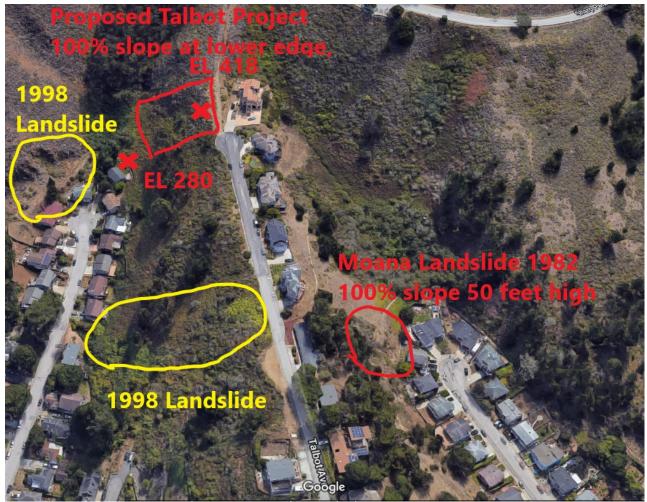
Yesterday I met with a neighbor at 708 Canyon Drive. He informed me of two other landslides on this hill during the 1998 El Nino winter. See highlighted areas below in yellow. He said the larger slide was caused by the construction of the Talbot Road extension and the new homes on Talbot. The two houses at the bottom of Canyon Drive, 676 and 684, on either side of a gap, suffered extensive damage and were red tagged as uninhabitable for weeks while repair work was done.

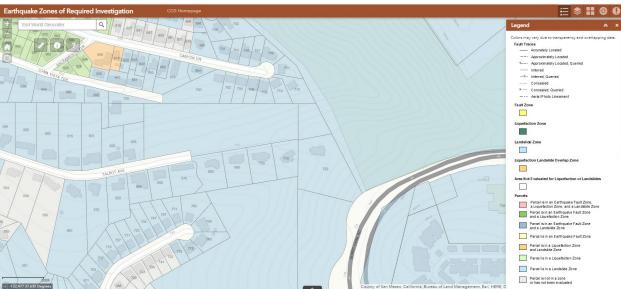
As you can see in the screenshot below, this parcel is in an identified landslide zone, identical to the area of the Moana slide. Please confirm that state requirements for required investigations are met based on this landslide risk identification.

3) On page 1 of the geotechnical report the land stability maps referenced as data sources date from 1983. These only reference seismic events. Current geologic maps which, according to my source at USGS, do include debris flow risk can be found at the US Department of Conservation website: https://maps.conservation.ca.gov/cgs/EQZApp/app/

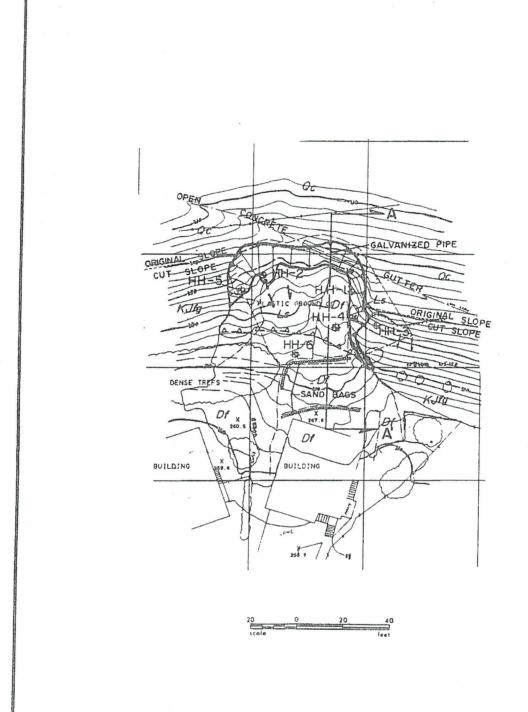
MOANA SLOPE FAILURE

The Moana slope failure was on a south-facing cut slope immediately north and upslope from single-family residential structures on Moana Drive as located on Plate 1. The slope failure was classified as an earth slump-earth flow. Earth from the failure flowed from the toe onto a residence downslope covering most of the lot to a depth of one foot. Fences were broken and buried while the house sustained minor structural damage by impact of the advancing earth flow. Details of the failure are shown on Plate 10, Moana Slope Failure.

The Moana slope failure was characterized by a nearly square crown where the slide pulled away from the cut slope. The total slide scar area was 55 feet wide by 50 feet long and included an estimated volume of 600 cubic yards. The headscarp varies in height from twelve feet, decreasing in height along the flanks to the toe where it was less than two feet high. The height of the left flank was greater than the right. The gradient of the headscarp ranged from vertical to more than 100 percent.

I have attached the relevant section of the HDAI report, including the location map and detailed plan and sections of the Moana slide. Talbot Avenue, built on the ridge of this hill, was extended and new homes built along the downslope sides after 1982.

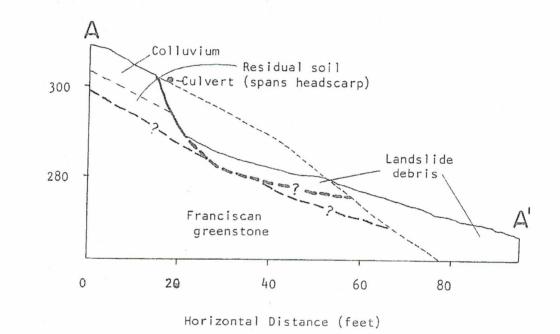
> CROSS SECTION A-A'
> MOANA SLOPE FAILURE
> HOWARD • DONLEY ASSOCIATES, INC. CONSULTING ENGINEERS & GEOLOGISTS

the failure occurred across the cut slope approximately twelve feet above the foot of the slope as seen on Plate 11, Cross Section A-A'.

PREVIOUS GROUND SURFACE PRESENT GROUND SURFACE GEOLOGIC CONTACT RUPTURE SURFACE

The Moana slope failure was classified as complex, consisting of an earth slump and secondary earth flow. Rotational failure of the earth slump occurred along a curvilinear slip surface located at an estimated depth of twelve feet near the crown. The toe of
