# SEA LEVEL RISE VULNERABILITY ASSESSMENT

## Pacifica, CA

Prepared for  
The City of Pacifica

June 2018

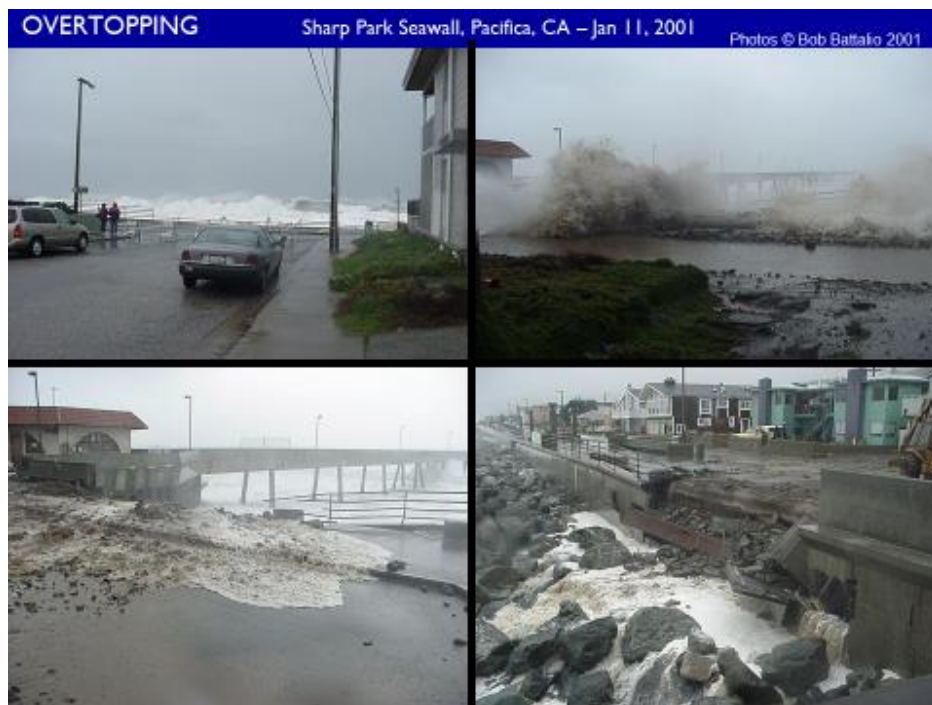
**Figure 2**

Observed flooding and erosion along Beach Blvd on January 11, 2001

- Winter 1983: Large swell and precipitation
- El Nino 1997-1998: Large swell
- January 11, 2001: Wave event and overtopping at Sharp Park seawall and erosion damages to Beach Blvd seawall (photographs shown in Figure 2)
- Winter 2009-2010: Large swell and resulting bluff erosion at Pacific Manor
- January 21, 2016: Large swell (photographs in Figure 3)
- Others identified and documented by City staff (for example see account for January 2, 2006 in Figure 4)

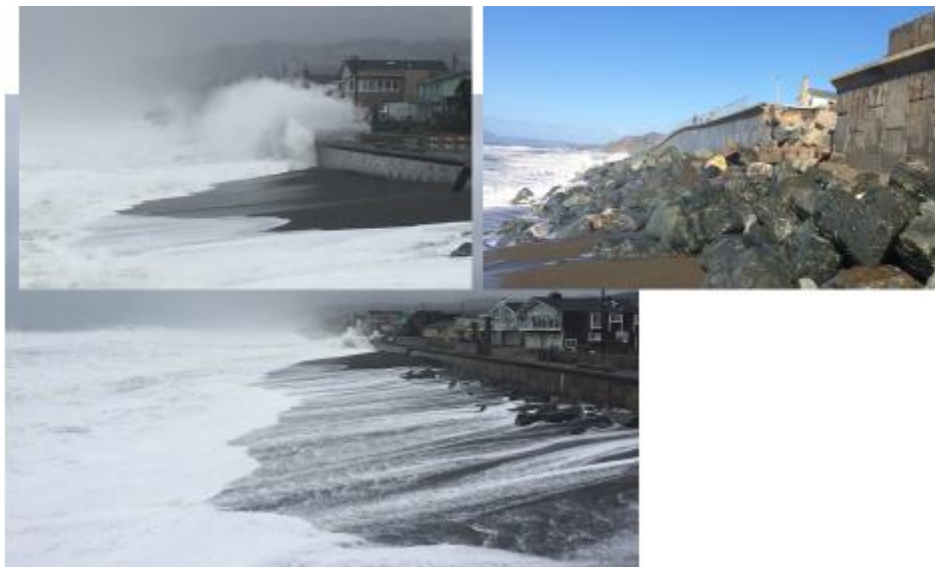
Observed flooding and erosion events at Pacifica on January 22, 2016

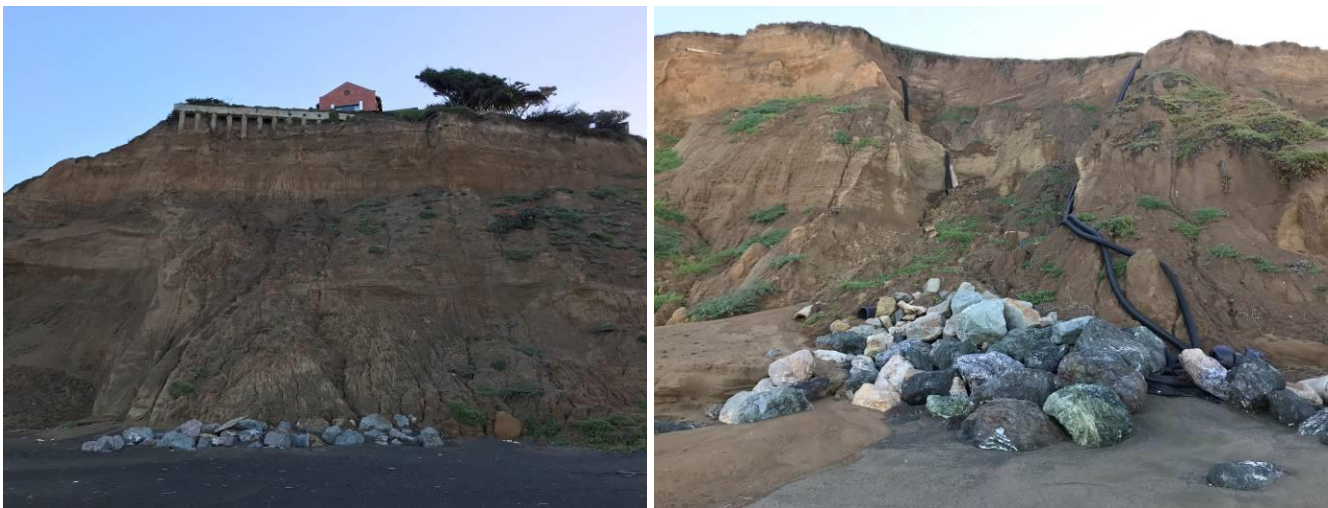
**Figure 6**  
Dollaradio Station with rock at toe and Piles at top of bluff (Left)  
Drainage pipes and terrestrial erosion of bluff south of Dollar Radio (Right)

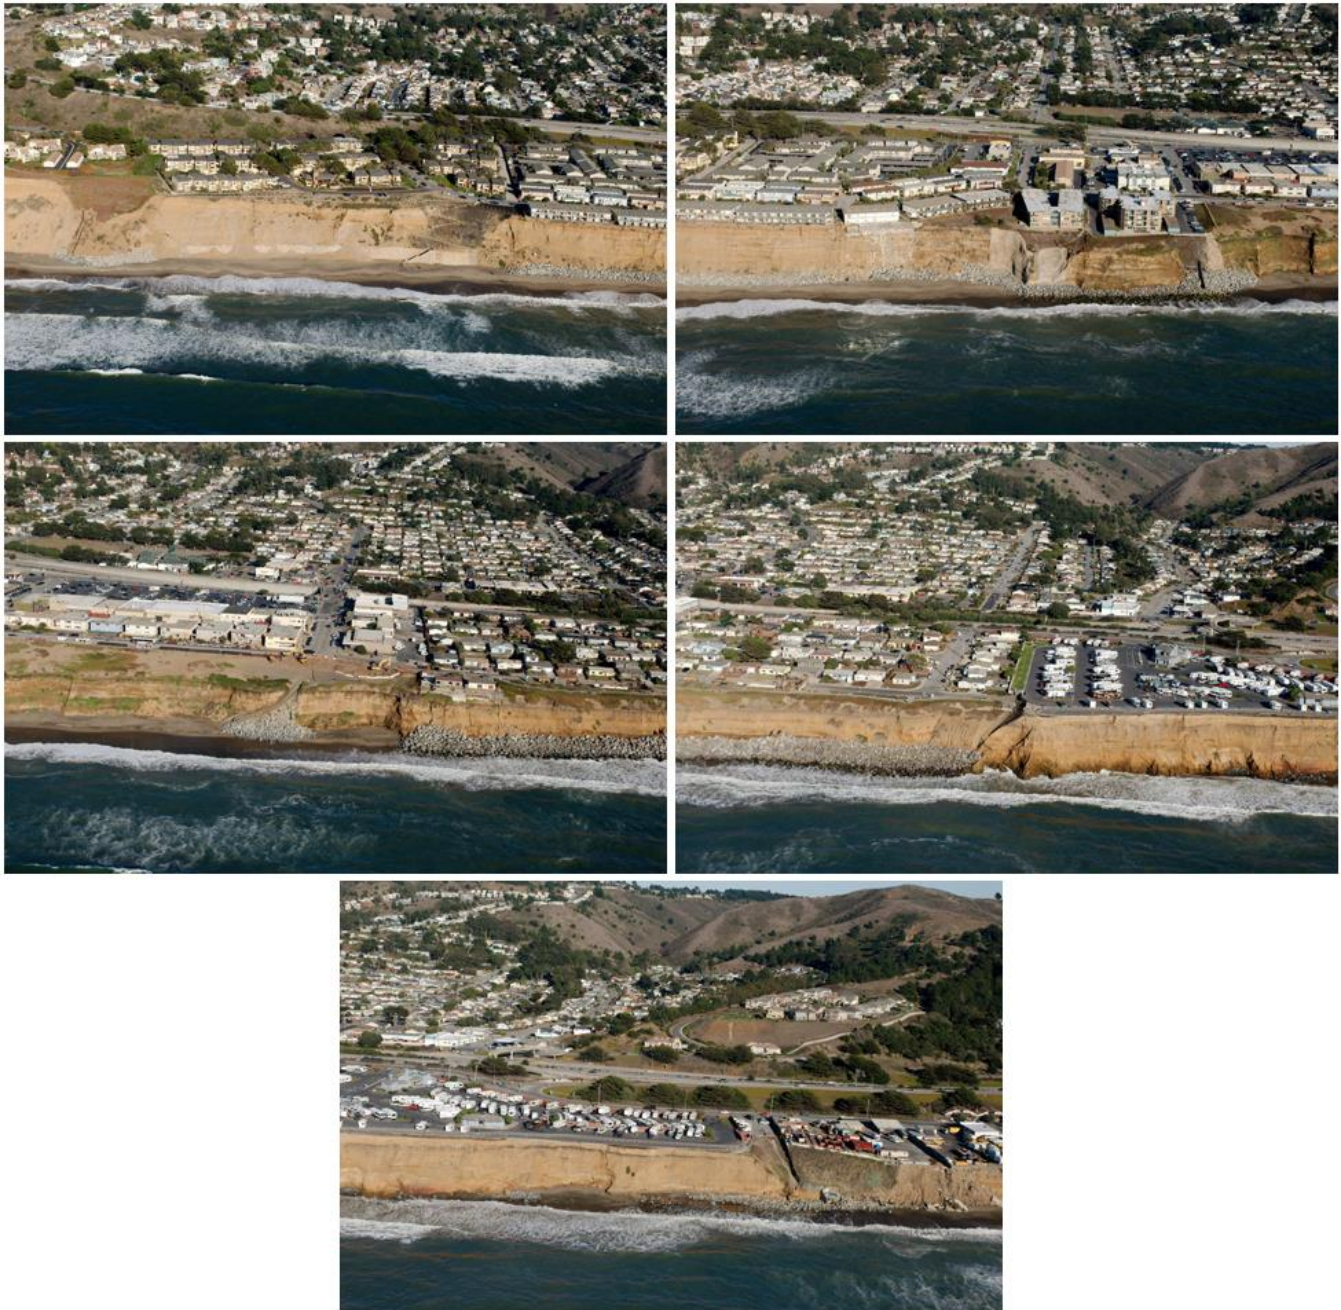
**Figure 7**  
West Edgemar and Pacific Manor Sub-area  
CA Coastal Records Photos

This West Edgemar and Pacific Manor sub-area includes all land west of Highway 1, south of Dollaradio Station to and including the San Francisco RV Resort (Figure 7, Appendix A-2). Land uses include single and multi-family residential, commercial (including Manor Plaza), auto services, office, vacant, and other public or community uses. The sub-area includes 0.8 miles of coastline that consists of rip rap and a few short (100-400

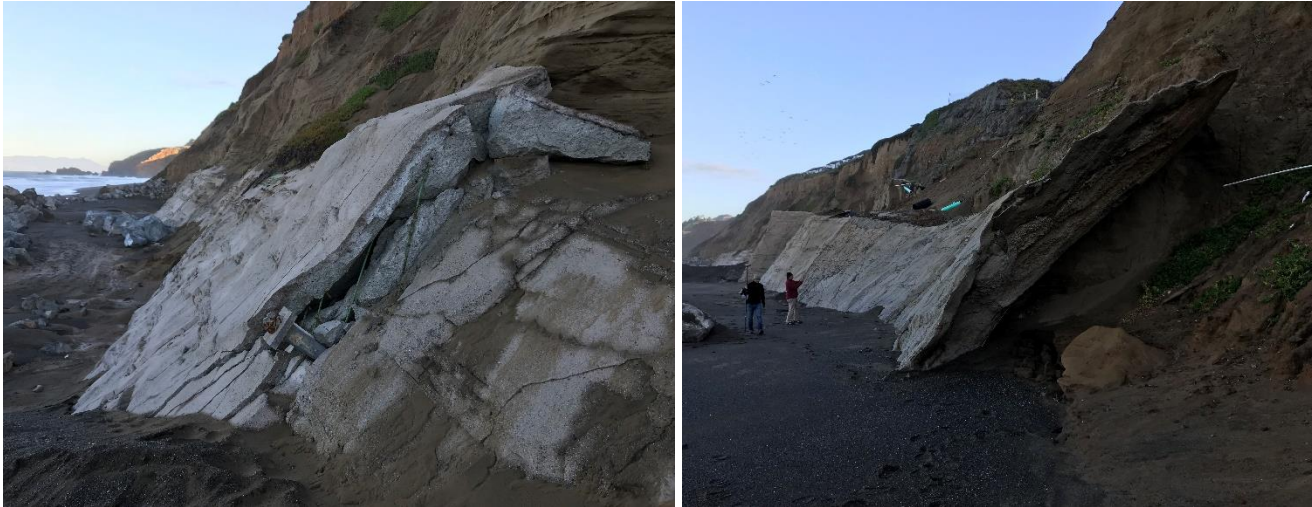
Failed seawall, showing partial collapse (right) and outflanking (left)

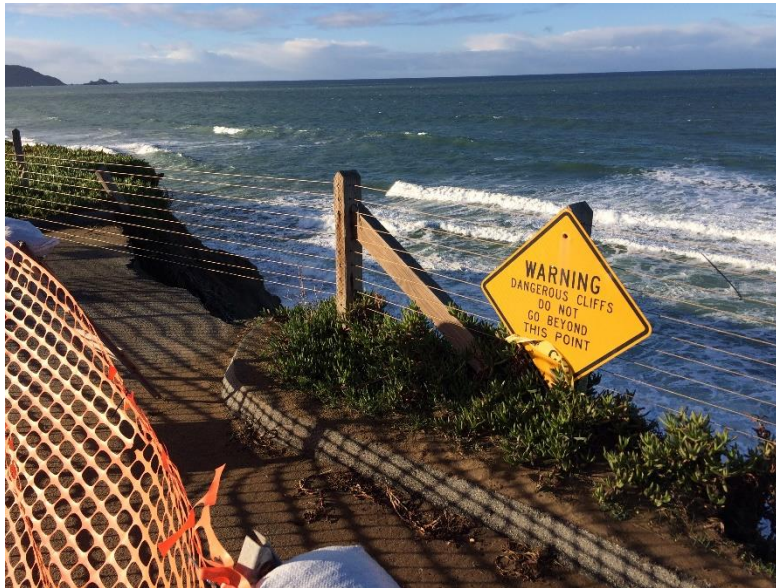
**Figure 10**  
Bluff top trail at Esplanade Ave at risk of erosion (photograph Dec 20 2017)

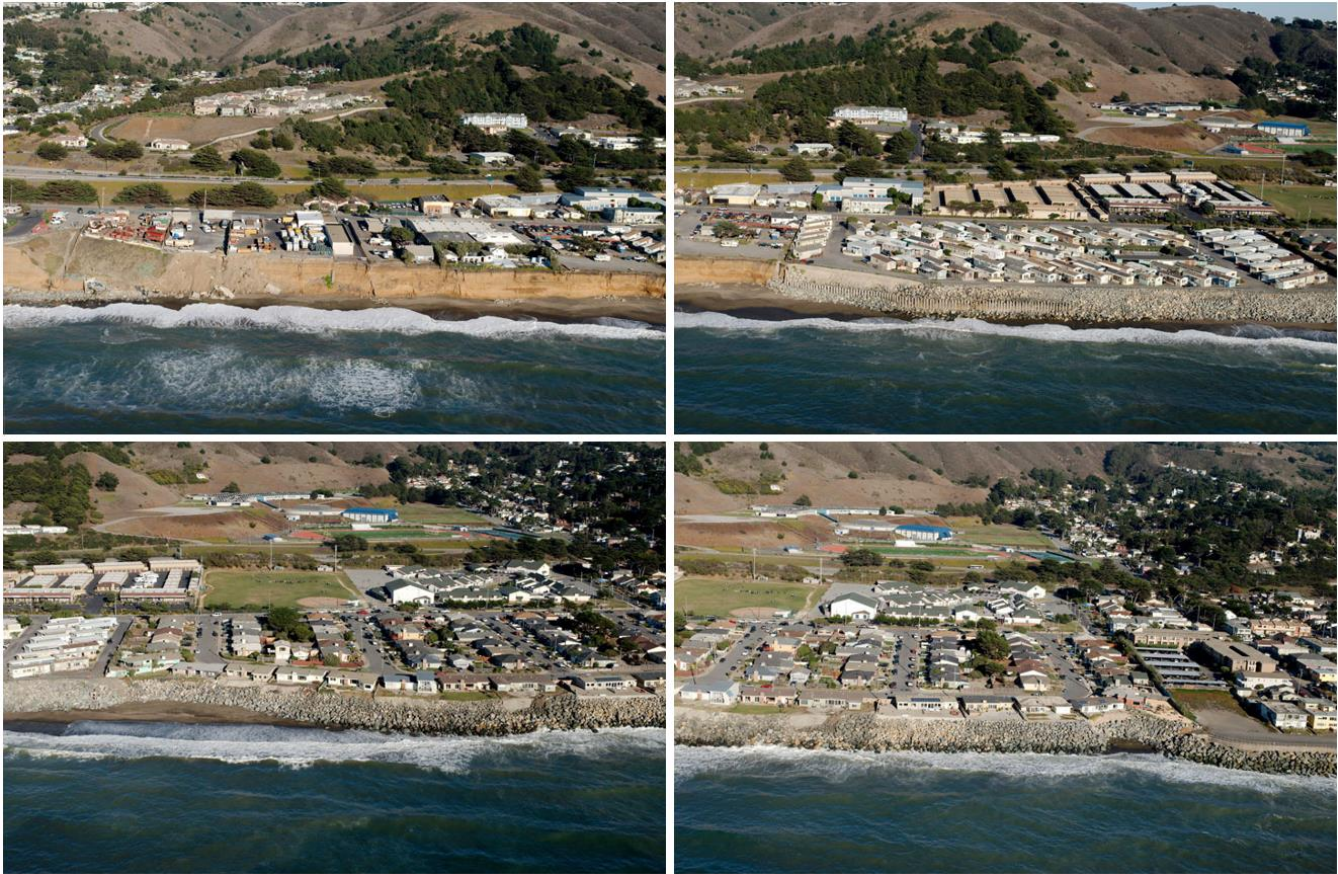
**Figure 12**  
Northwest Sharp Park Sub-area  
CA Coastal Records Photos

The Northwest Sharp Park sub-area includes land west of Highway 1 and between the SF RV Resort and Bella Vista Ave (Figure 12, Appendix A-3). Land uses include residential, industrial, commercial, school, mobile homes, office, auto services and mixed use. This sub-area is the northern portion of the West Sharp Park sub-area defined in the draft LCP. For this study, the West Sharp Park sub-area from the LCP was divided along the parcel boundaries between Shoreview Avenue and Paloma Avenue for two reasons. First, the backshore armoring infrastructure changes at this location from private to public. North of the divide, private homes are armored by rock revetments and gunnite covering the bluff face. South of the divide, a public walkway and Beach Boulevard runs along the bluff top which is protected by a seawall and fronting rock revetment. Secondly, flooding at the Sharp Park Golf Course (SPGC) affects residences surrounding the course. ESA and the City recognize this direct linkage and that any shoreline management strategies taken for SPGC will have implications for the neighborhood north of and adjacent to the golf course. Thus, the southern portion of West Sharp Park sub-area was combined with the Sharp Park sub-area in order to more clearly discuss existing conditions, evaluate vulnerability and develop adaptation strategies that account for this flooding linkage. The Sharp Park sub-area is discussed in the following section.

Northwest Sharp Park sub-area includes approximately 2,800 feet of shoreline from the south end of the San Francisco RV Resort to the north end of the Beach Boulevard seawall. The shoreline is almost entirely covered with rock or rubble; the beach is currently very narrow at the north end and disappears in front of the armored homes along Shoreview Avenue. Bluff top land use includes industrial, commercial, and residential uses. One of the residential uses includes The Cottages at Seaside (previously known as the Pacific Skies Estates mobile home park). The backshore is about 90 percent armored in this sub-area, owing to gaps in rubble along the northern bluffs. A damaged stormwater outfall is located at the north end of this sub-area (Figure 13). Along these areas of industrial use, scattered rubble and landfill material resulting from erosion of the bluff is present along the bluff toe. A rock revetment was built since 2010 along the private property situated in Industrial North Palmetto. The coastal armor at The Cottages at Seaside consists of rock, concrete piles and gunnite. Various rock revetments and gunnite cover the bluff along the Shoreview Avenue residences. New rock was observed on December 19, 2017 in and around the bluff notch at the south end of Shoreview Avenue. The new rock was placed in front of homes and the City stormwater outfall. The FEMA BFE in this sub-area is 32 feet NAVD, compared to bluff elevations of 34 to 68 feet NAVD.

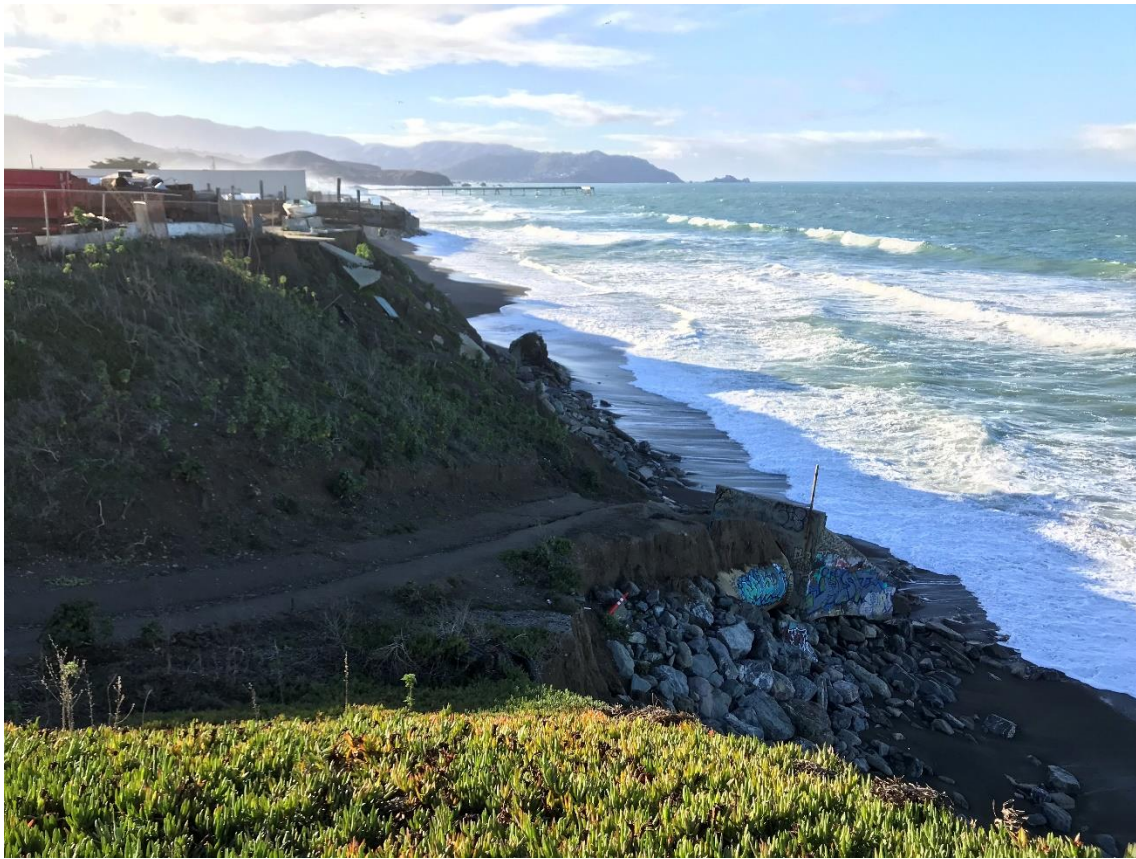
**Figure 13**  
Damaged stormwater outfall in foreground, landfill and eroded rubble on narrow beach beyond

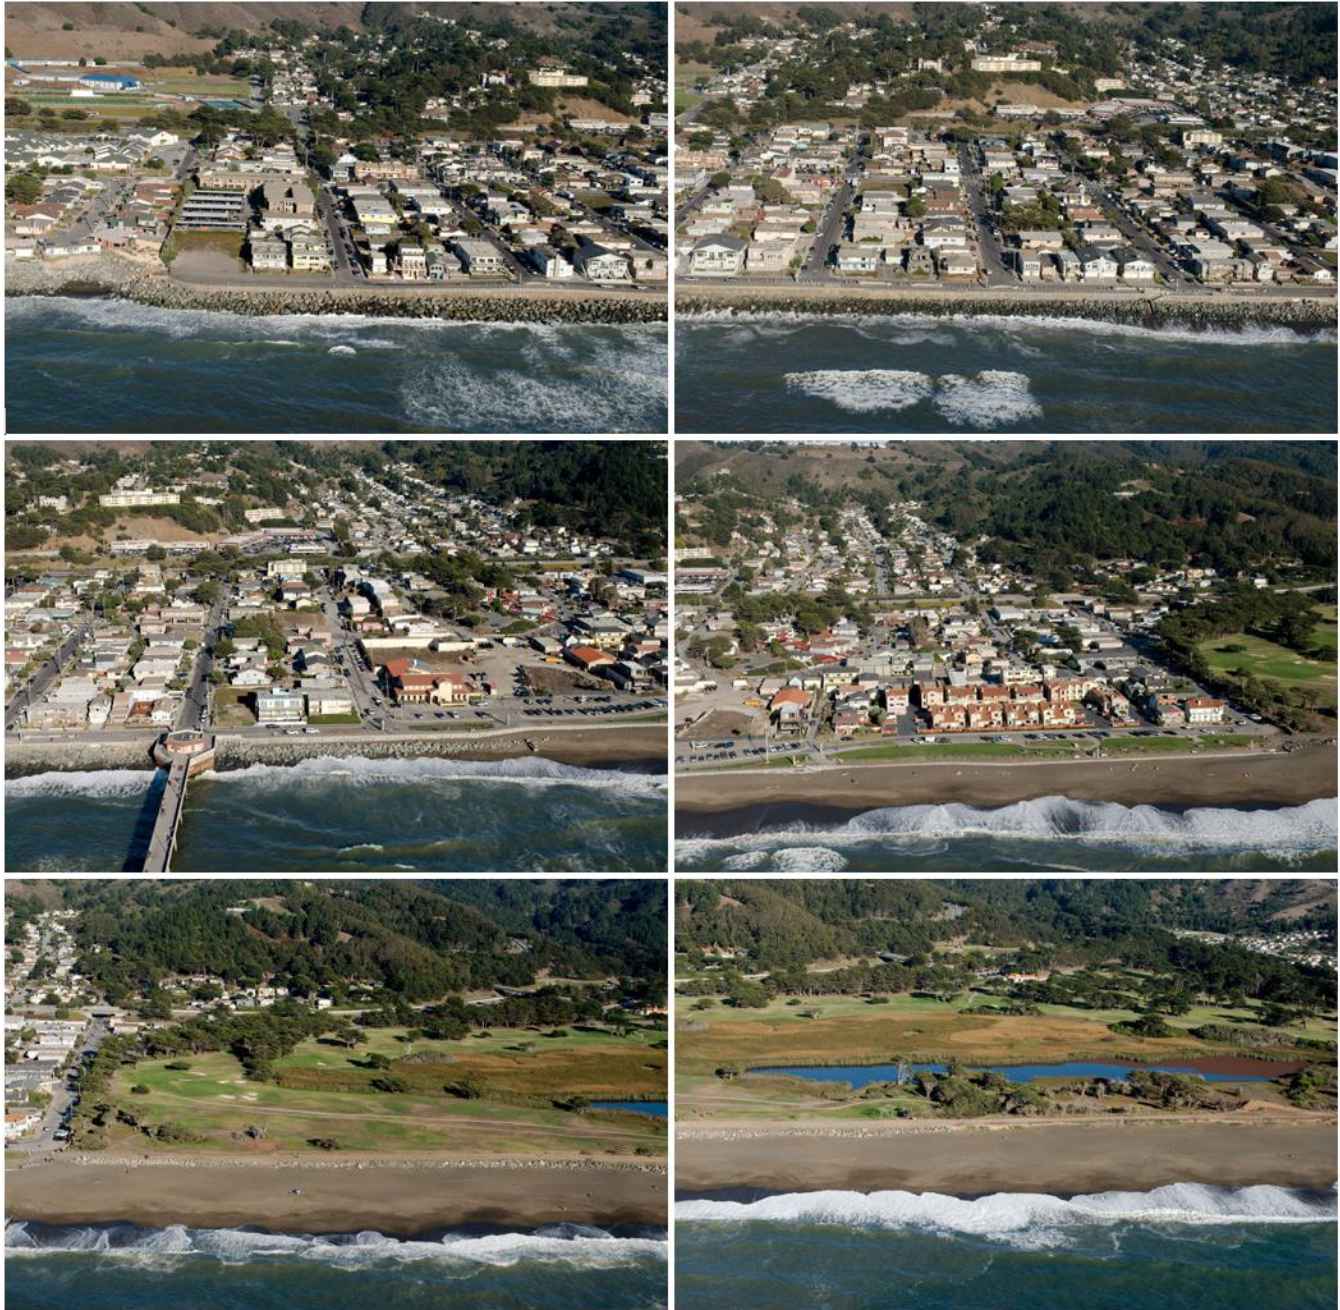
**Figure 14**  
Sharp Park, West Fairway Park and Mori Point Sub-area  
CA Coastal Records Photos

The Sharp Park, West Fairway Park and Mori Point sub-area (Figure 14 and Figure 15, Appendix A-4) includes land west of Highway 1 and contains the Palmetto Ave business district, Beach Boulevard Promenade, Fishing Pier, multiple City-owned parcels and landmarks, the Sharp Park Golf Course, West Sharp Park and West Fairway Park neighborhoods and Mori Point. Land use is diverse in this sub-area and includes residential, commercial, auto services, office, mixed use, industrial, church, public and community uses, parks, some vacant/undeveloped parcels and beach.

South of Clarendon, the backshore consists of an earthen berm levee that spans south to the headlands of Mori Point (Figure 14 and Figure 15). The levee was built in the 1980s to protect the Sharp Park Golf Course. The fronting beach is approximately 200 feet wide with sparse vegetation along the back of beach. Approximately 1,150 feet of the northern portion of the levee are covered with rock, while the southern approximately 250 feet are armored by a revetment where the drainage outfall is located. The levee elevation ranges from 28 to 31 feet NAVD and is managed the City of San Francisco. The CA Coastal Commission recently approved Coastal Development Permit 2-17-0702 that authorized these after the fact amendments to the berm levee and authorizes armoring of the remainder of the berm. Behind the levee sits Sharp Park Golf Course and Laguna Salada, which drains a 1,200-acre watershed. A pump station is used to manage the water level in Laguna Salada. The pumping

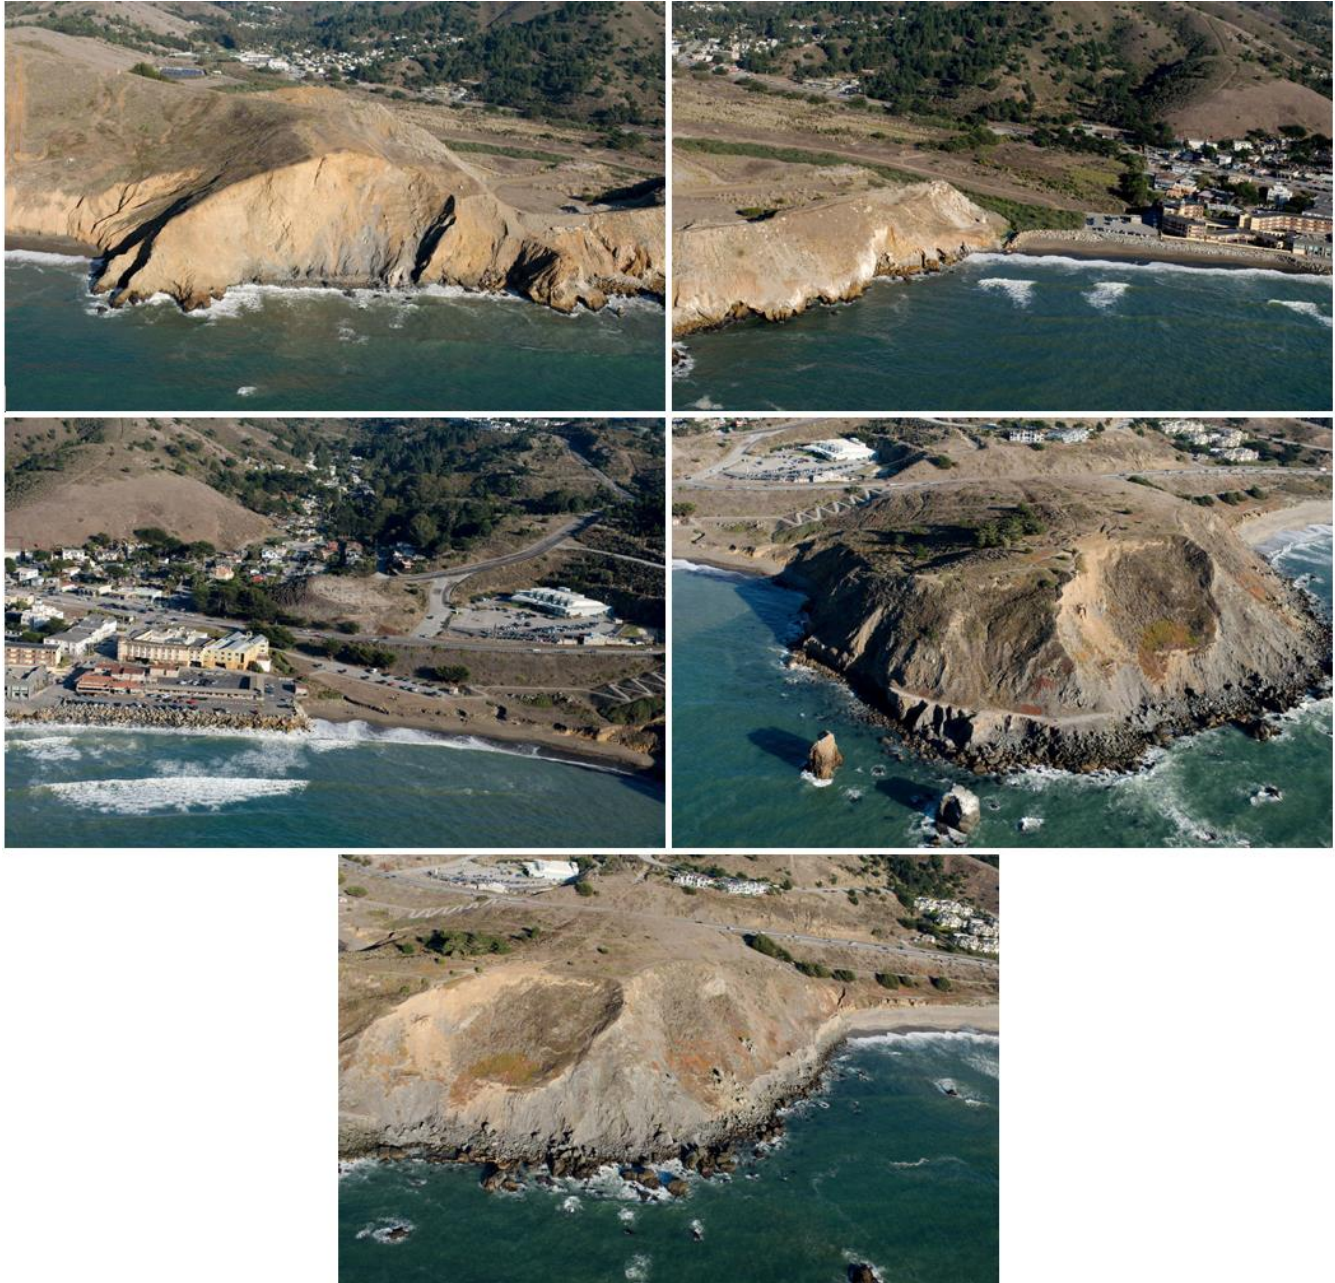
**Figure 17**  
Rockaway Beach, Quarry and Headlands Sub-area  
CA Coastal Records Photos

This sub-area includes the vacant quarry site, Rockaway Beach, and Rockaway Headlands (Figure 17, Appendix A-5). Land use includes hotels, mixed use, commercial, residential, office, public and community use, and beach.

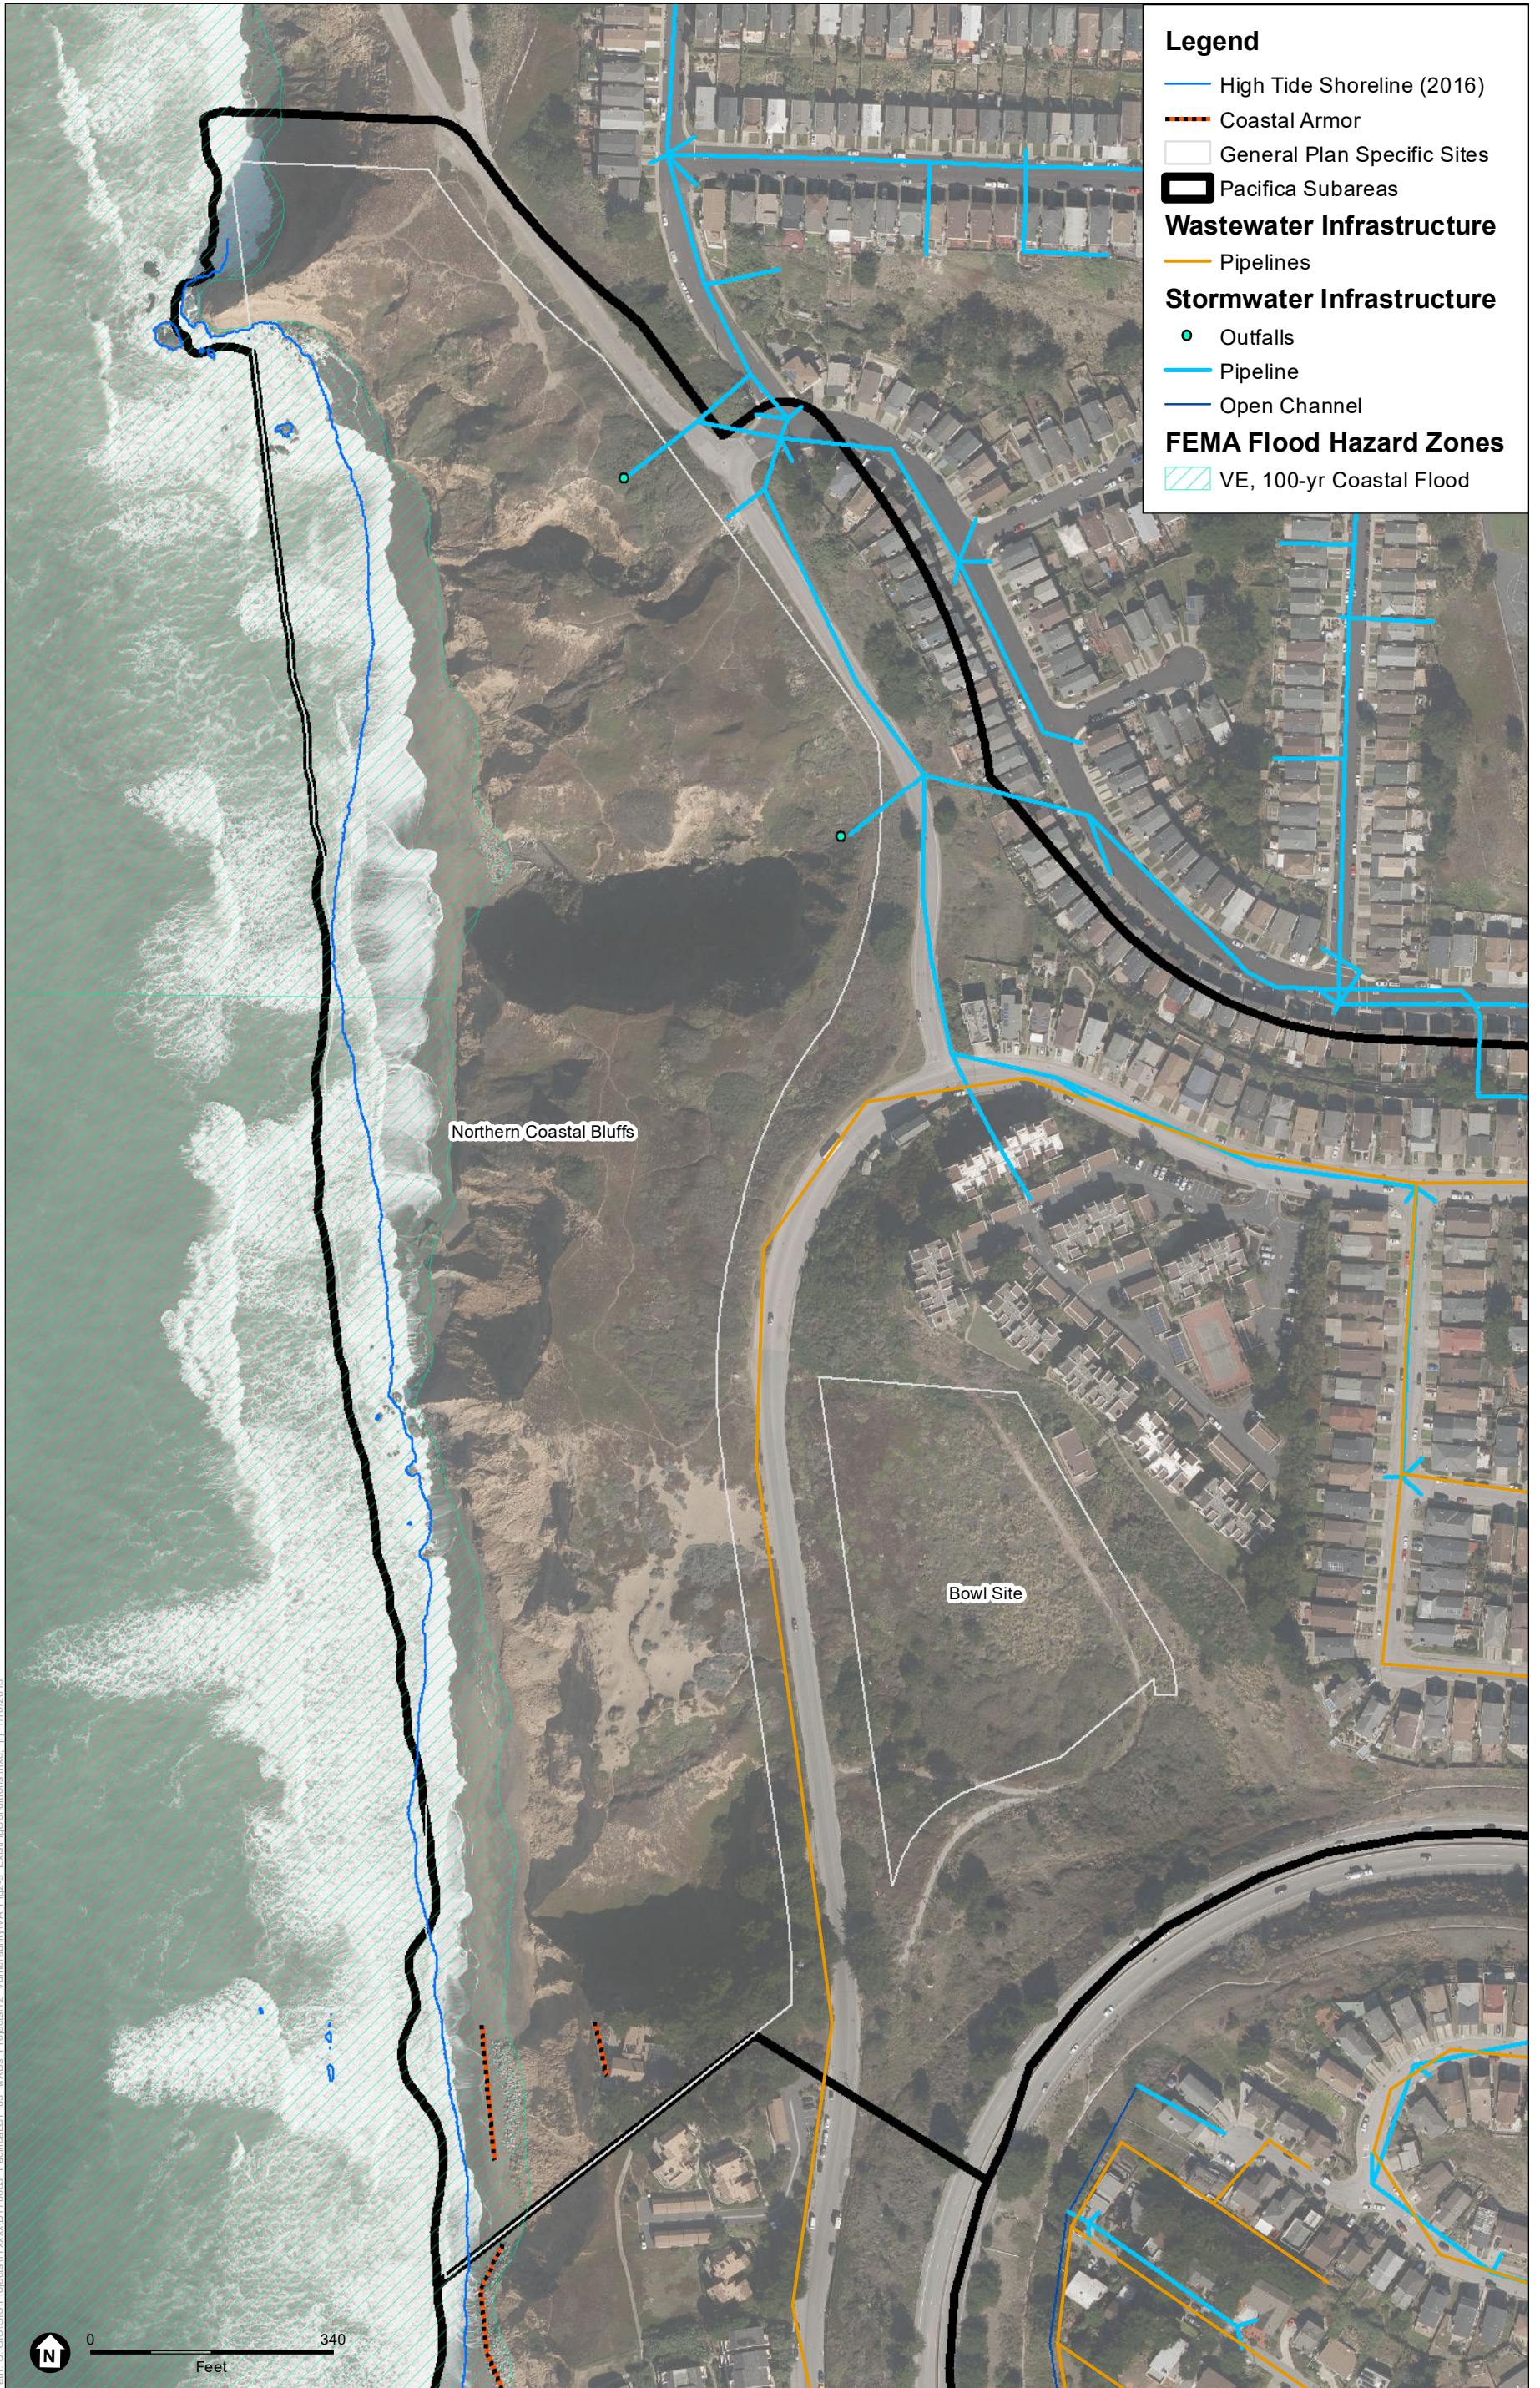
**Appendix A-1**  
Existing Conditions Map  
Fairmont West

SOURCE: San Mateo County 2017 Imagery; City of Pacifica Assets (2017); FEMA Flood Hazard Areas (2017)

Each Pacifica sub-area (shown in Figure 1) is discussed below. Existing conditions maps were created for each sub-area (Appendix A). Each map shows stormwater and wastewater infrastructure, coastal armoring structures, existing FEMA flood hazard zones, and the latest available (2016) mean higher high tide shoreline. ESA reviewed current FEMA maps (shown in Appendix A) to assess existing flooding risk in Pacifica. FEMA flood hazard maps, which are used for the National Flood Insurance Program, present coastal and fluvial flood hazards. FEMA recently released updated coastal flood hazard maps for San Mateo County (effective 8/2/2017) according to the 2005 Pacific Coast Guidelines (FEMA 2005a). The latest FEMA National Flood Hazard Layer is hosted online via an ArcGIS webmap<sup>3</sup>. In the following sub-area descriptions, we will refer to existing coastal hazards using the following FEMA terms:

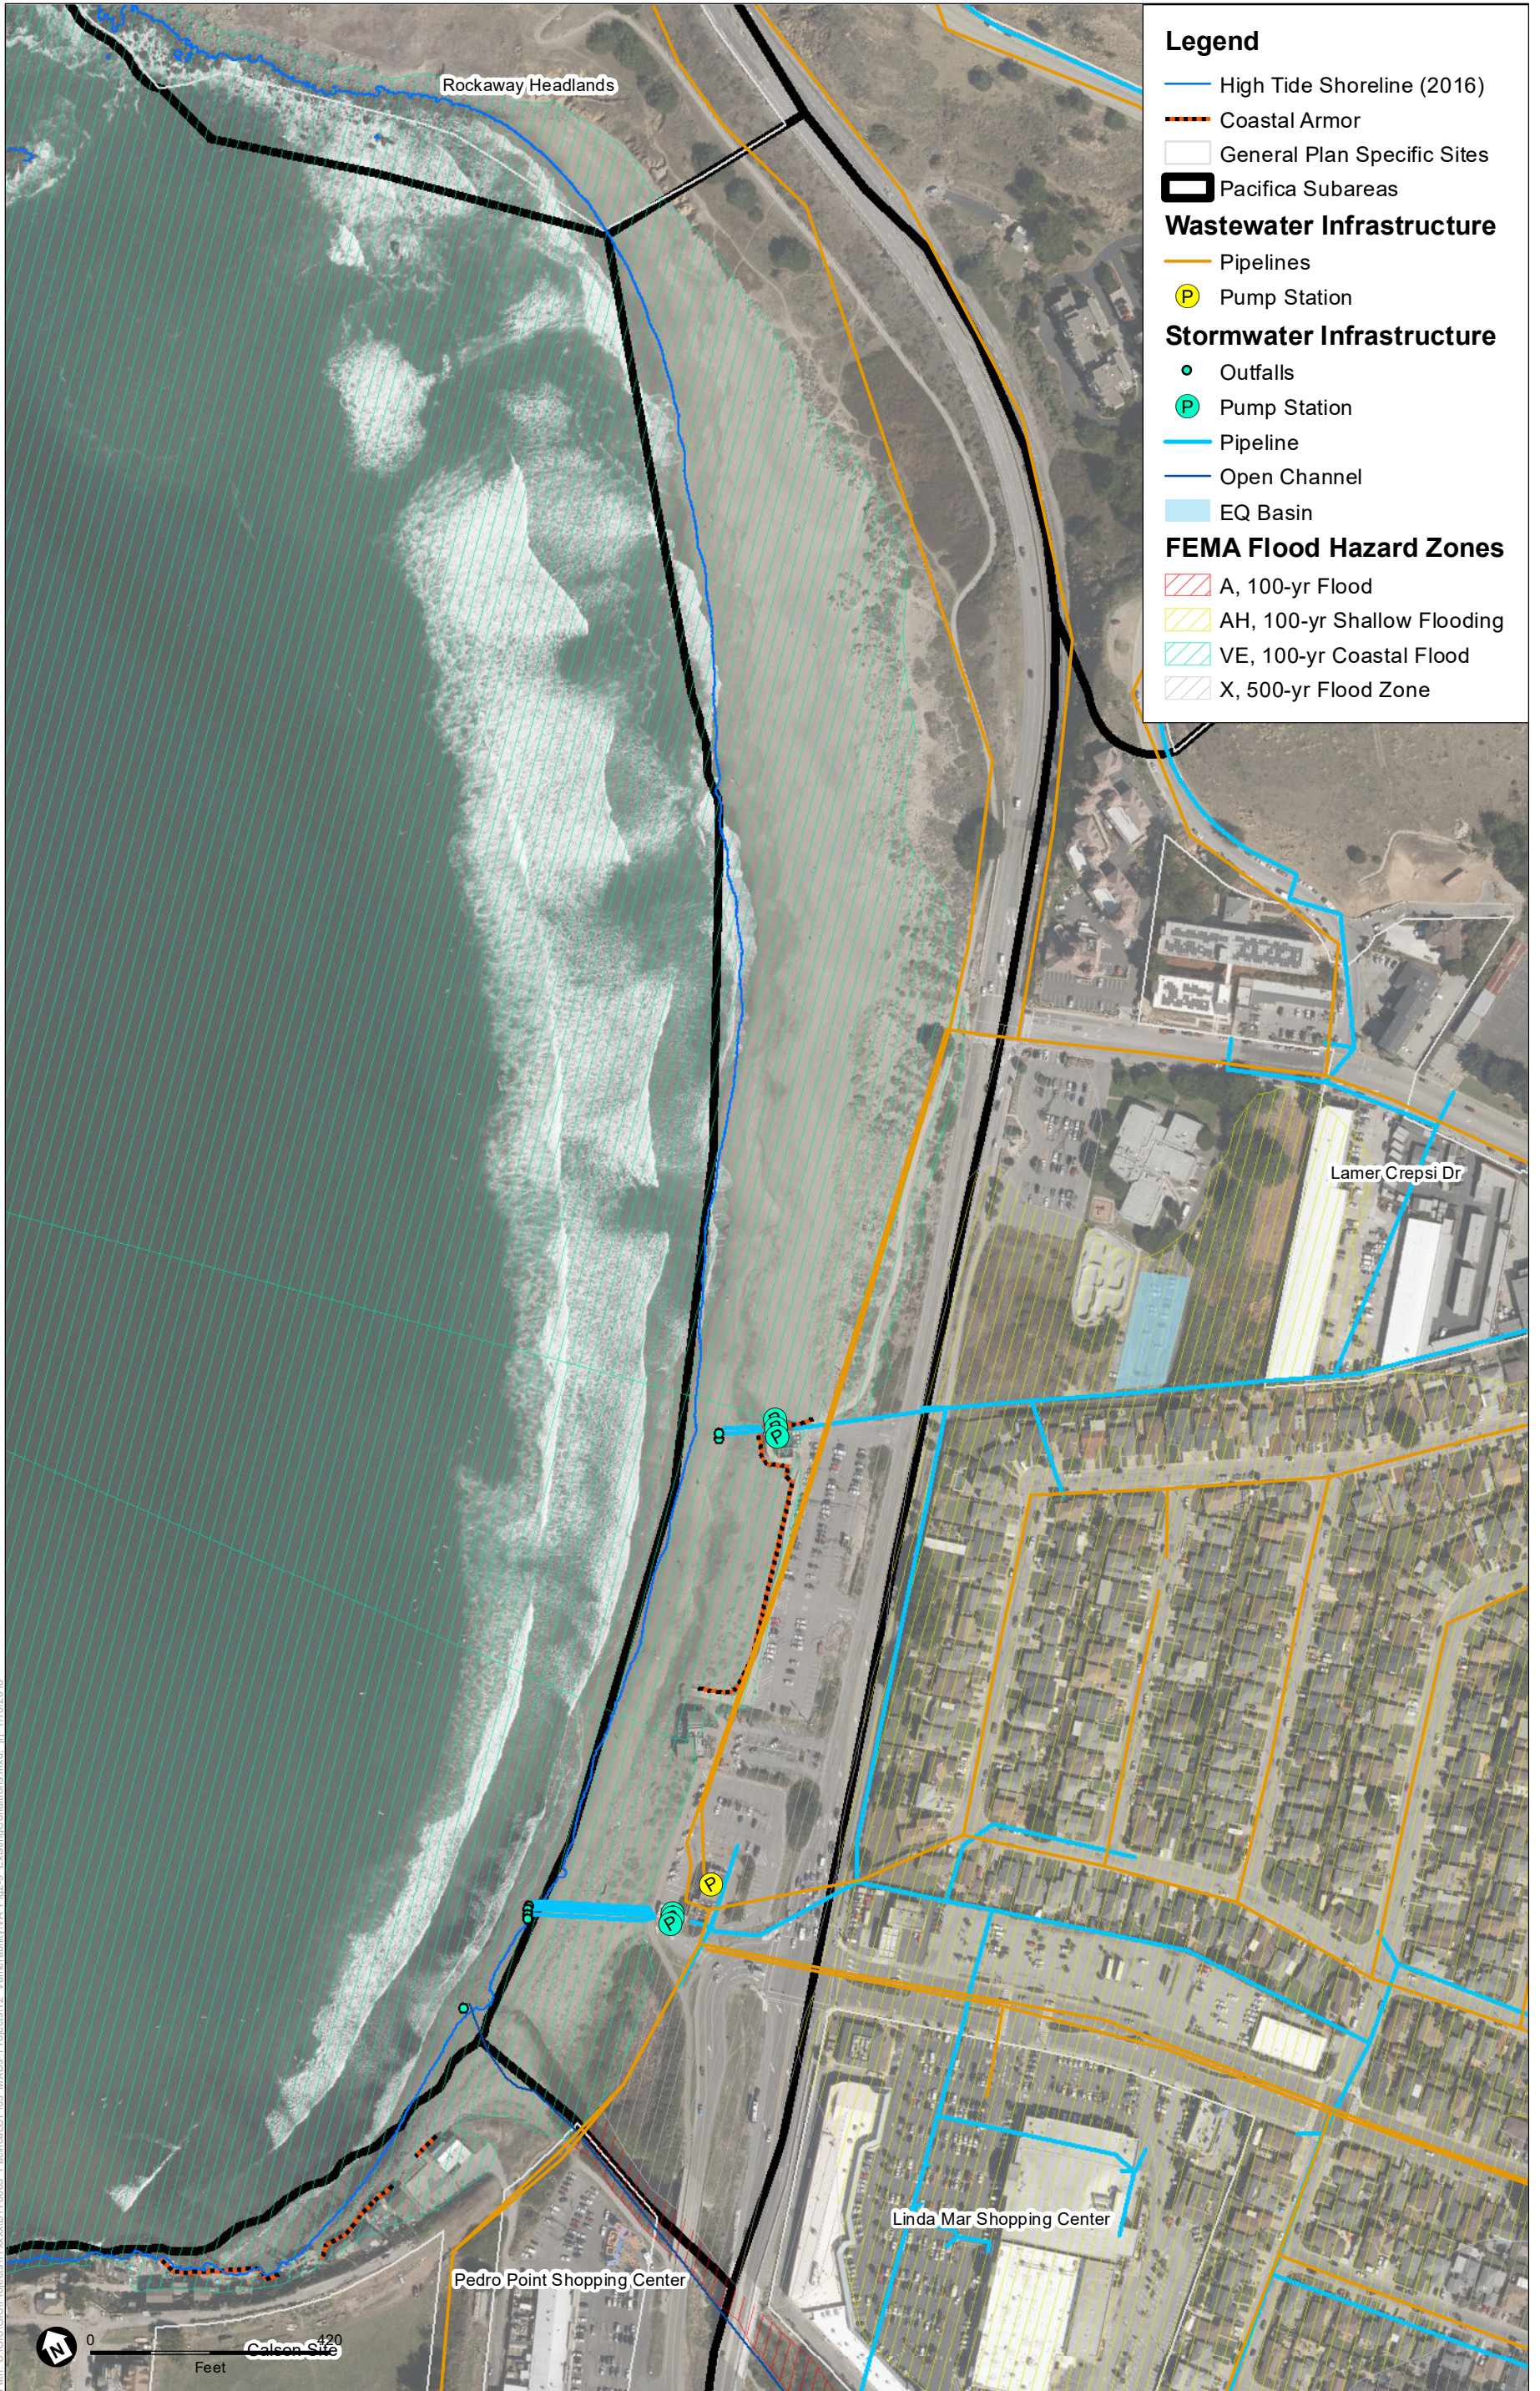
**Appendix A-6**  
Existing Conditions Map  
Pacifica State Beach

SOURCE: San Mateo County 2017 Imagery; City of Pacifica Assets (2017); FEMA Flood Hazard Areas (2017)
