CITY OF PACIFICA

PRESS RELEASE

Second Sink Hole Opens Along Beach Blvd. Promenade in Pacifica

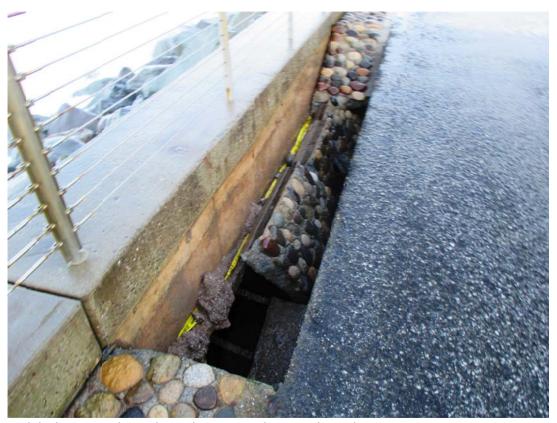
"Another section of the promenade has been undermined along Beach Blvd.," said City Manager Lorie Tinfow. "The new surface opening measures 25 feet long by 3 feet wide by 4 feet deep. The good news is that the sea wall below the surface opening appears to remain intact."

Sink hole at Beach Boulevard promenade near the Paloma Avenue intersection, view facing north

Funding for repairs to all damaged City structures has been requested from the State of California.

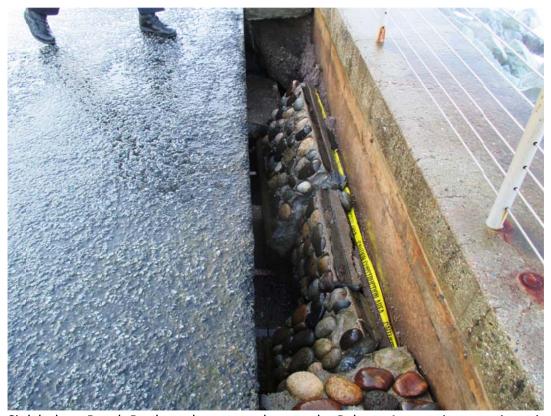
Sink hole at Beach Boulevard promenade near the Paloma Avenue intersection, view facing south
