Pacifica Municipal Fishing Pier

2023 Condition Assessment Report

City of Pacifica

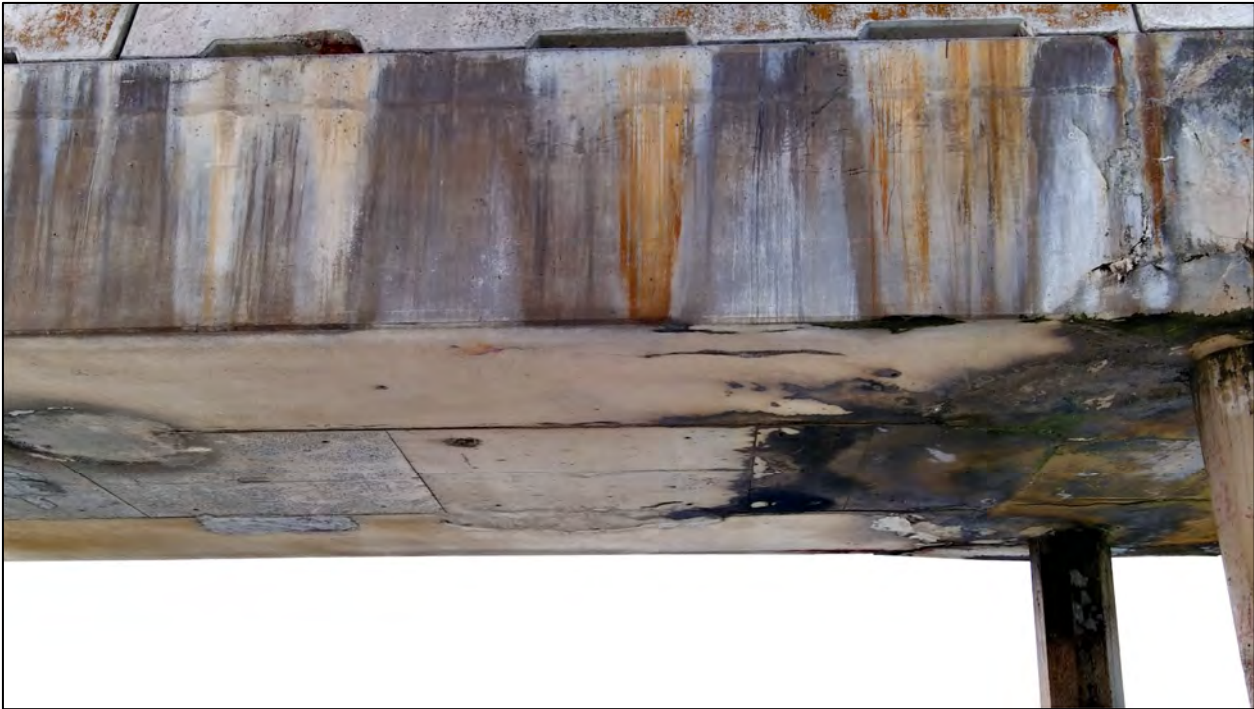
Figure 4.6 **Deck Moderate Rating (Bent 1C)**

The condition of the Pier exterior sides and soffits were assessed from the images captured by the drone. The images were reviewed by GHD's engineers to identify damages such as discoloration from algae growth, rust stains, cracks, and spalls. Typical damages on the sides and soffits of the deck and bent caps are shown in Figure 4.6 through

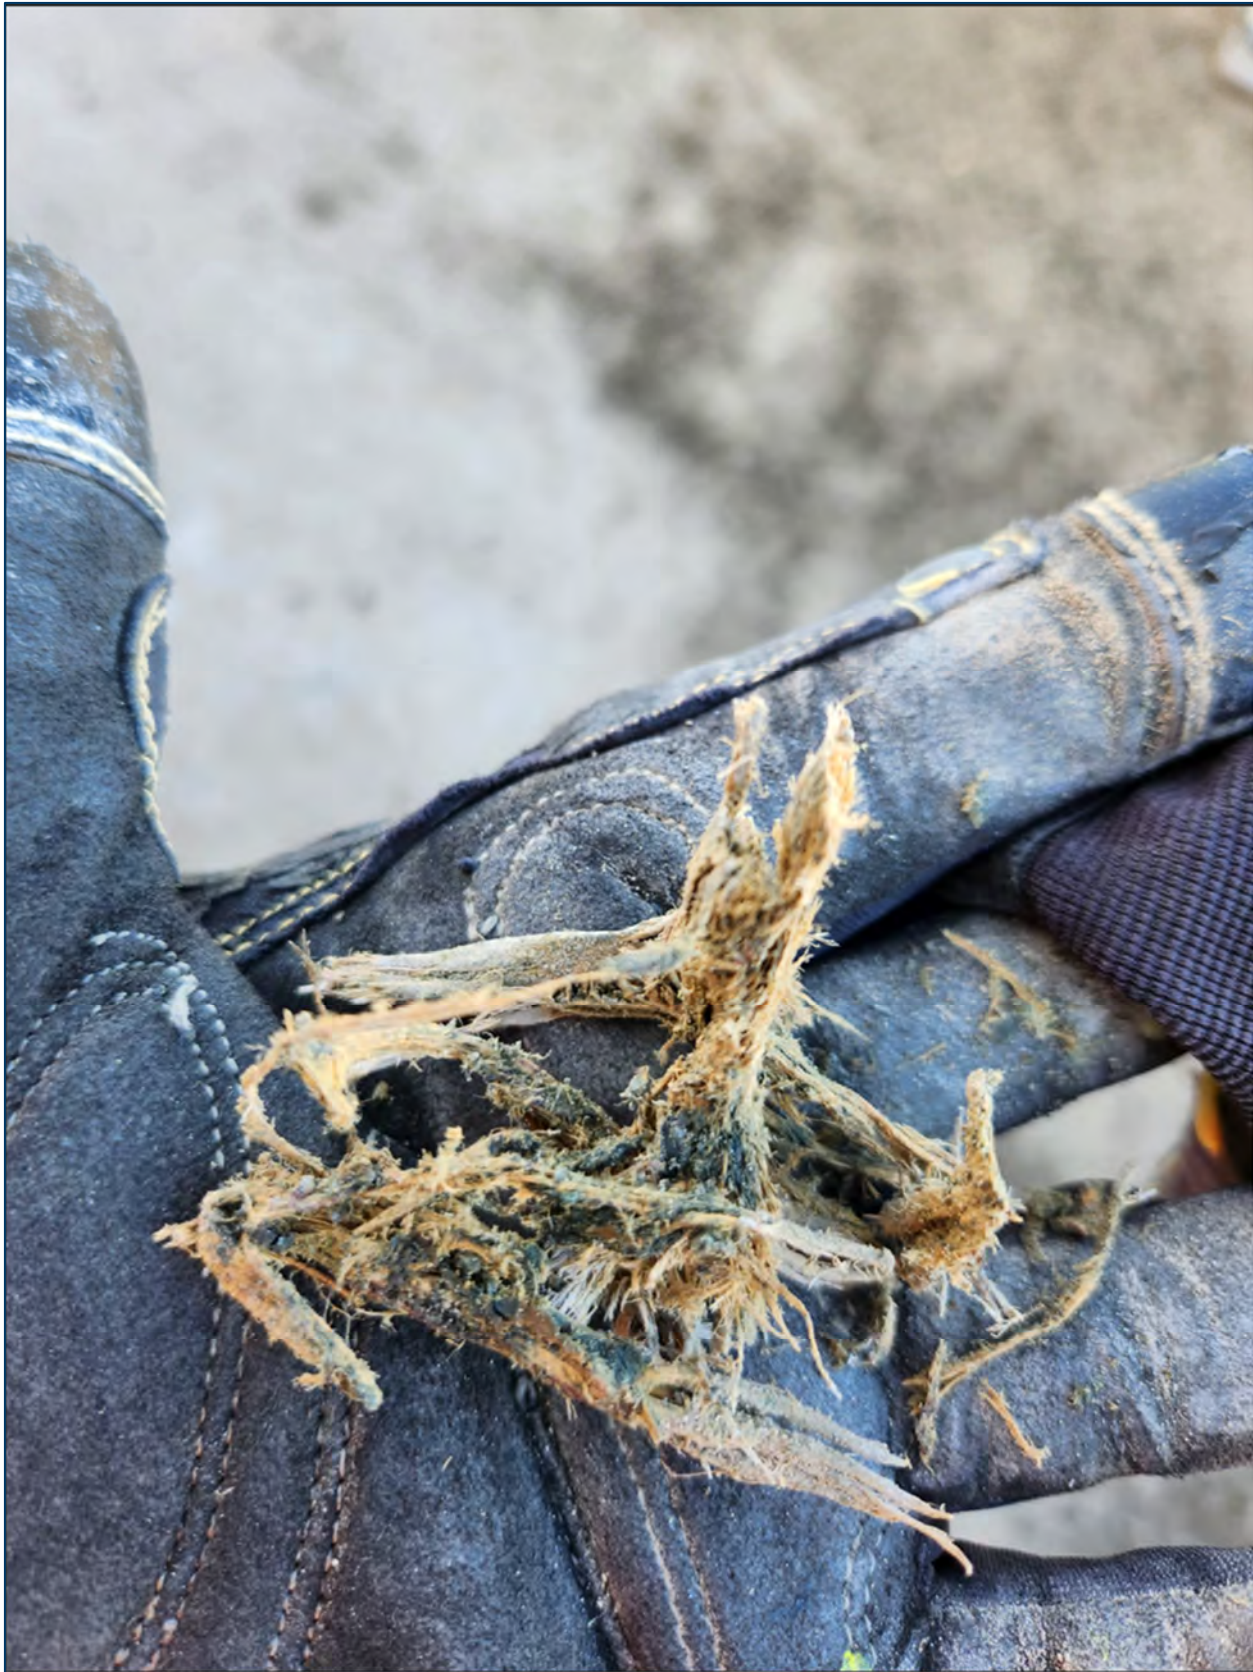
Figure A.1-15 *Wood Shavings at B6 Location*

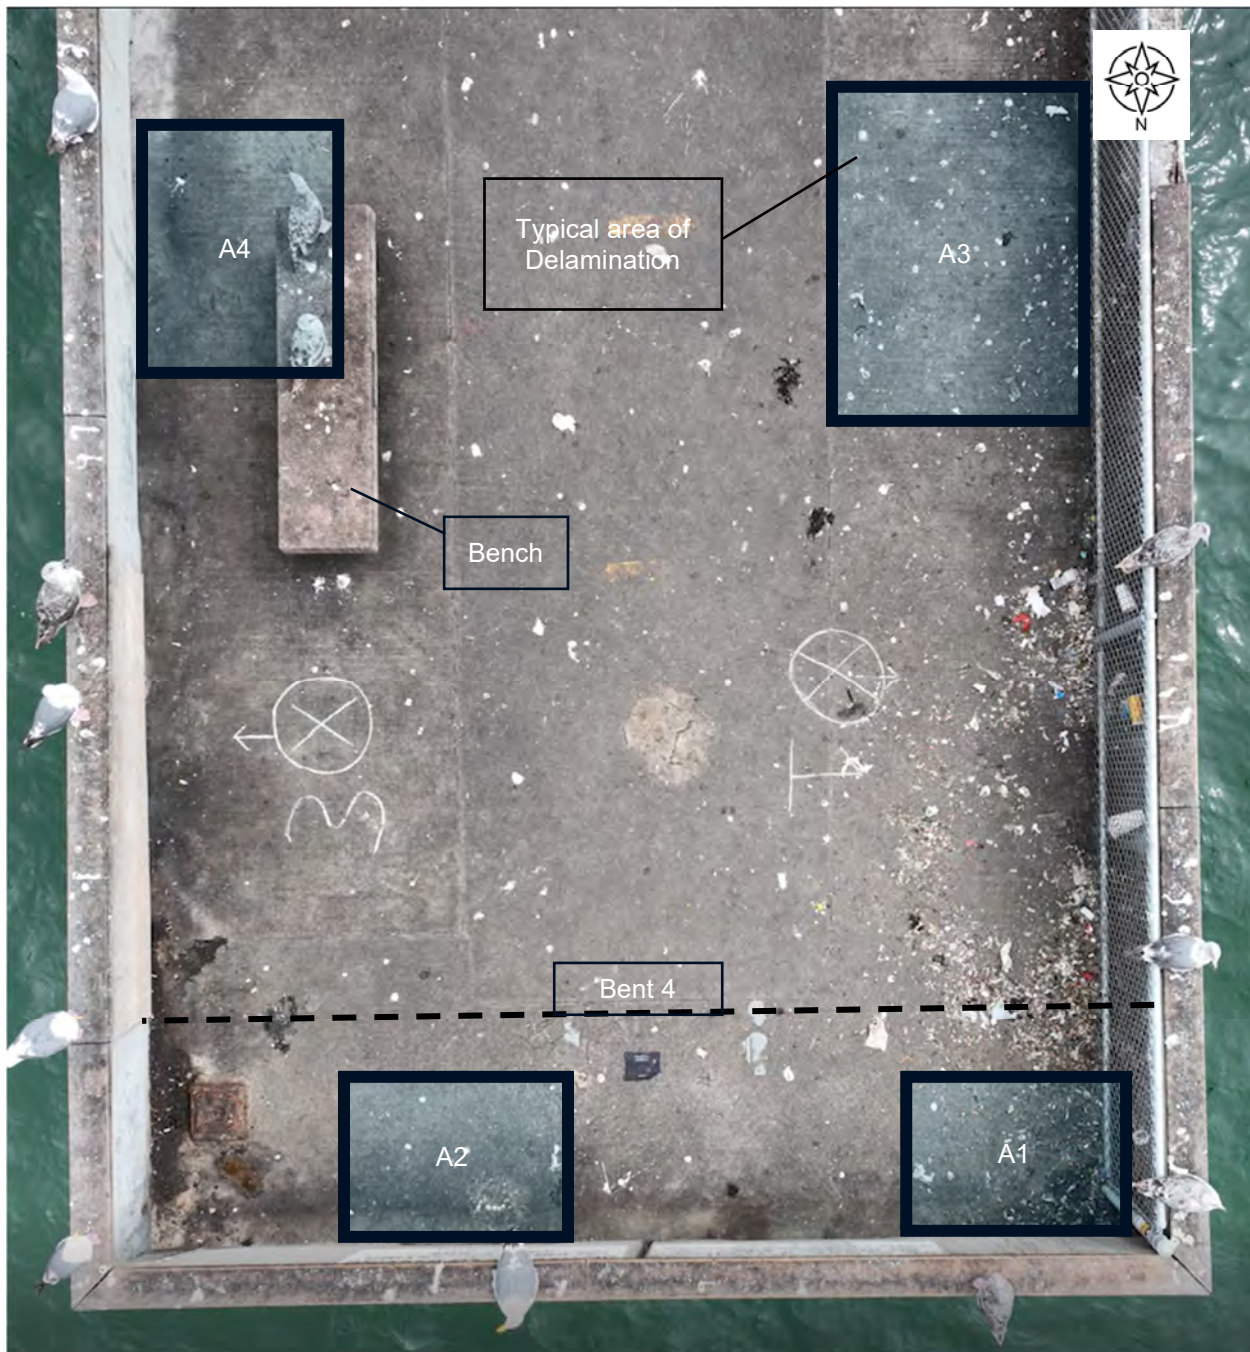
Figure A.2-1 Delaminated Areas at Bent 4 - N-S Extension Pier

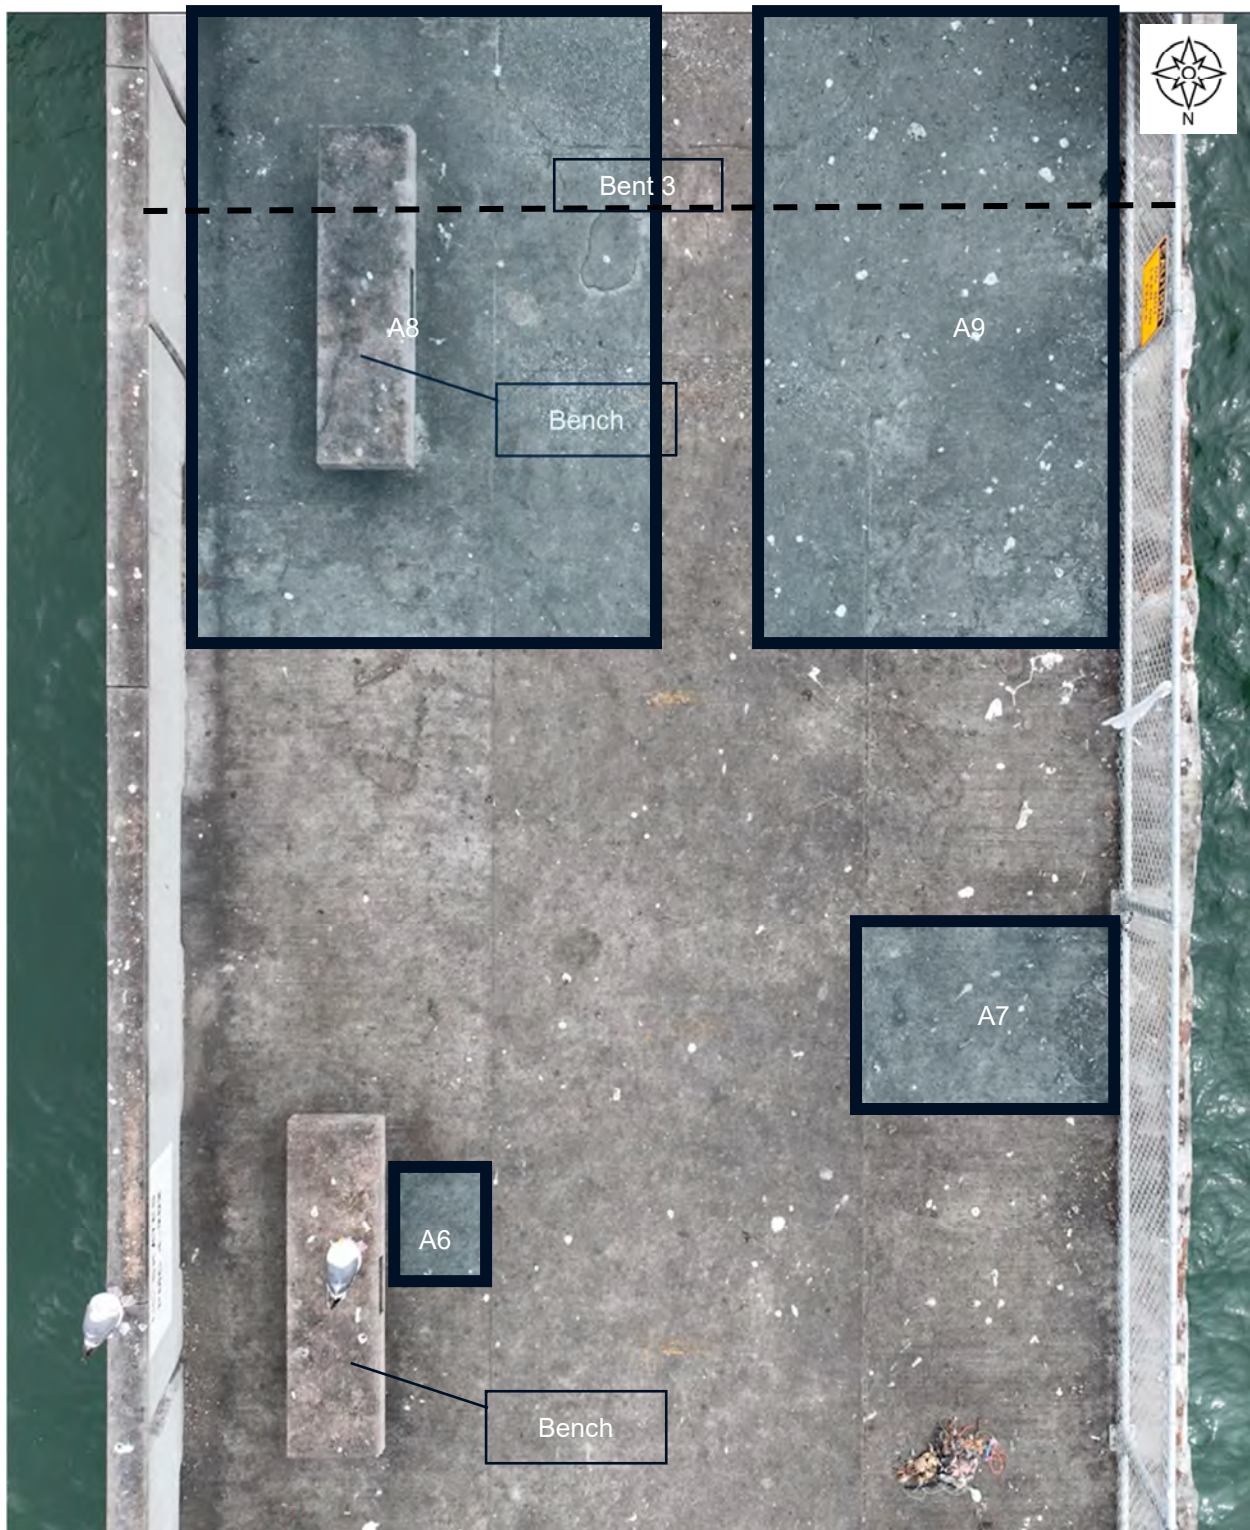
Figure A.2-3 Delaminated Areas Between Bent 4 and Bent 3 - N-S Extension Pier

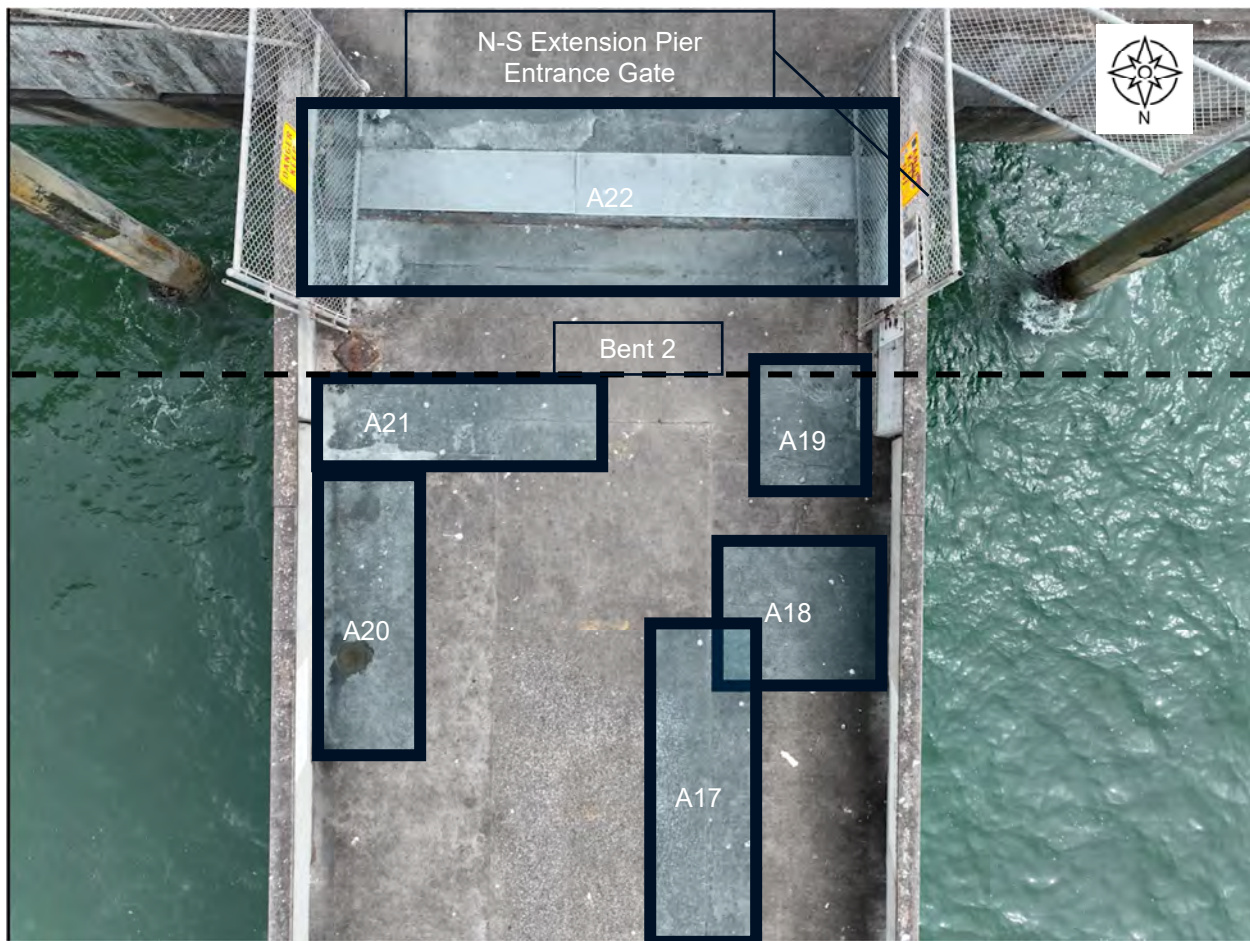
Figure A.2-7 Delaminated Areas at Bent 2 - N-S Extension Pier Entrance

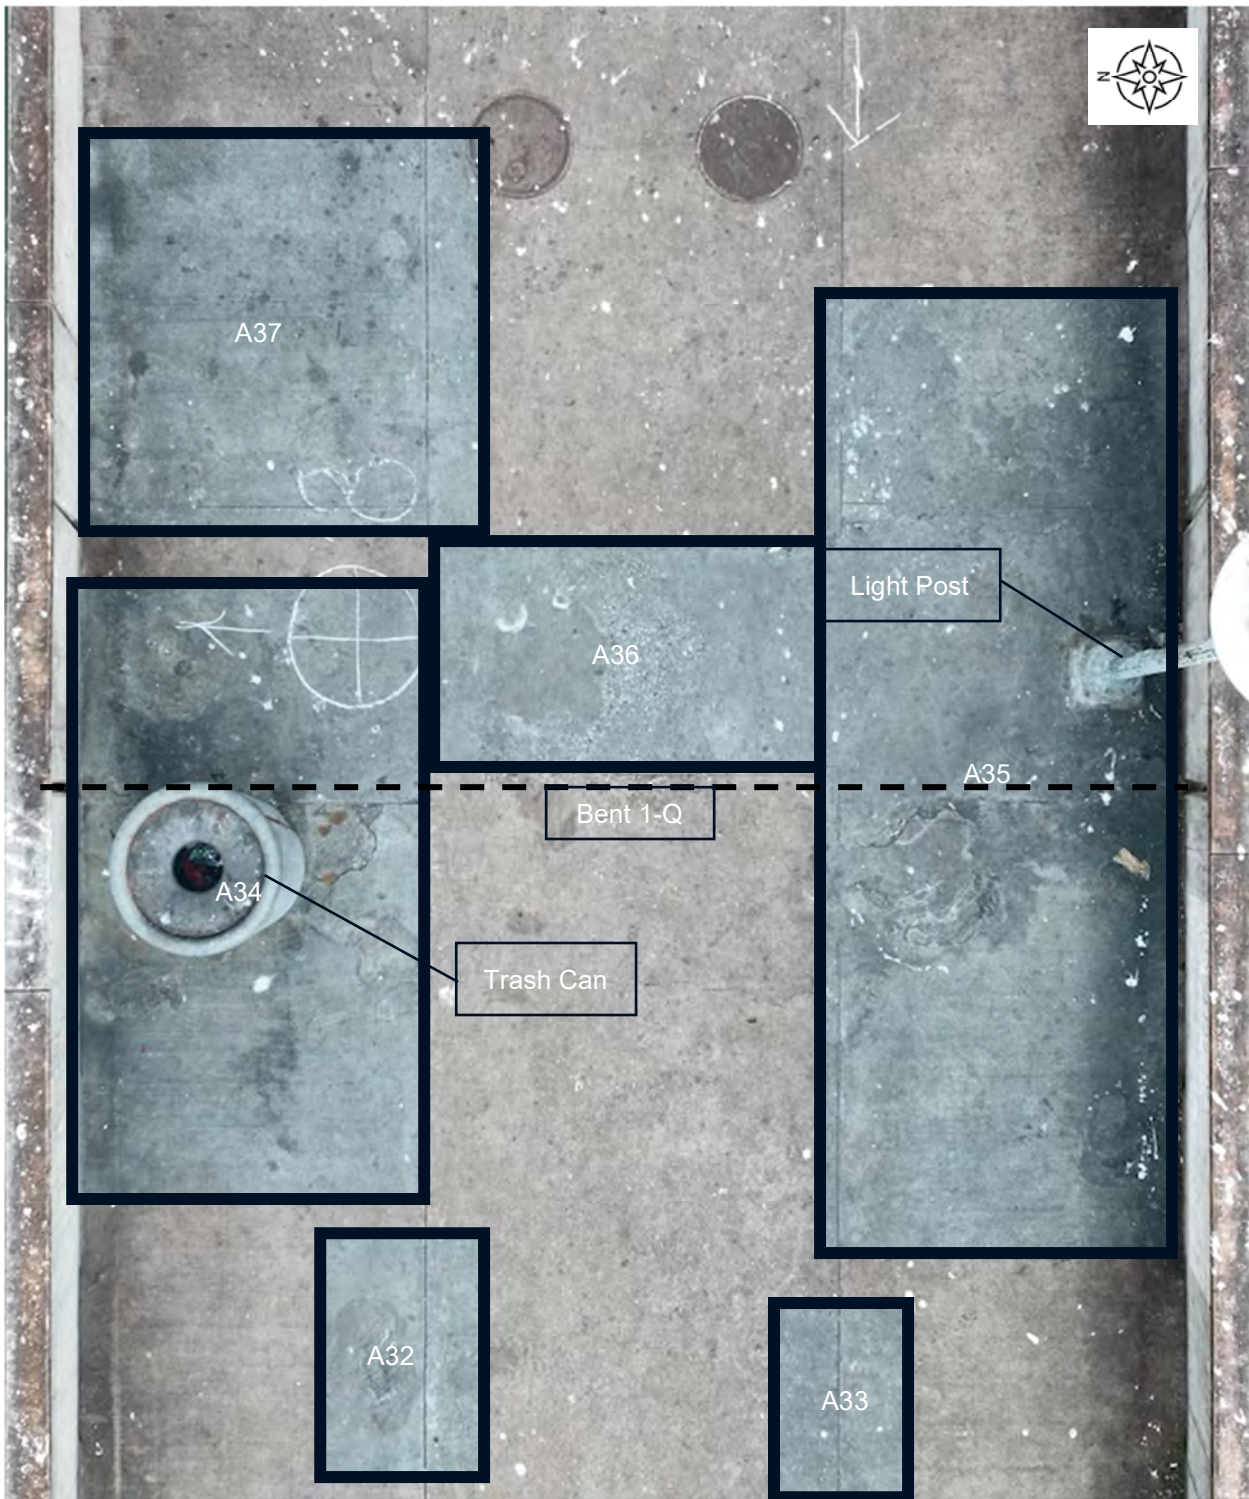
Figure A.2-10 Delaminated Areas at Bent 1-Q - E-W Main Pier

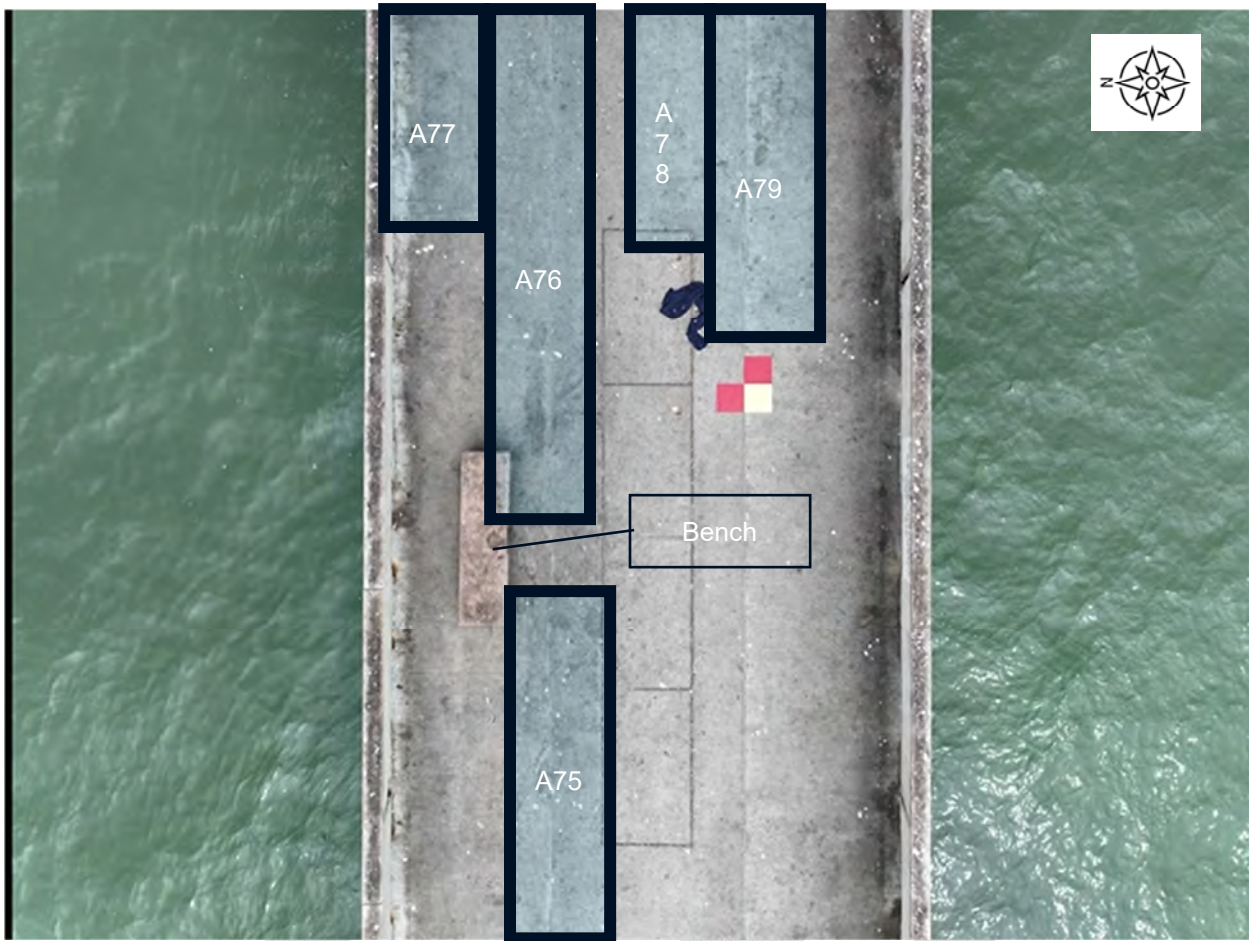
Figure A.2-24 Delaminated Areas between Bent 1-L and Bent 1-K – E-W Main Pier

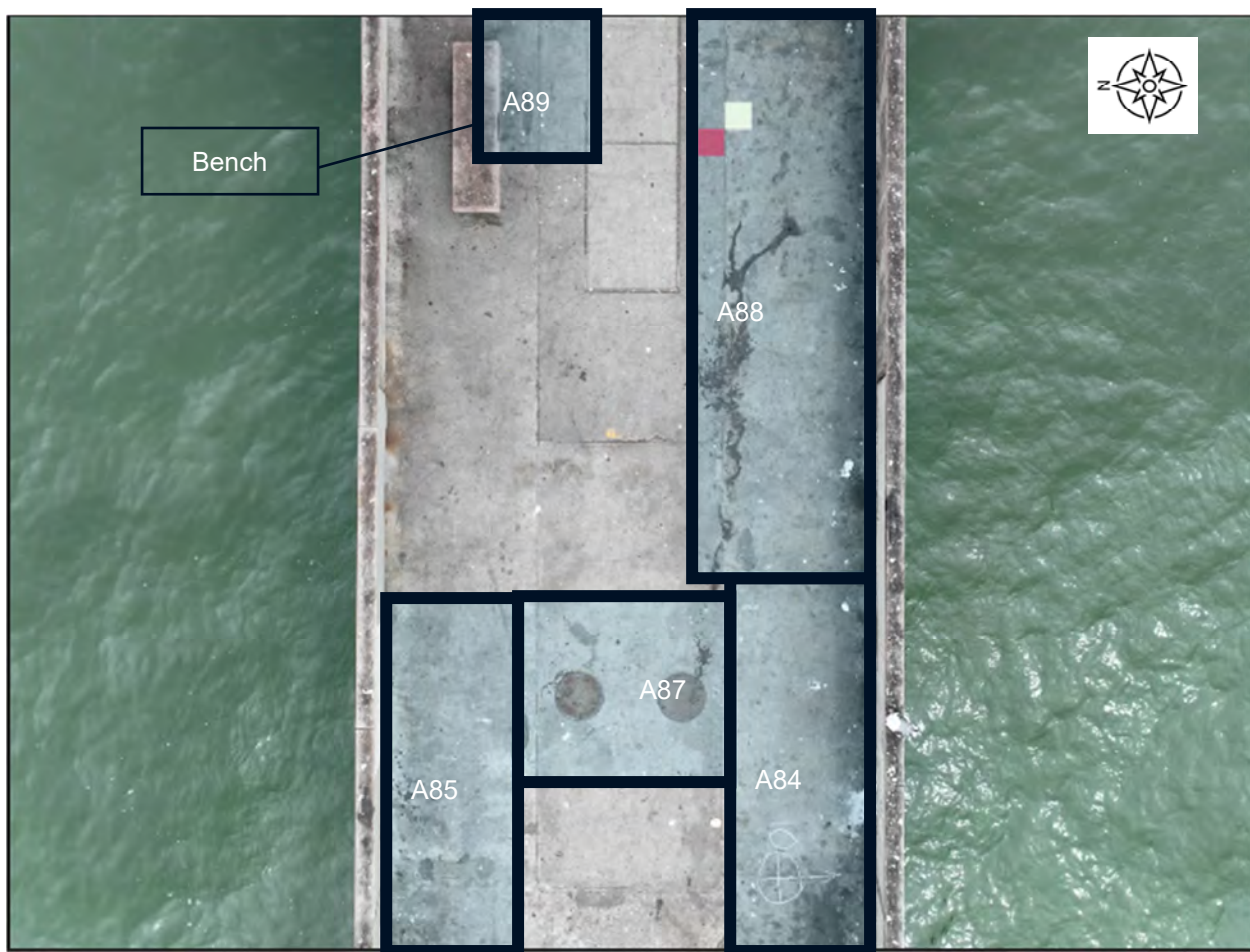
Figure A.2-28 Delaminated Areas between Bent 1-J and Bent 1-I – E-W Main Pier

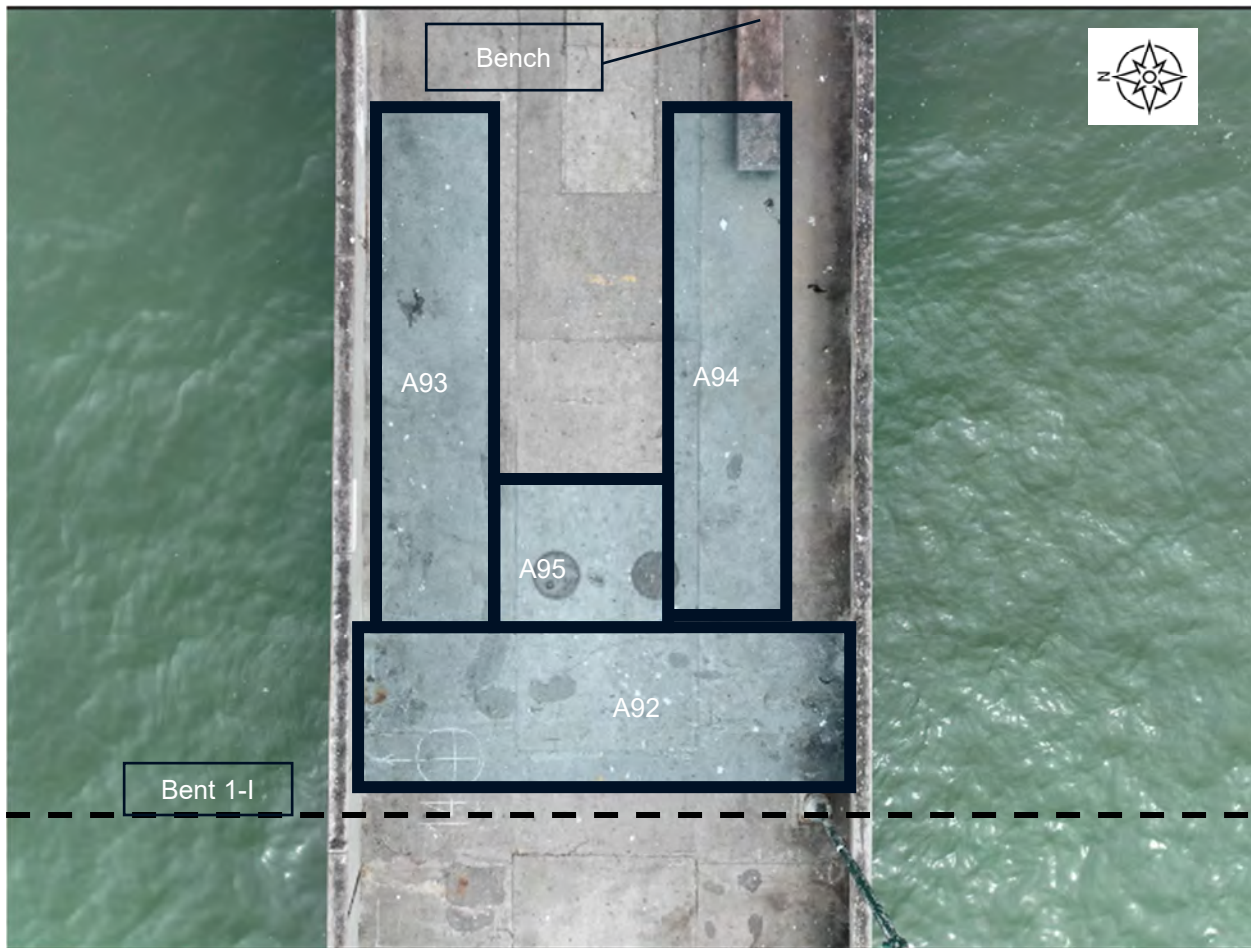
Figure A.2-30 Delaminated Areas at Bent 1-I – E-W Main Pier

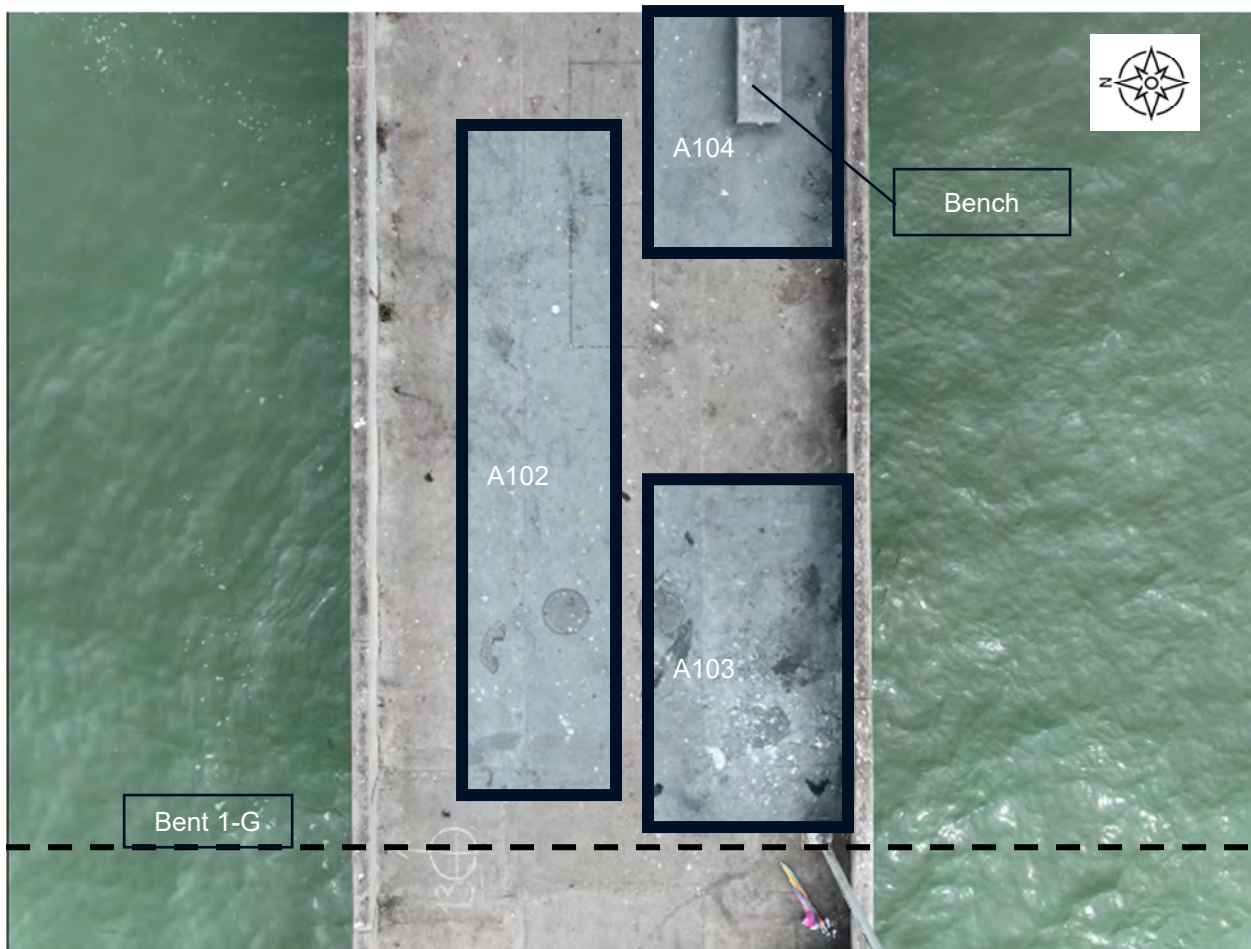
Figure A.2-34 Delaminated Areas around Bent 1-G – E-W Main Pier

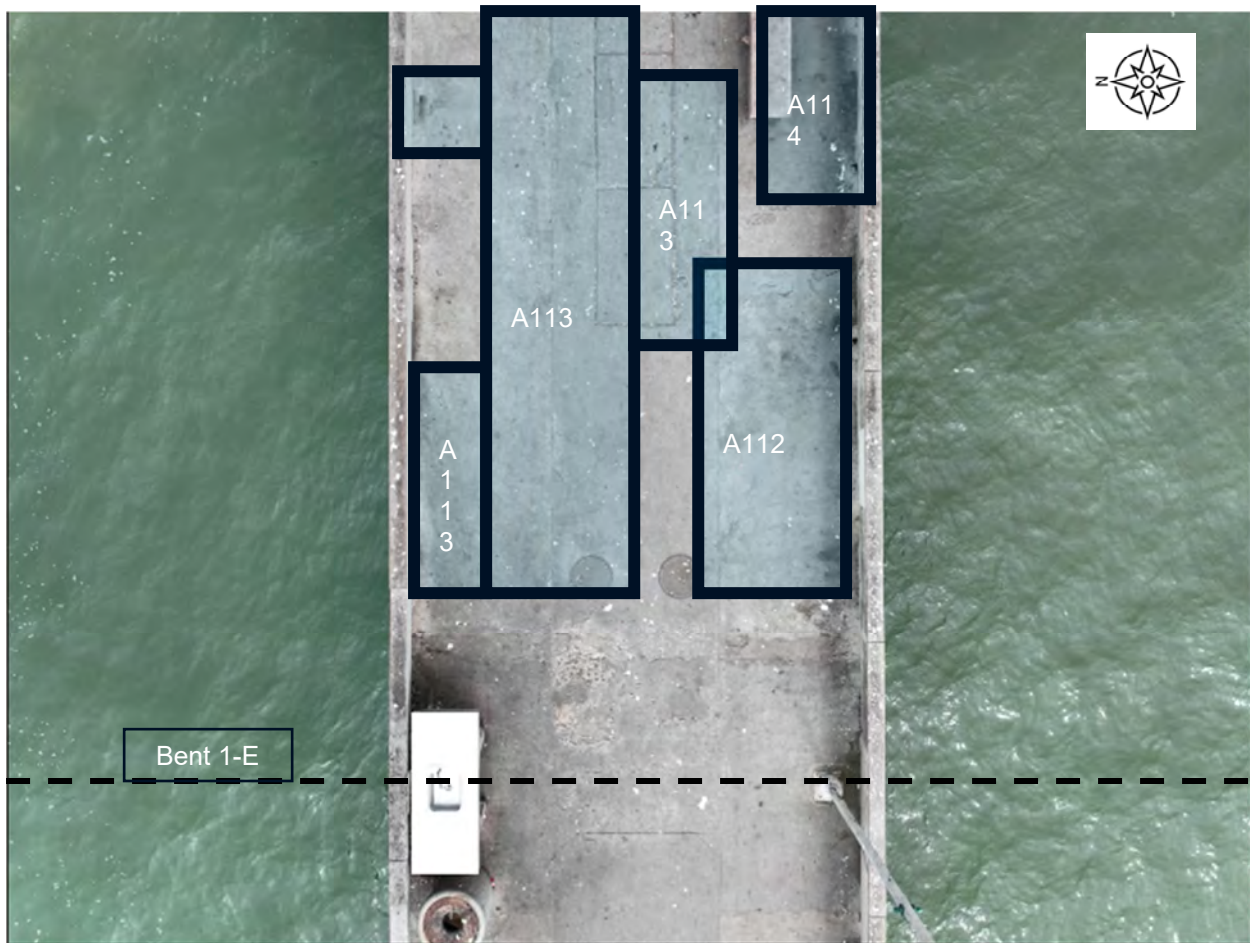
Figure A.2-37 Delaminated Areas between Bent 1-E and Bent 1-D – E-W Main Pier

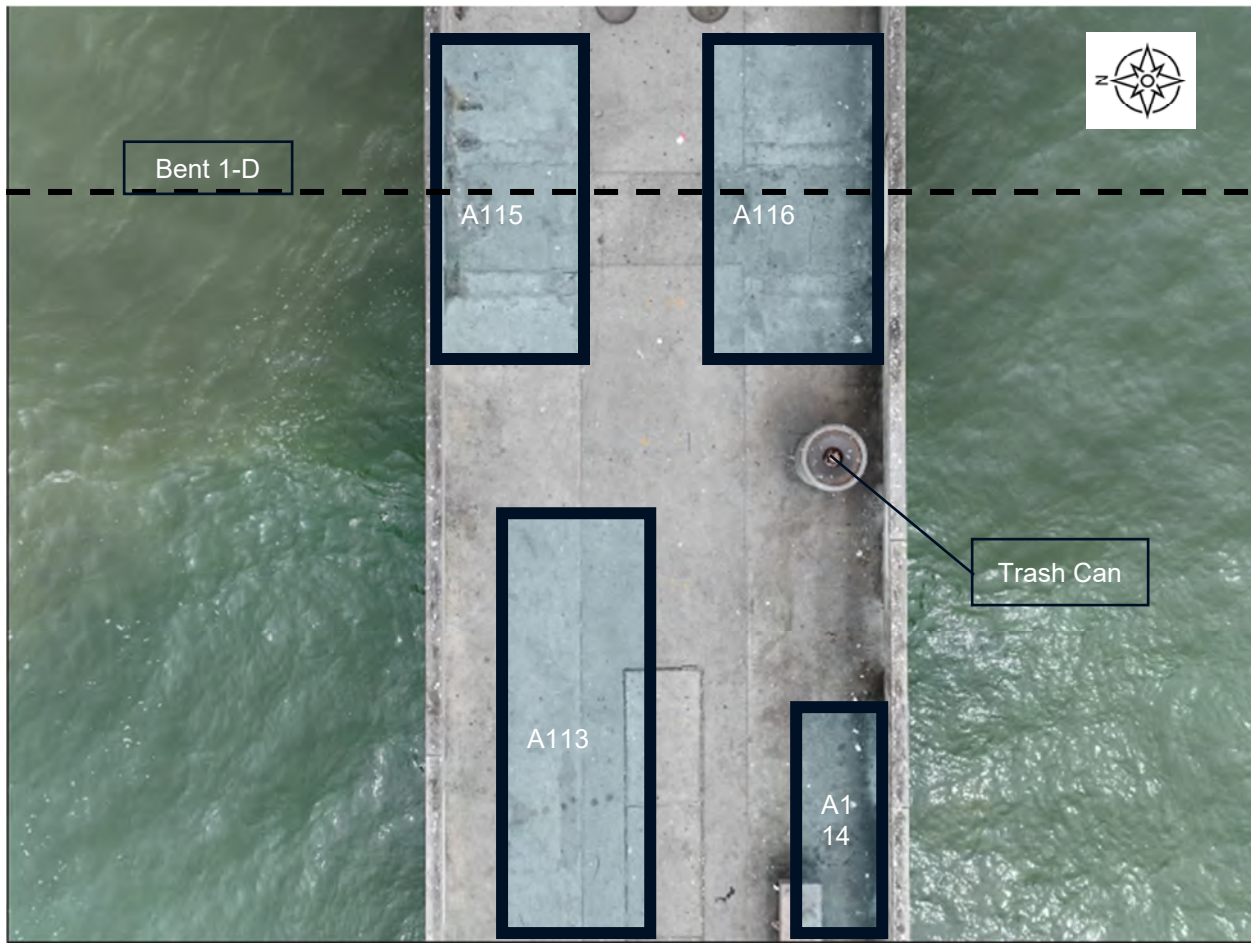
Figure A.2-38 Delaminated Areas around Bent 1-D – E-W Main Pier

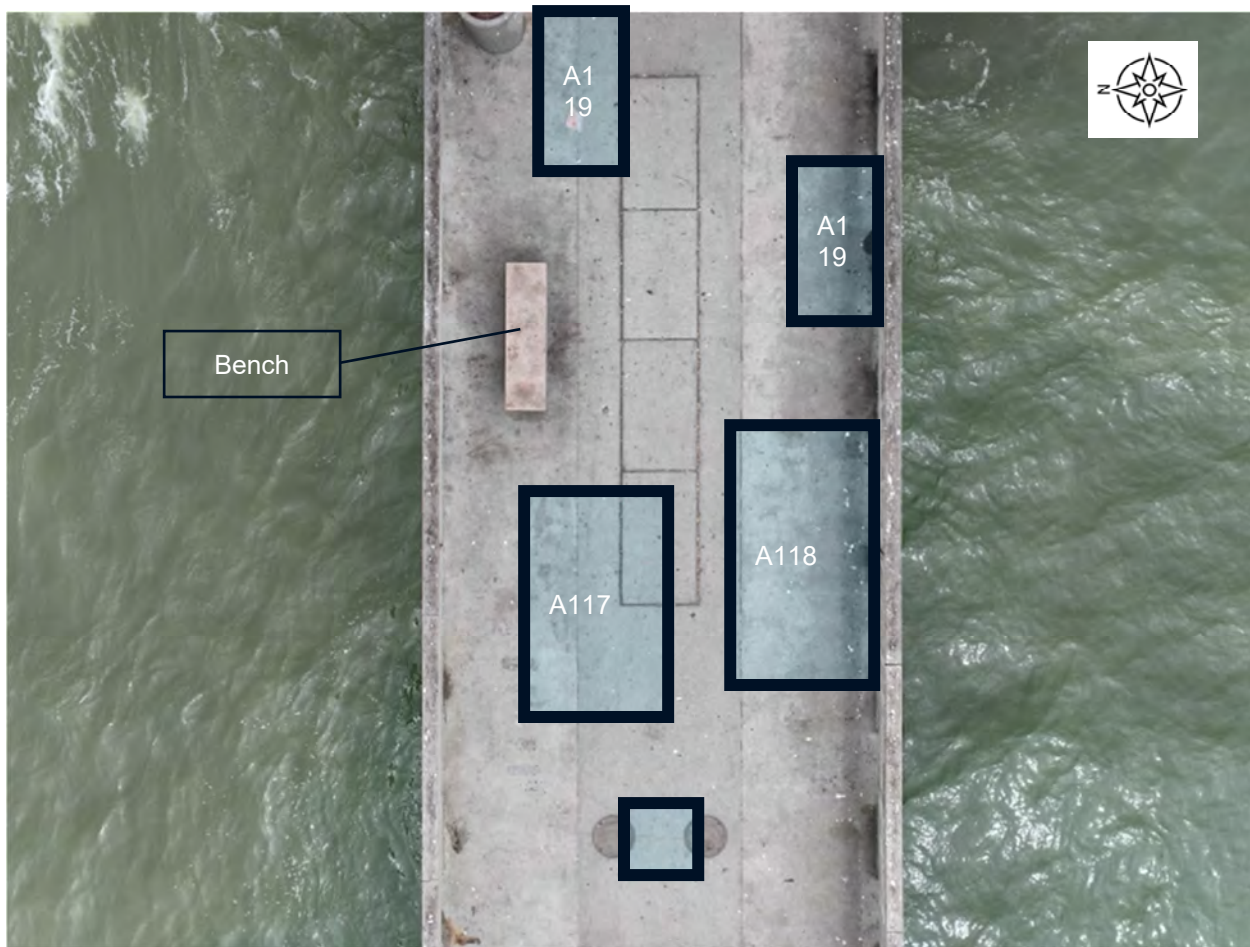
Figure A.2-39 Delaminated Areas between Bent 1-C and Bent 1-D – E-W Main Pier

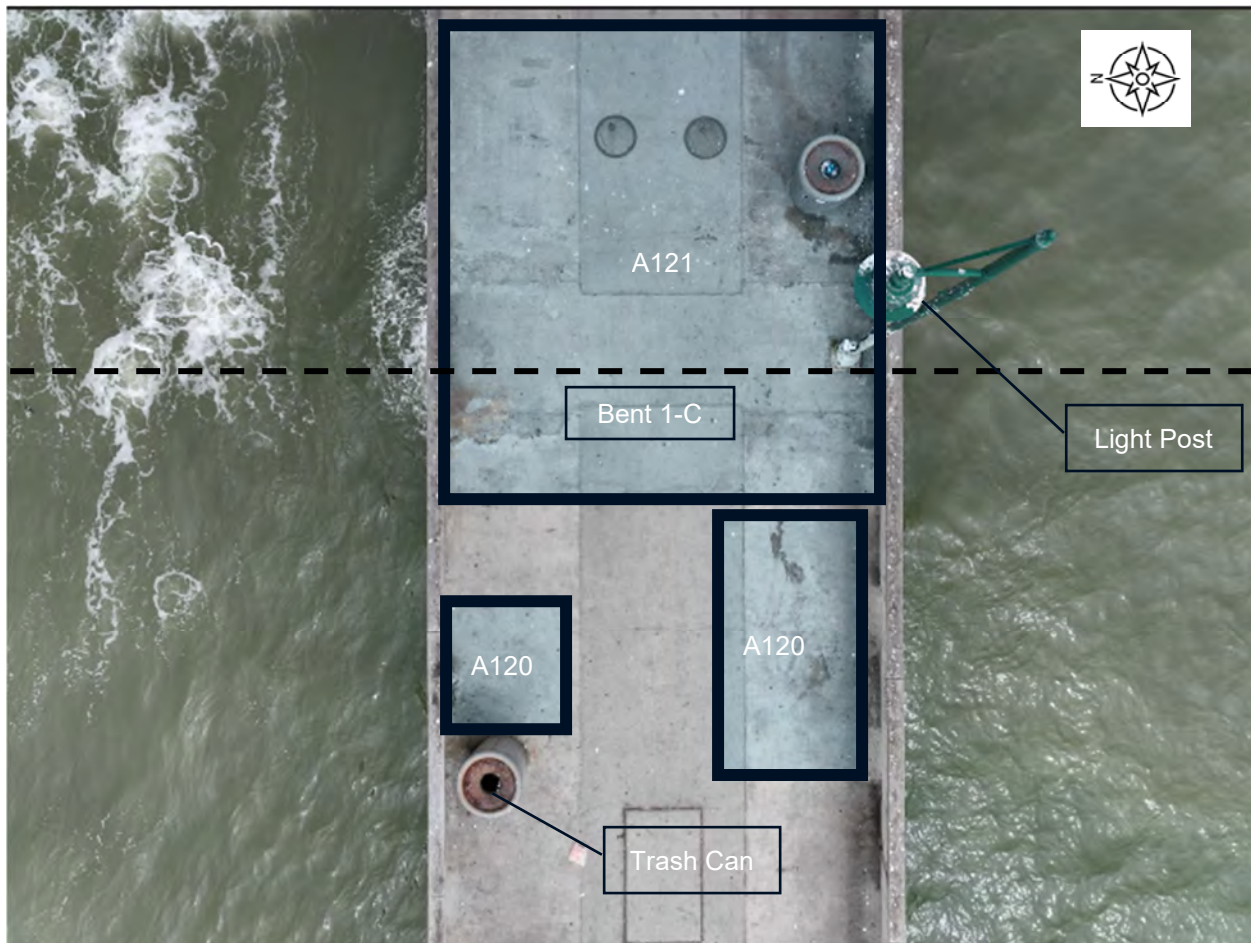
Figure A.2-40 Delaminated Areas around Bent 1-C – E-W Main Pier

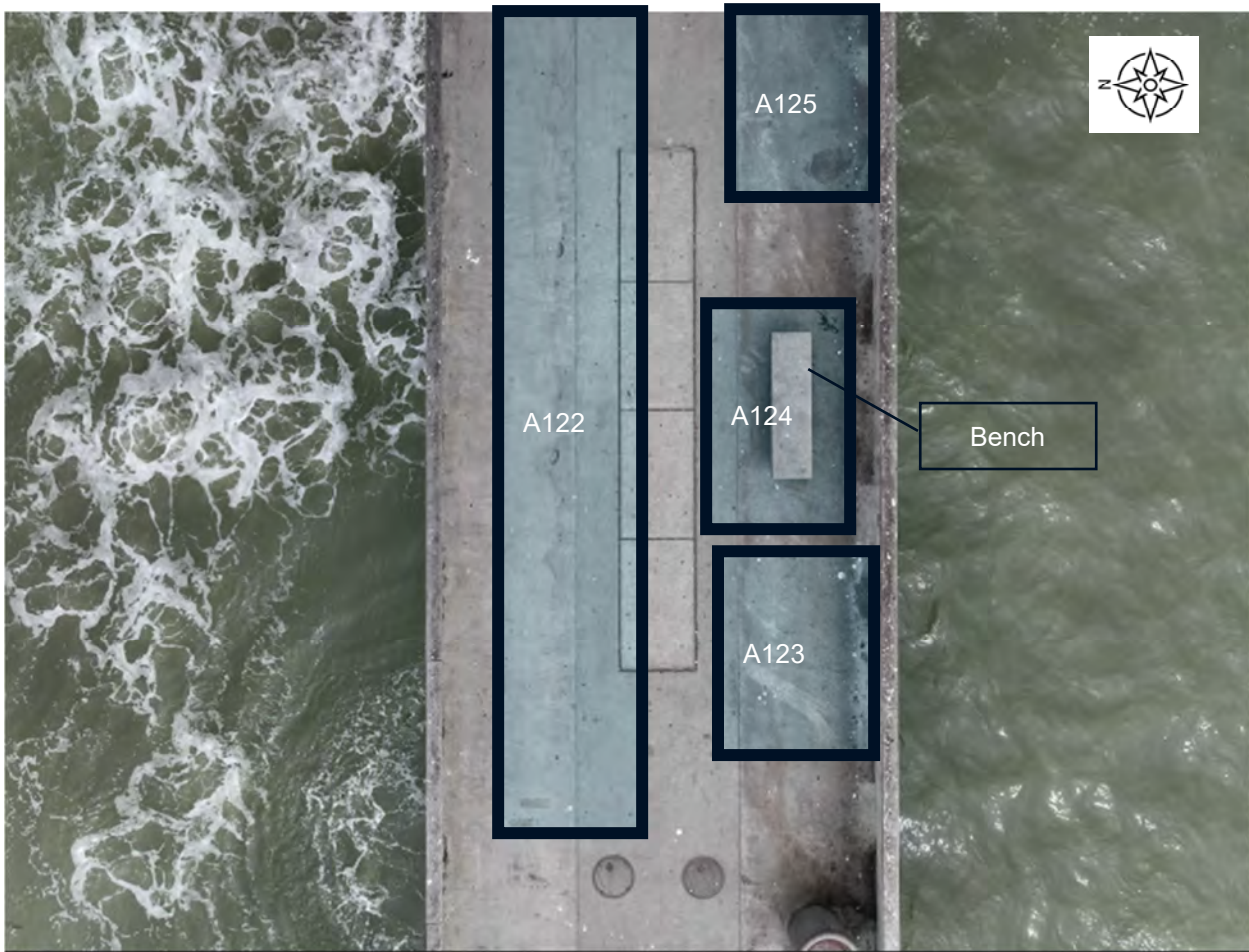
Figure A.2-41 Delaminated Areas between Bent 1-C and Bent 1-B – E-W Main Pier

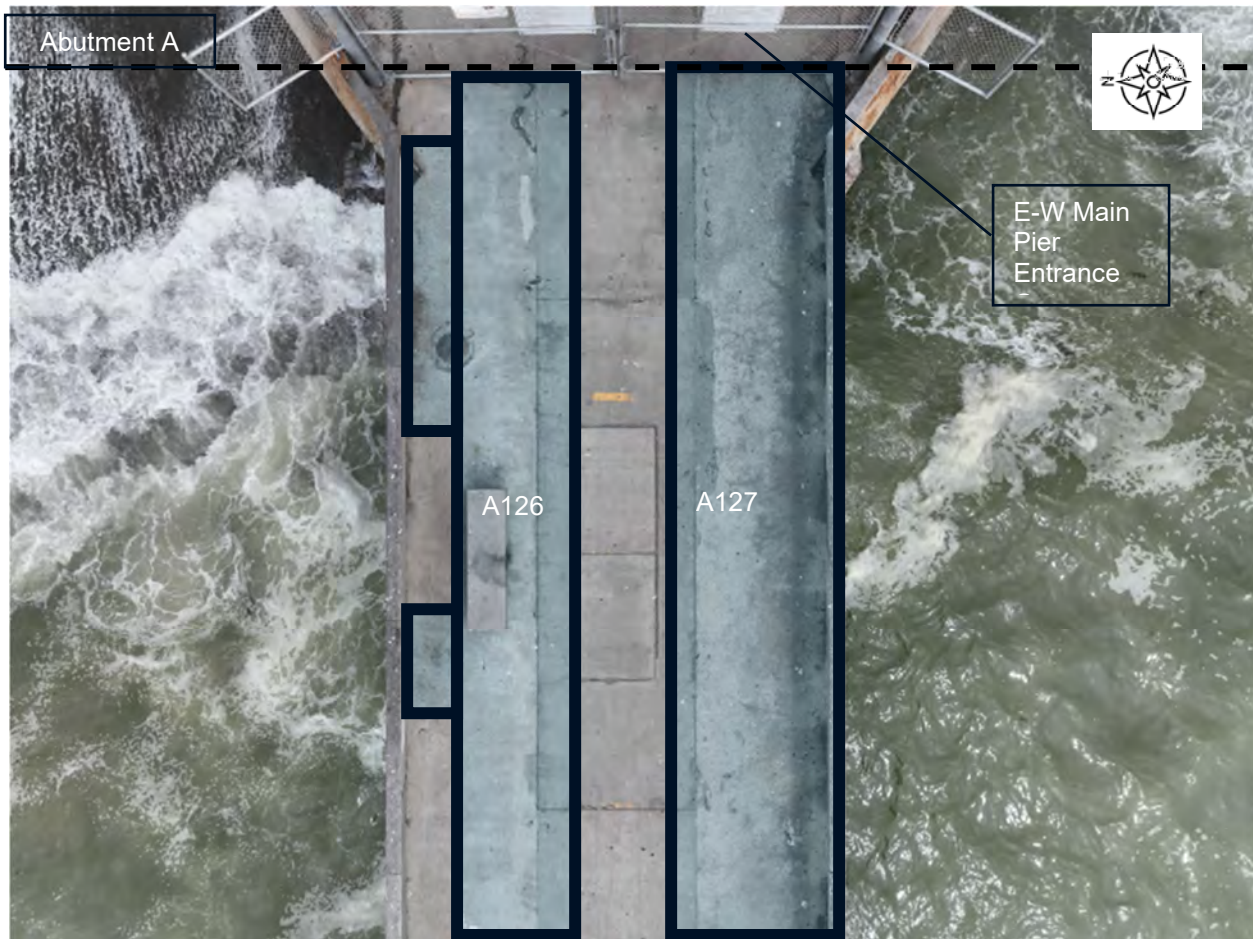
Figure A.2-43 Delaminated Areas around Abutment 1-A

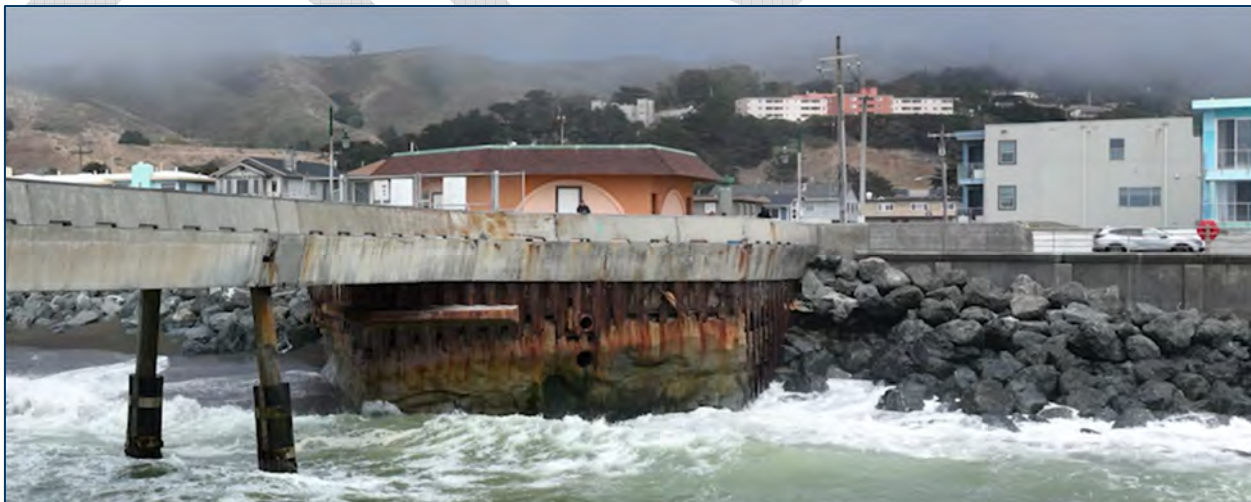
Figure A.3-6 Deck Exterior between Pier Abutment and Bent 1B – South Face

- Unattended broken wiring coming out of the deck underside.
- Discoloration of concrete (black/green algae)
- Rust bleed stains around deck and handrail connection
- Moderate to Severe corrosion and structural spalls with visible rebar
- Moderate to Major cracks and rust bleed stains around deck underside edges
- Overall rating of deck – Severe
