Pacifica Municipal Fishing Pier

2023 Condition Assessment Report

City of Pacifica

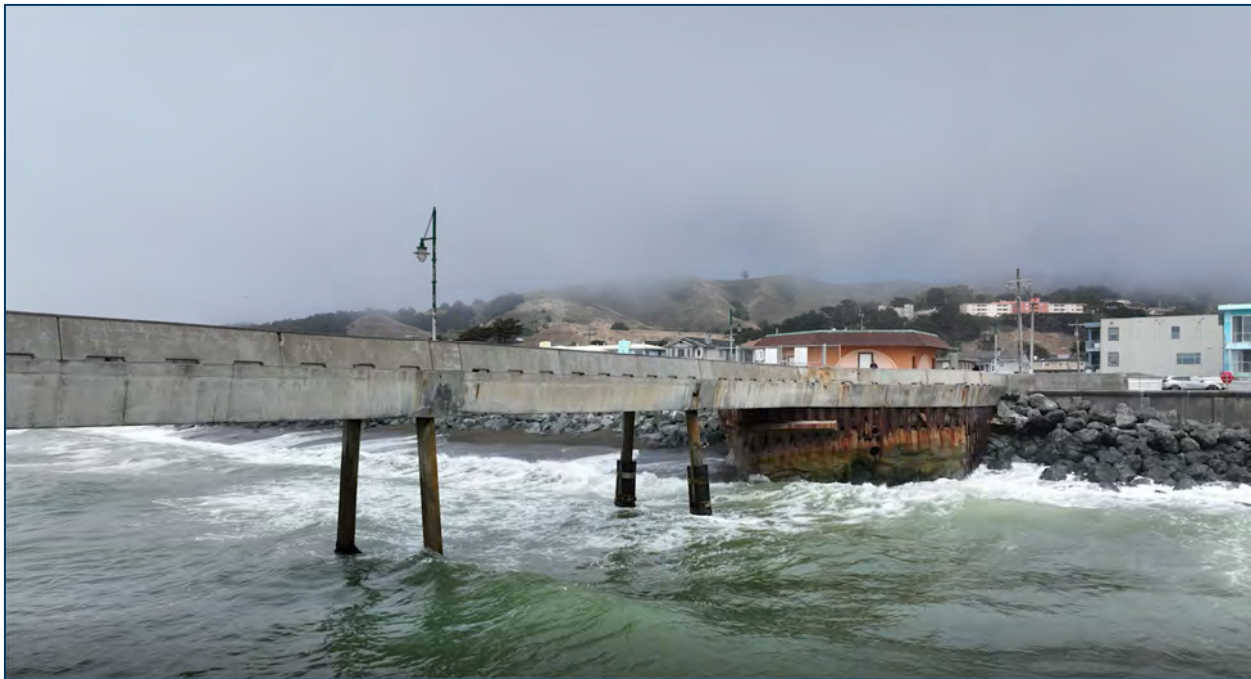
Figure A.3-12 Deck Exterior between Bent 1C and Pier Abutment – South Face

- Discoloration of concrete (black/green algae)
- Rust bleed stains around deck and handrail connection at some places, deck, and bent connection
- Minor to Moderate corrosion and structural spalls on deck between Bent 1B and 1C
- Moderate to Major corrosion and structural spalls around and under Bent 1C
- Moderate to Major cracks around and under Bent 1C
- Minor to Moderate cracks on deck between Bent 1B and 1C
- Rust stains and moderate cracks on piles
- Abrasion on piles
- Minor impact spalls on piles
- Overall rating for Deck – Moderate
- Overall rating for Bent – Major
- Overall rating for Pile - Moderate

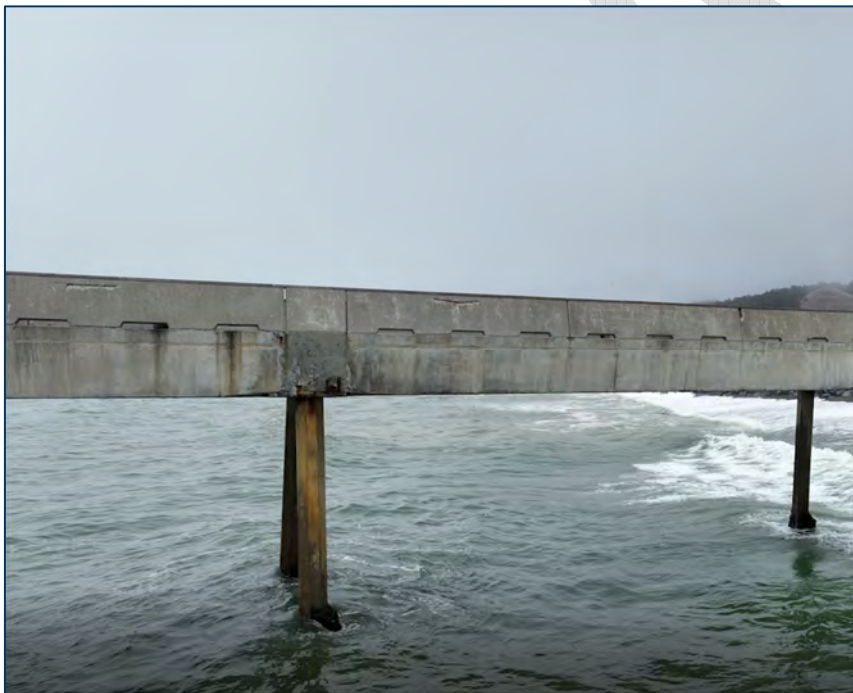
Figure A.3-16 *Deck Exterior around Bent 1D – South Face*

- Discoloration of concrete (black/green algae)
- Rust bleed stains around deck and handrail connection at some places, deck and bent connection
- Moderate to Severe corrosion and structural spalls on deck between Bent 1C and 1D – Visible rebar
- Moderate to Severe corrosion and structural spalls around Bent 1D
- Moderate to Major cracks around and under Bent 1D
- Moderate cracks between on deck Bent 1C and 1D
- Rust stains and moderate cracks on piles
- Abrasion on piles
- Minor impact spalls on piles
- Overall rating for Deck – Severe
- Overall rating for Bent - Severe
- Overall rating for Pile - Moderate

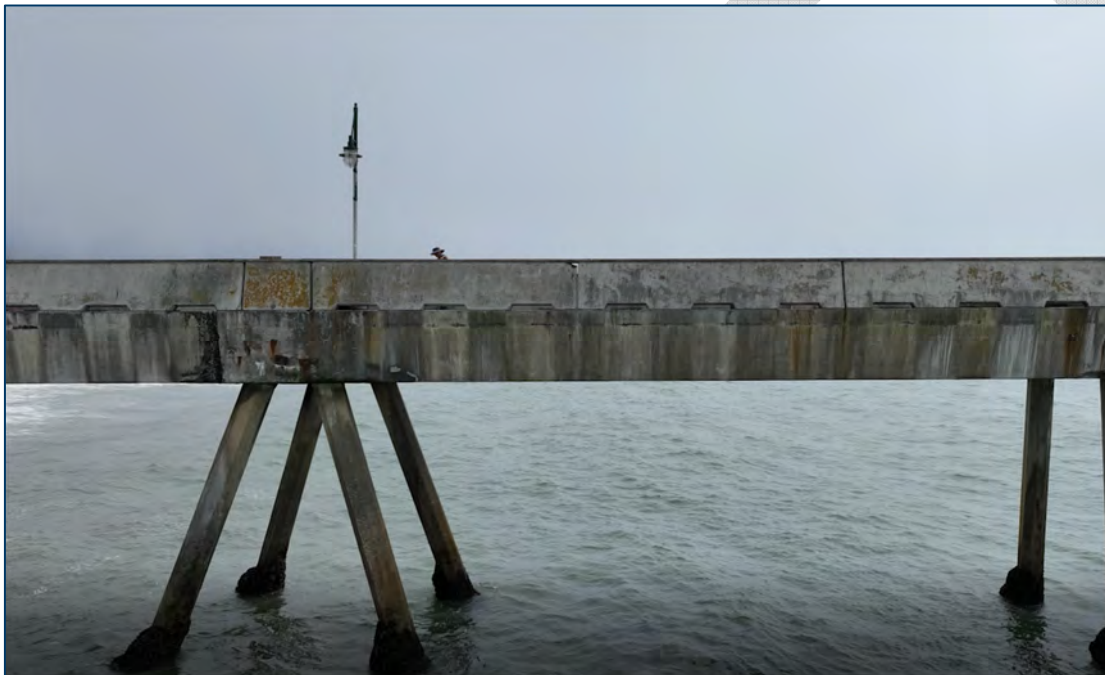
Figure A.3-21 Deck Exterior around Bent 1E and Bent 1F – North Face

- Rust bleed stains around deck and handrail connection at some places, deck and bent connection
- Moderate to Severe corrosion and structural spalls on deck between Bent 1D and 1E – Visible rebar
- Moderate to Major cracks around and under Bent 1E
- Moderate cracks on deck between Bent 1D and 1E
- Rust stains and moderate cracks on piles
- Abrasion on piles
- Minor impact spalls on piles
- Overall rating for Deck – Severe
- Overall rating for Bent - Major

Overall rating for Pile - Moderate

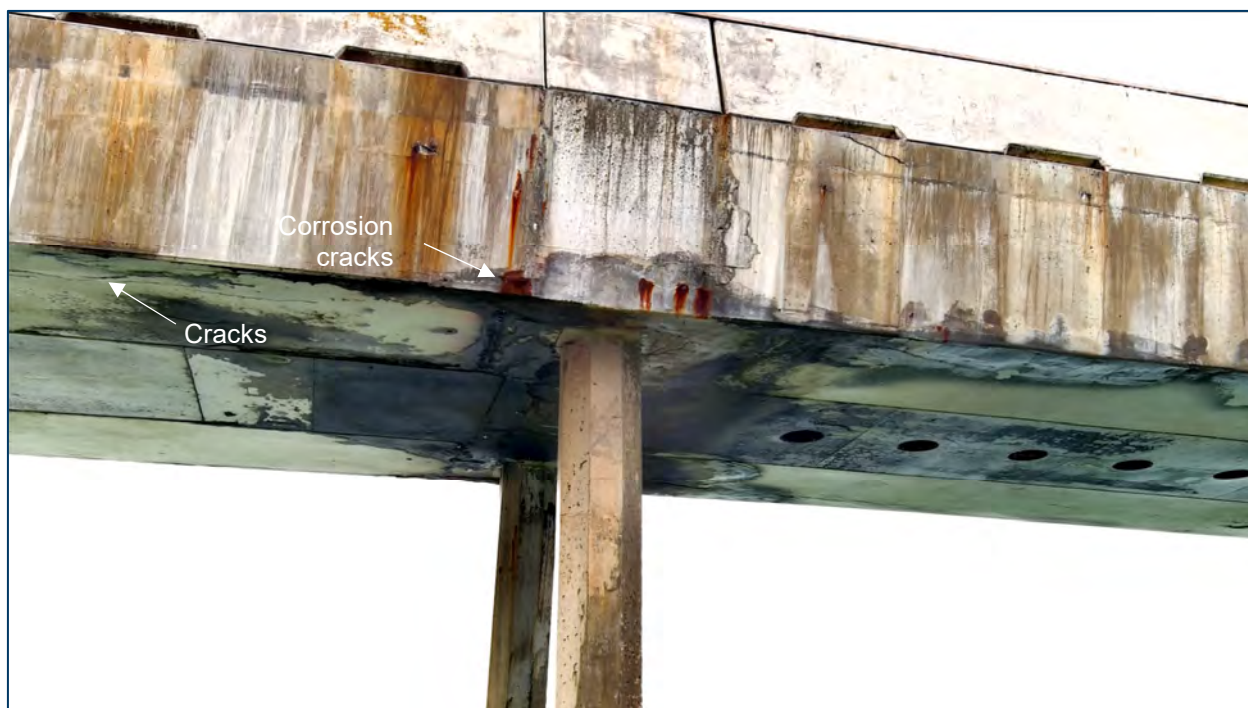
Figure A.3-28 Deck Exterior at Bent 1F – North Face

- Discoloration of concrete (black/green algae)
- Rust bleed stains around deck and handrail connection at some places, deck and bent connection
- Moderate to Major corrosion and structural spalls on deck between Bent 1E and 1F
- Moderate to Major corrosion and structural spalls around Bent 1F
- Moderate to Major cracks around and under Bent 1E
- Moderate to Major cracks between Bent 1E and 1F
- Rust stains and moderate cracks on piles
- Abrasion on piles
- Minor impact to Major corrosion/structural spalls on piles
- Overall rating for Deck – Major
- Overall rating for Bent - Major
- Overall rating for Pile – Bent F-N – Moderate, Bent F-S - Major

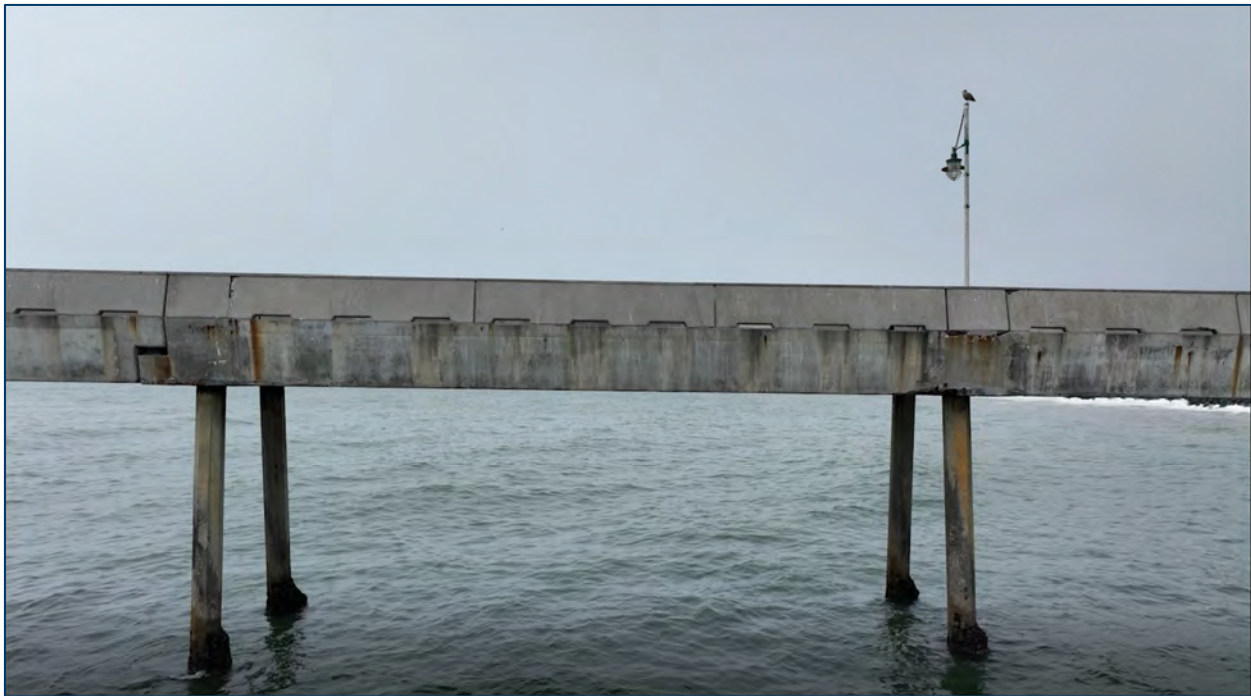
Figure A.3-31 Deck Exterior around Bent 1H and 1G – South Face

- Discoloration of concrete (black/green algae)
- Rust bleed stains around deck and handrail connection at some places, deck, and bent connection
- Moderate to Major corrosion and structural spalls on deck between Bent 1F and 1G
- Moderate to Severe corrosion and structural spalls around Bent 1G
- Moderate to Major cracks around and under Bent 1G
- Moderate to Major cracks between Bent 1F and 1G
- Rust stains and moderate cracks on piles
- Abrasion on piles
- Minor impact spalls on piles
- Overall rating for Deck – Major
- Overall rating for Bent - Severe
- Overall rating for Pile - Moderate

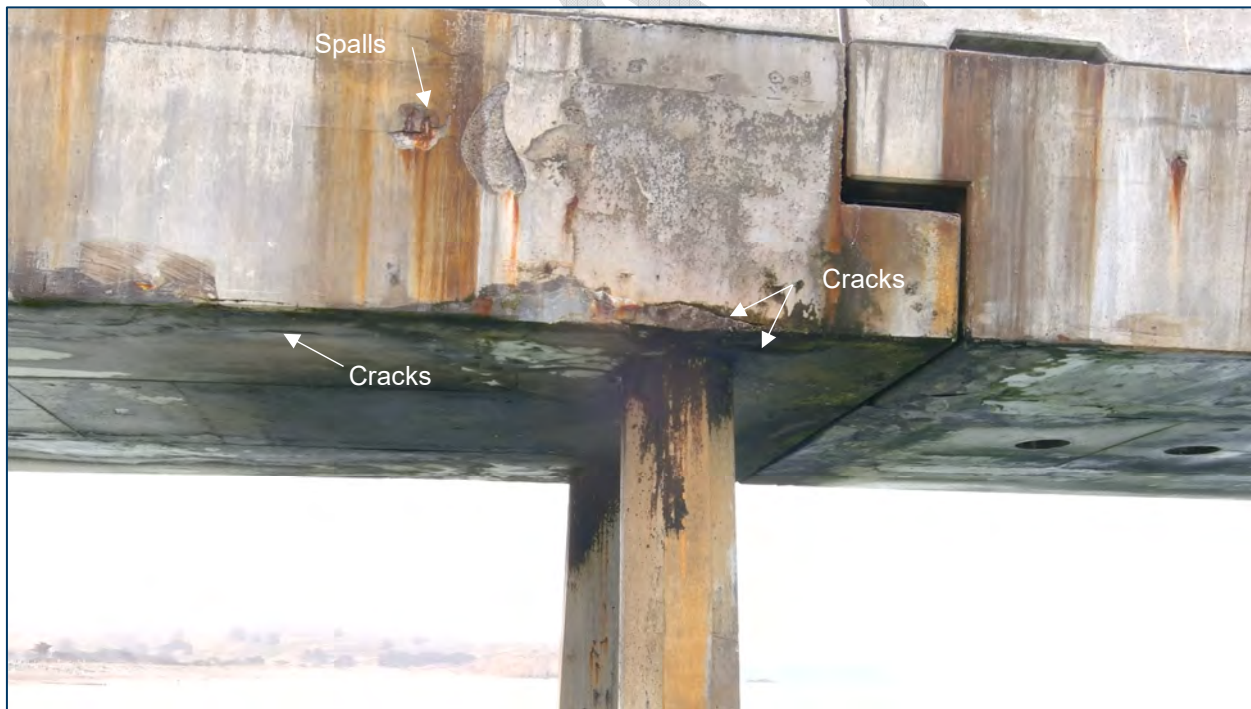
Figure A.3-35 Deck Exterior at Bent 1H – North Face

- Discoloration of concrete (black/green algae)
- Rust bleed stains around deck and handrail connection at some places, deck and bent connection (bearing plate connection)
- Moderate corrosion and structural spalls between Bent 1G and 1H
- Moderate corrosion and structural spalls around Bent 1H
- Moderate to Major cracks around and under Bent 1H
- Moderate to Major cracks between Bent 1G and 1H
- Rust stains and moderate cracks on piles
- Abrasion on piles
- Minor impact spalls on piles
- Overall rating for Deck – Major
- Overall rating for Bent - Major
- Overall rating for Pile - Moderate

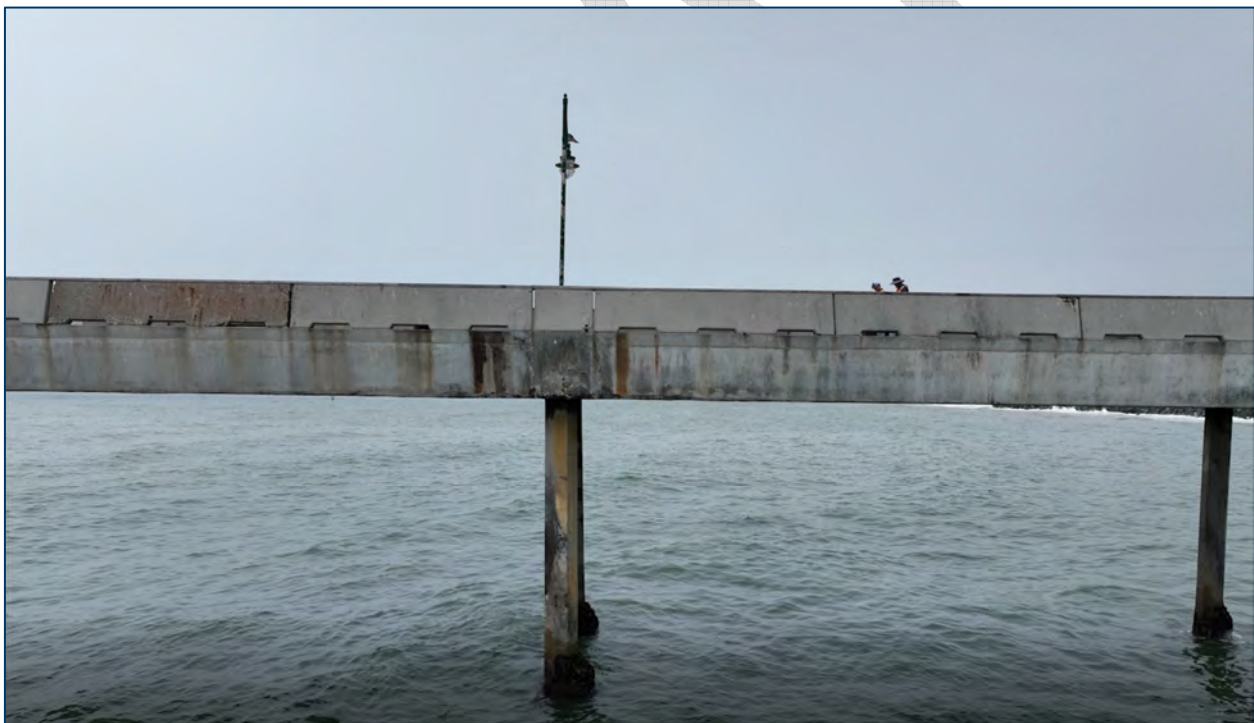
Figure A.3-38 Deck Exterior around Bent 1I - South Face

- Discoloration of concrete (black/green algae)
- Rust bleed stains around deck and handrail connection at some places, deck and bent connection (bearing plate connection)
- Minor impact spalls between Bent 1H and 1I
- Moderate to Major corrosion and structural spalls around Bent 1I
- Moderate to Major cracks around and under Bent 1I
- Minor to Moderate cracks between Bent 1H and 1I
- Rust stains and moderate cracks on piles
- Abrasion on piles
- Minor impact spalls on piles
- Overall rating for Deck – Moderate
- Overall rating for Bent - Major
- Overall rating for Pile - Moderate

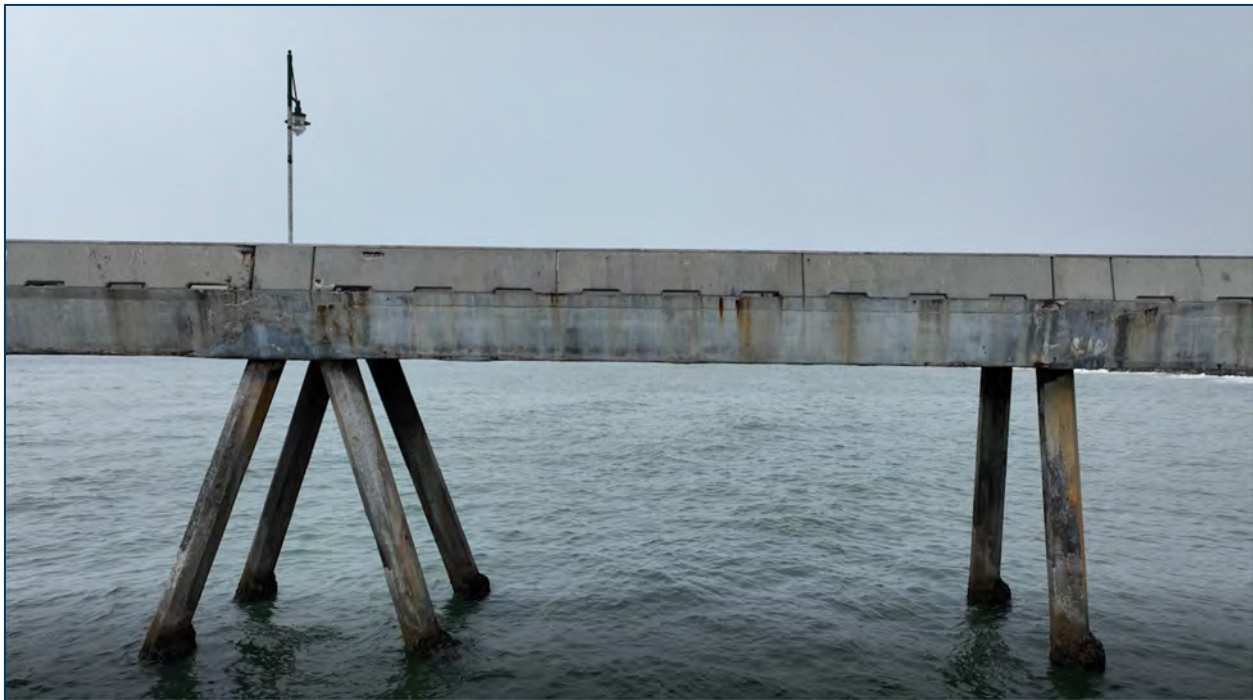
Figure A.3-42 Deck Exterior between Bent 1K and 1J – South Face

- Discoloration of concrete (black/green algae)
- Rust bleed stains around deck and handrail connection at some places, deck and bent connection
- Minor spalls between Bent 1I and 1J
- Moderate to Major corrosion and structural spalls around Bent 1J
- Moderate to Major cracks around and under Bent 1I
- Moderate to Major cracks between Bent 1I and 1J
- Rust stains and moderate cracks on piles
- Abrasion on piles
- Minor impact spalls on piles
- Overall rating for Deck – Major
- Overall rating for Bent - Major
- Overall rating for Pile – Moderate

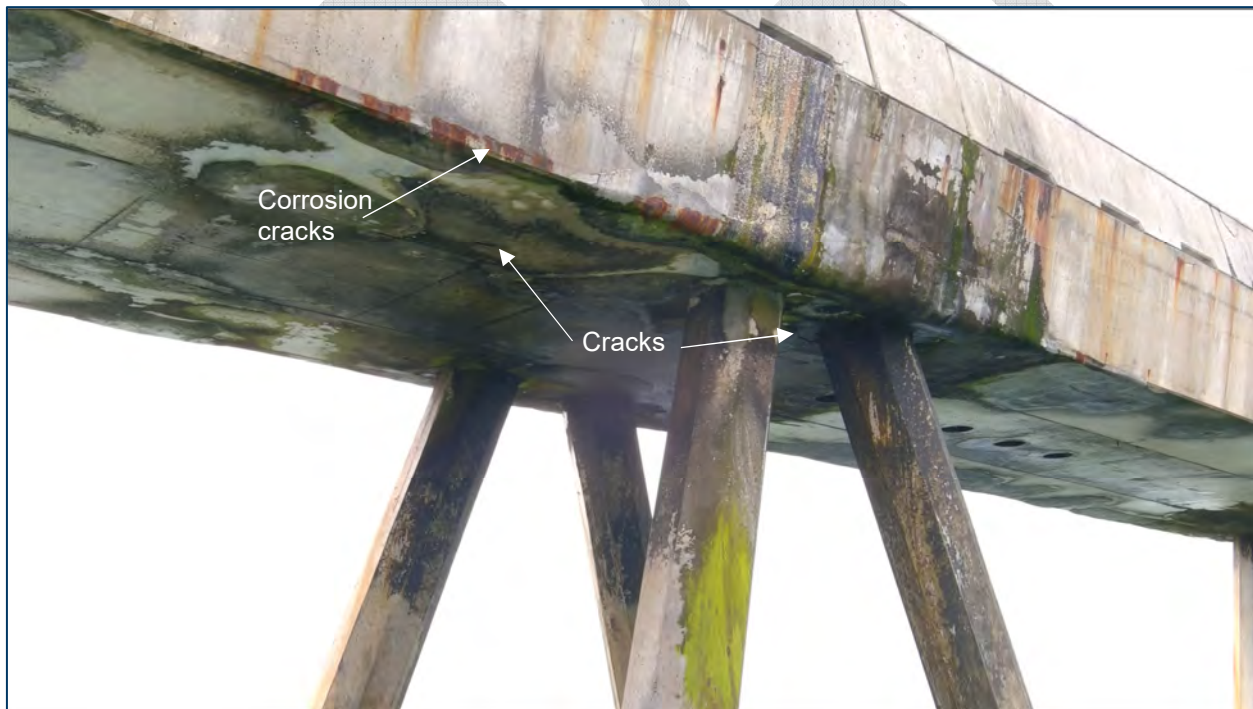
Figure A.3-46 Deck Exterior at Bent 1K – North Face

- Discoloration of concrete (black/green algae)
- Rust bleed stains around deck and handrail connection at some places, deck and bent connection
- Minor spalls between Bent 1J and 1K
- Moderate to Major corrosion and structural spalls around Bent 1K
- Moderate to Major cracks around and under Bent 1K
- Moderate to Major cracks between Bent 1J and 1K
- Rust stains and moderate cracks on piles
- Abrasion on piles
- Minor impact to Major corrosion/structural spalls on piles
- Overall rating for Deck – Major
- Overall rating for Bent - Major
- Overall rating for Pile – Bent K-NE - Moderate, Bent K-NW - Moderate, Bent K-SE - Major, Bent K-SW - Major

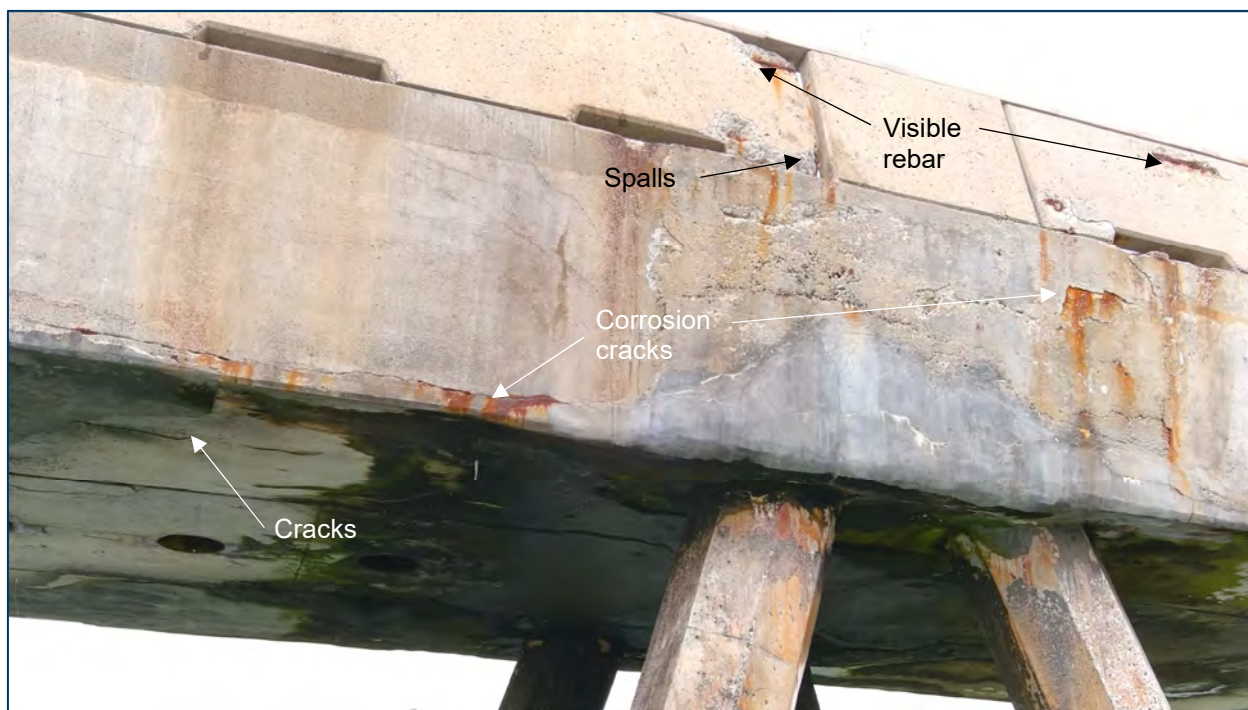
Figure A.3-47 Deck Exterior at Bent 1K – South Face

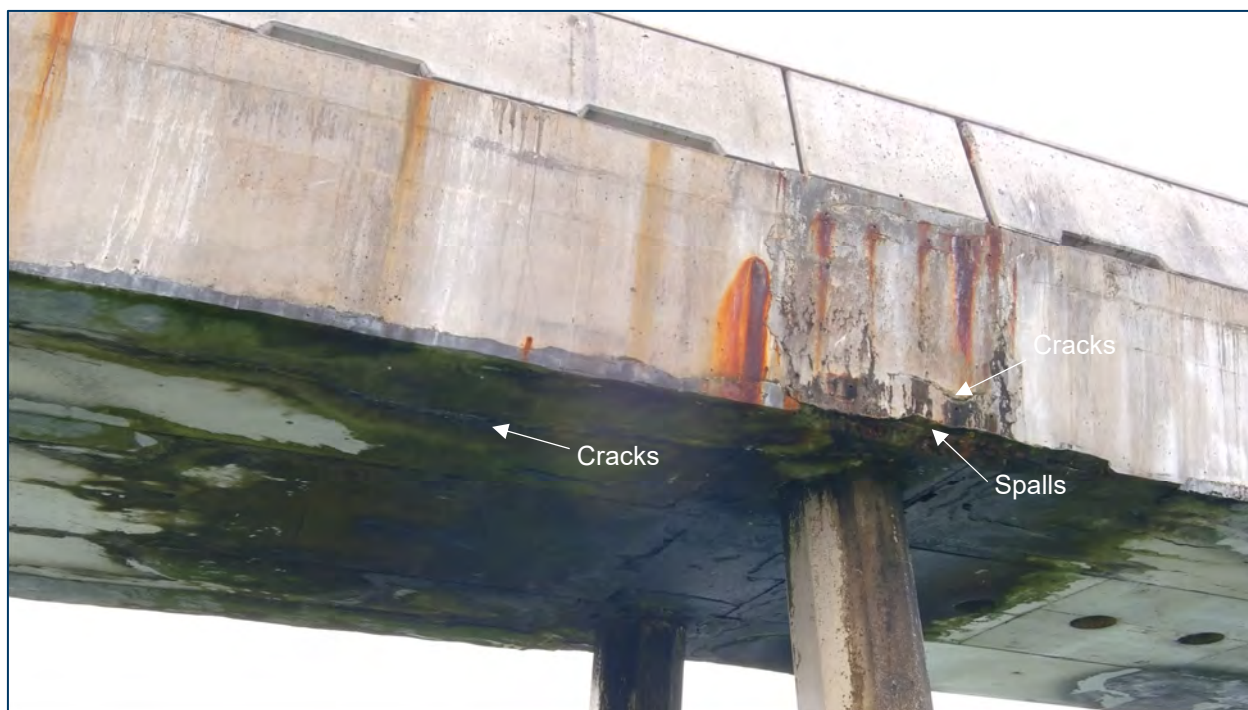
- Discoloration of concrete (black/green algae)
- Rust bleed stains around deck and handrail connection at some places, deck and bent connection
- Moderate to Major corrosion and structural spalls between Bent 1K and 1L
- Moderate to Severe corrosion and structural spalls around Bent 1L
- Moderate to Major cracks around and under Bent 1L
- Moderate to Major cracks between Bent 1K and 1L
- Rust stains and moderate cracks on piles
- Abrasion on piles
- Minor impact to Major corrosion/structural spalls on piles
- Overall rating for Deck – Major
- Overall rating for Bent - Severe
- Overall rating for Pile – Major

Figure A.3-49 Deck Exterior at Bent 1L – North Face

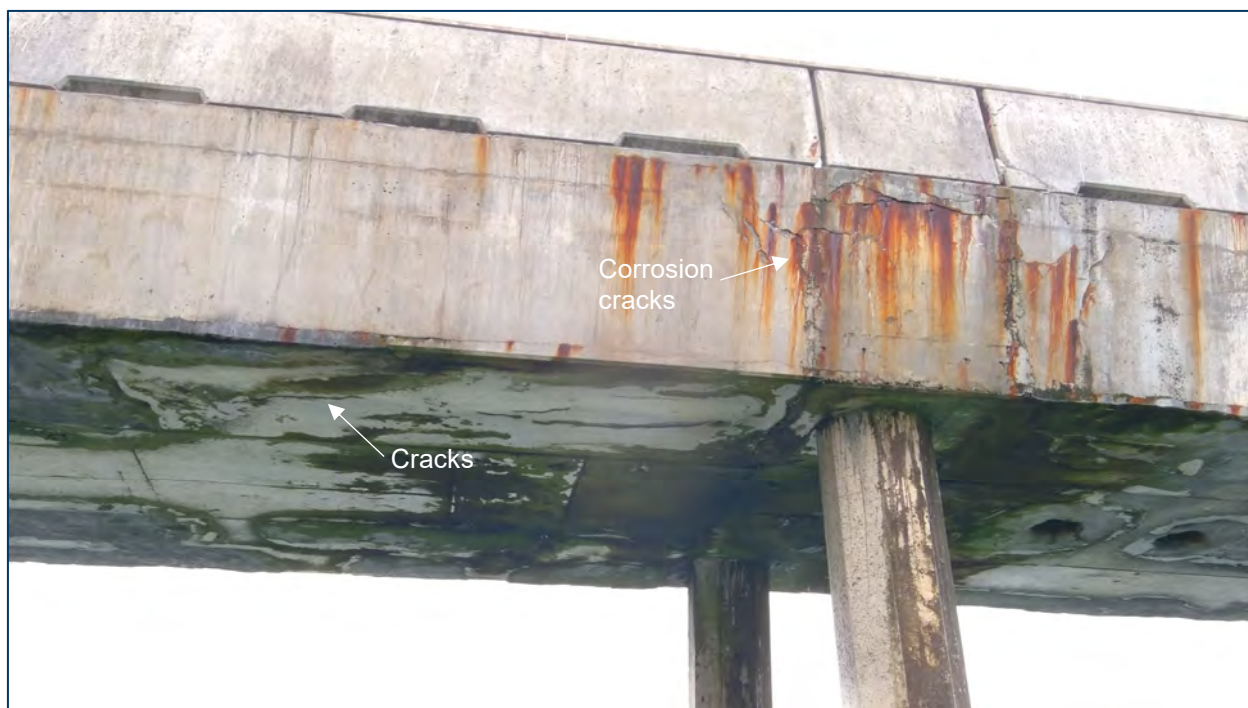
- Rust bleed stains around deck and handrail connection at some places, deck and bent connection
- Minor spalls between Bent 1L and 1M
- Moderate to Severe corrosion and structural spalls around Bent 1M – Visible Rebar
- Moderate to Major cracks around and under Bent 1M
- Moderate to Major cracks between Bent 1L and 1M
- Rust stains and moderate cracks on piles
- Abrasion on piles
- Minor impact to Major corrosion/structural spalls on piles
- Overall rating for Deck – Major
- Overall rating for Bent - Severe
- Overall rating for Pile – Bent M-N - Major, Bent M-S - Moderate

Figure A.3-52 Deck Exterior at Bent 1M – North Face

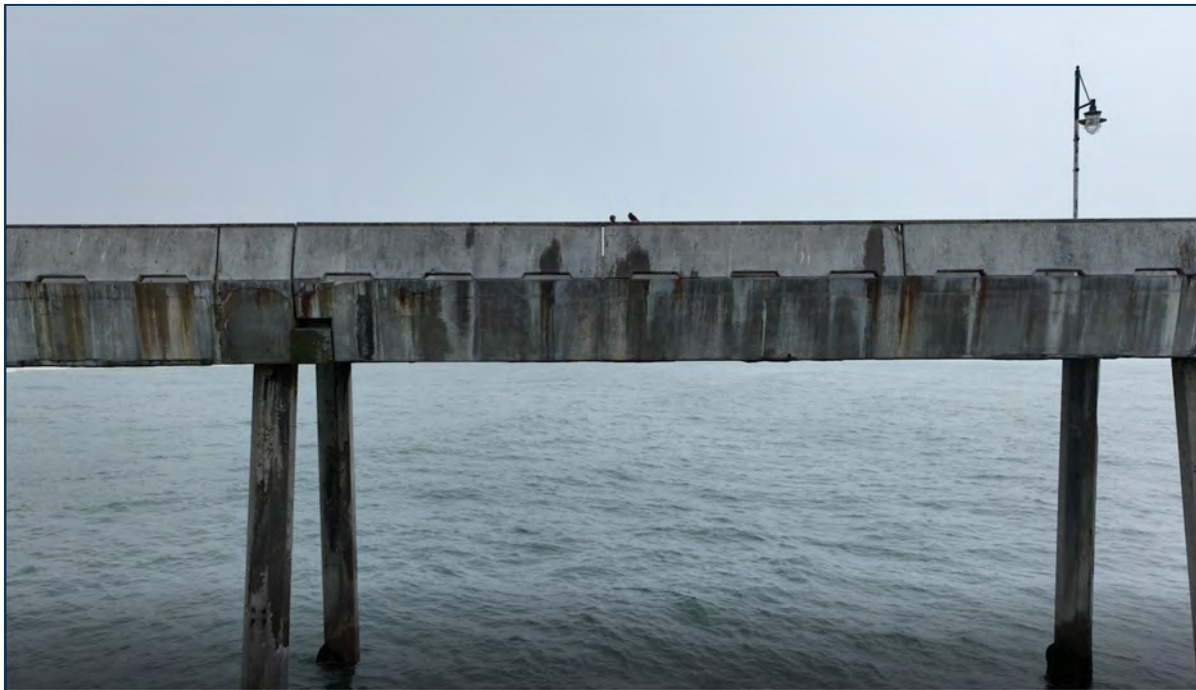
- Minor spalls between Bent 1M and 1N
- Moderate to Major spalls around Bent 1N
- Moderate to Major cracks around and under Bent 1N
- Moderate to Major cracks between Bent 1M and 1N
- Rust stains and moderate cracks on piles
- Abrasion on piles
- Minor impact to Major corrosion/structural spalls on piles
- Overall rating for Deck – Major
- Overall rating for Bent - Major
- Overall rating for Pile – Major

Figure A.3-54 Deck Exterior around Bent 1N - North Face

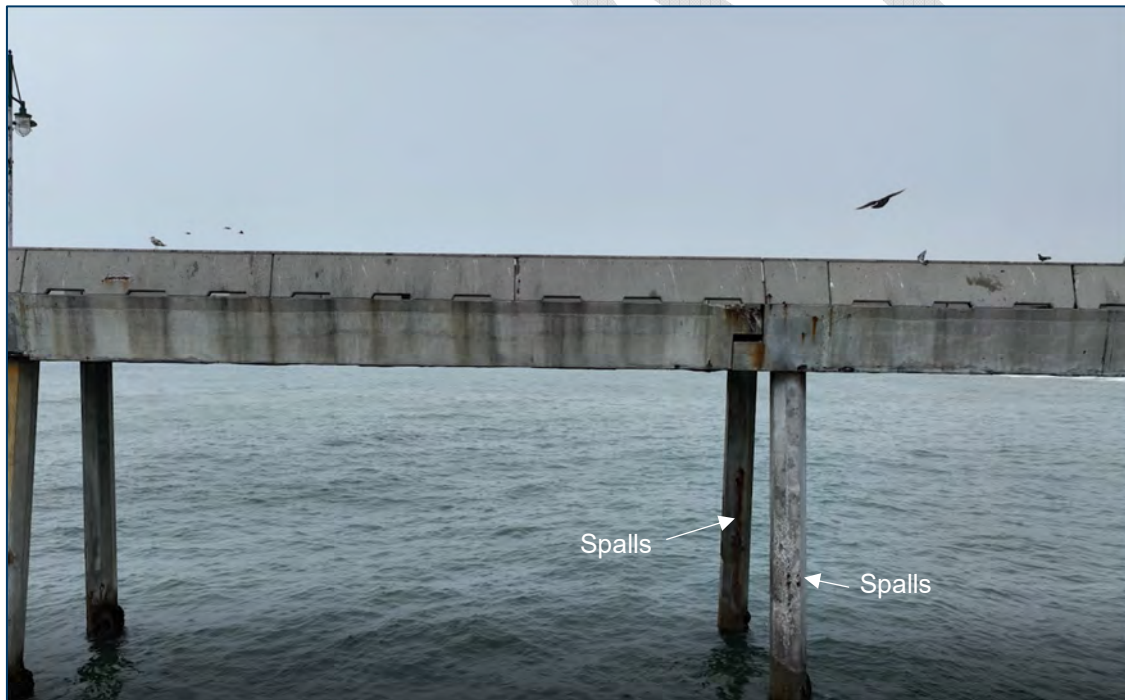
Figure A.3-55 Deck Exterior between Bent 10 and 1N – South Face

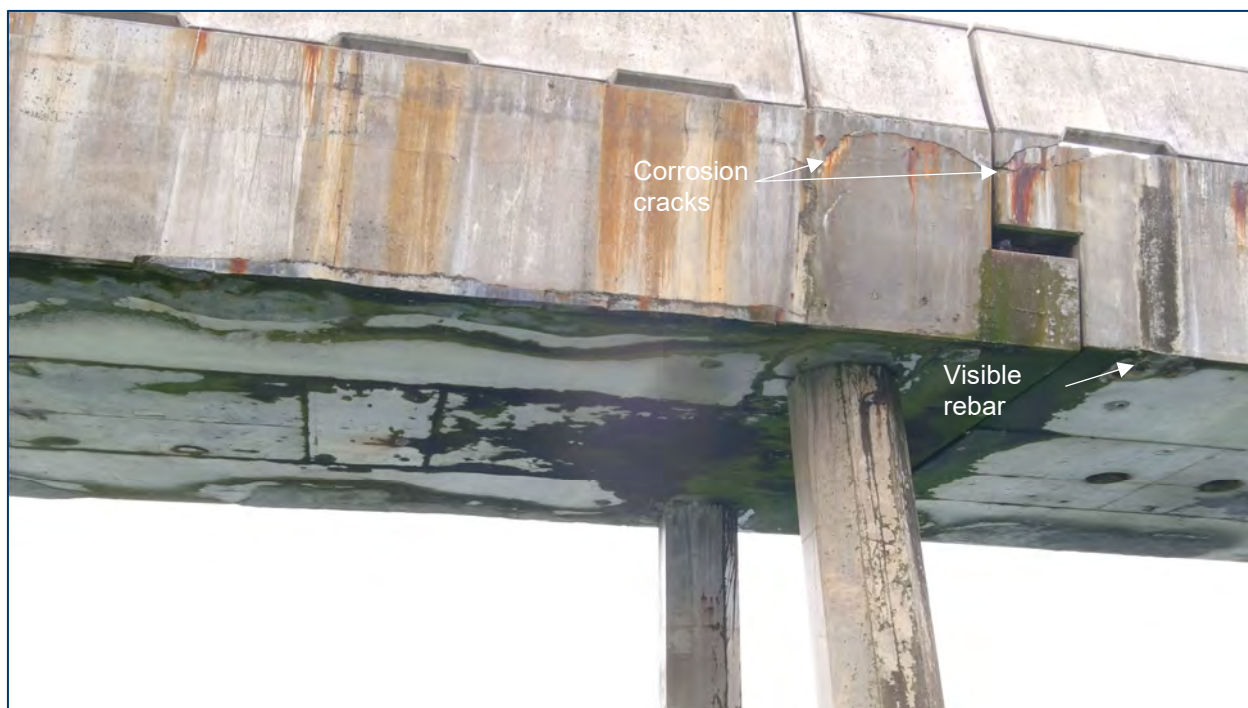
Figure A.3-56 Deck Exterior at Bent 1N – North Face

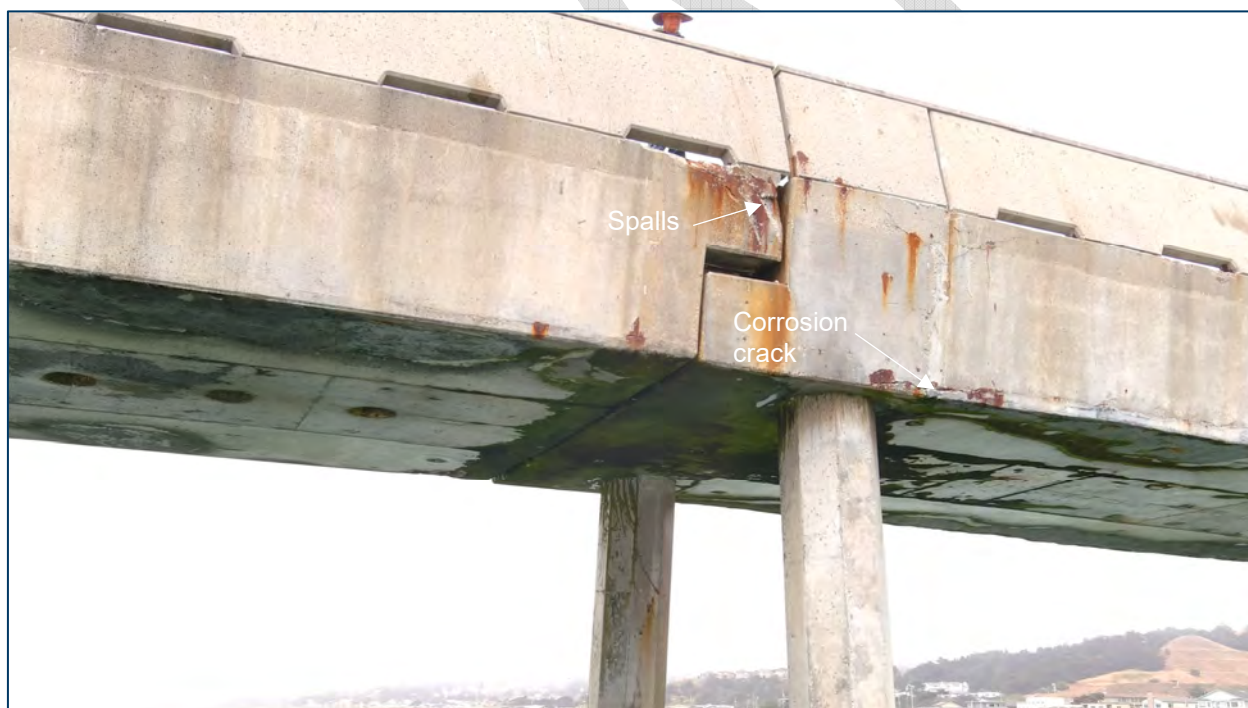
Figure A.3-57 Deck Exterior at Bent 1N - South Face

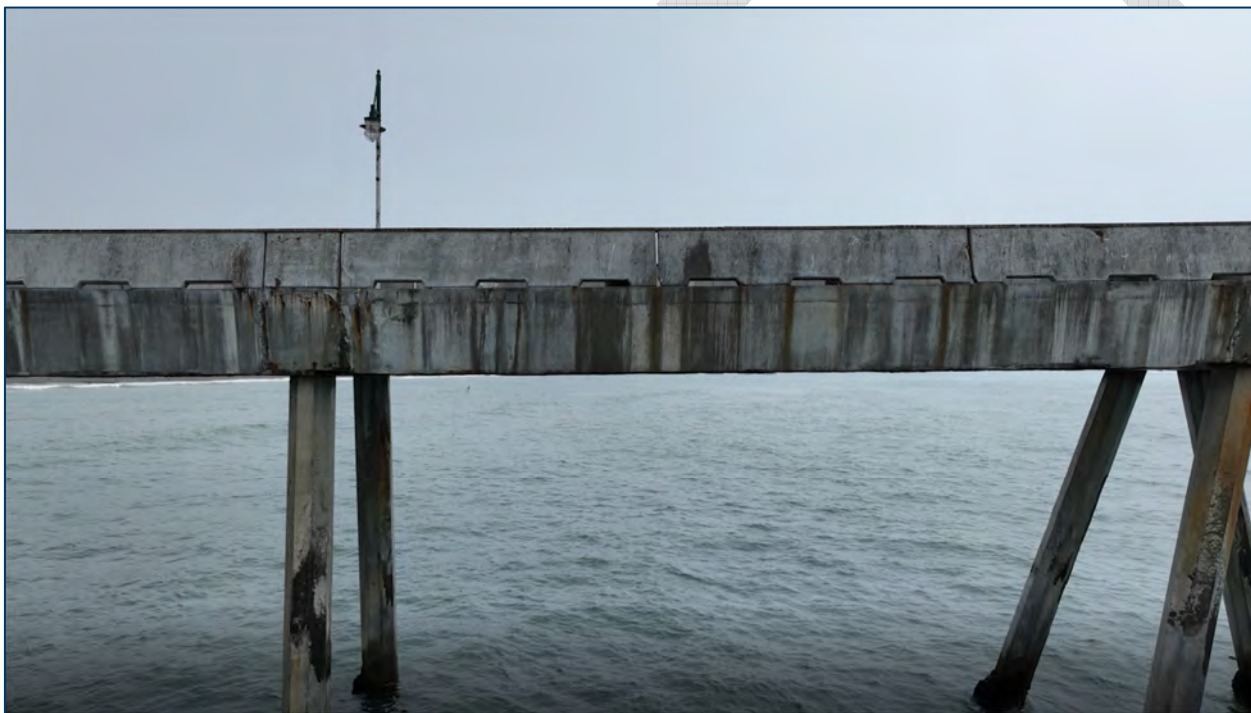
- Rust bleed stains around deck and handrail connection at some places, deck and bent connection
- Moderate to Severe corrosion and structural spalls between Bent 1N and 1O – Corroded Visible Rebar
- Moderate to Severe corrosion and structural spalls around Bent 1O – Corroded Visible Rebar, Significant section loss
- Moderate to Major cracks around and under Bent 1O
- Moderate cracks between Bent 1N and 1O
- Rust stains and moderate cracks on piles
- Abrasion on piles
- Minor impact to Major corrosion/structural spalls on piles
- Overall rating for Deck – Severe
- Overall rating for Bent - Severe
- Overall rating for Pile – Bent O-N Moderate, Bent O-S Major

Figure A.3-58 Deck Exterior around Bent 1O - North Face

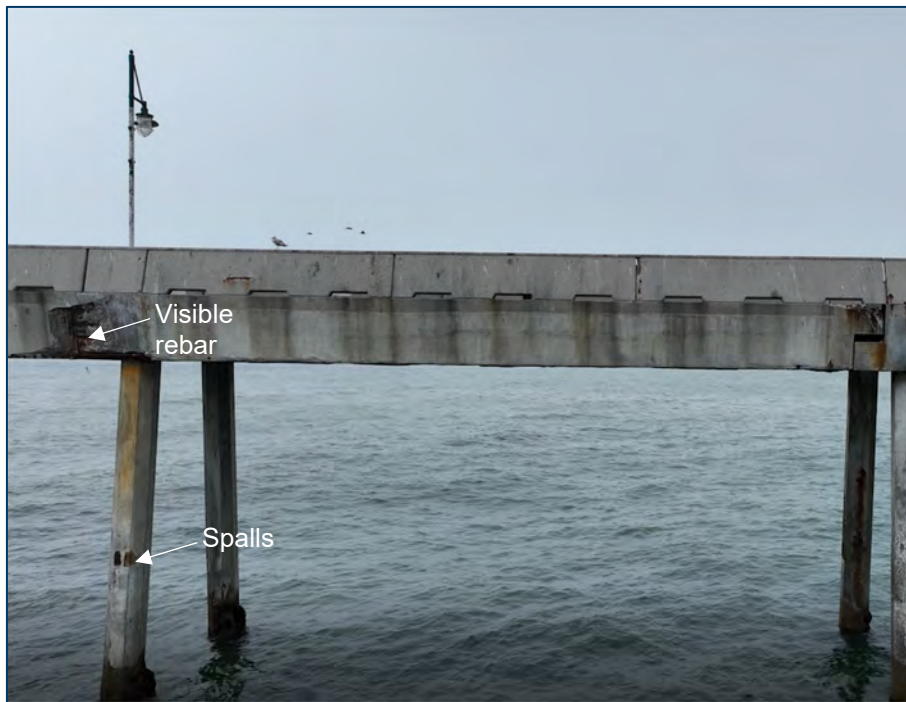
Figure A.3-59 Deck Exterior between Bent 10 and 1N – South Face

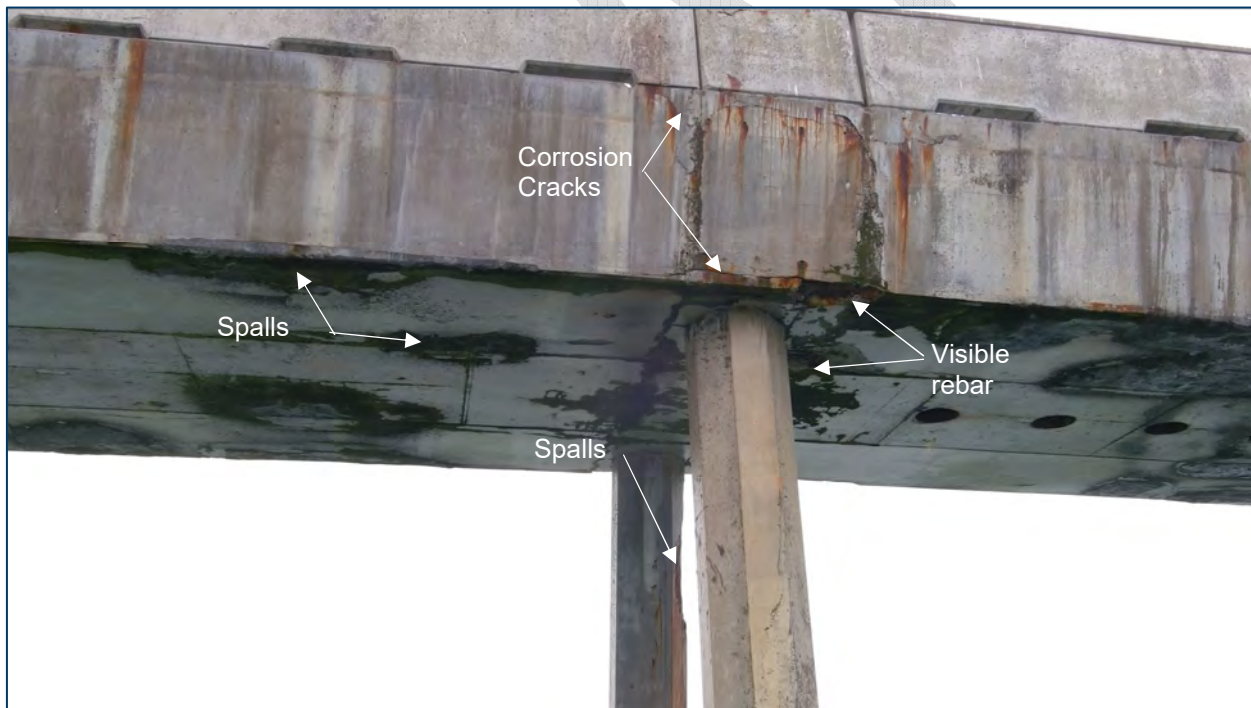
Figure A.3-60 Deck Exterior at Bent 10 - North Face

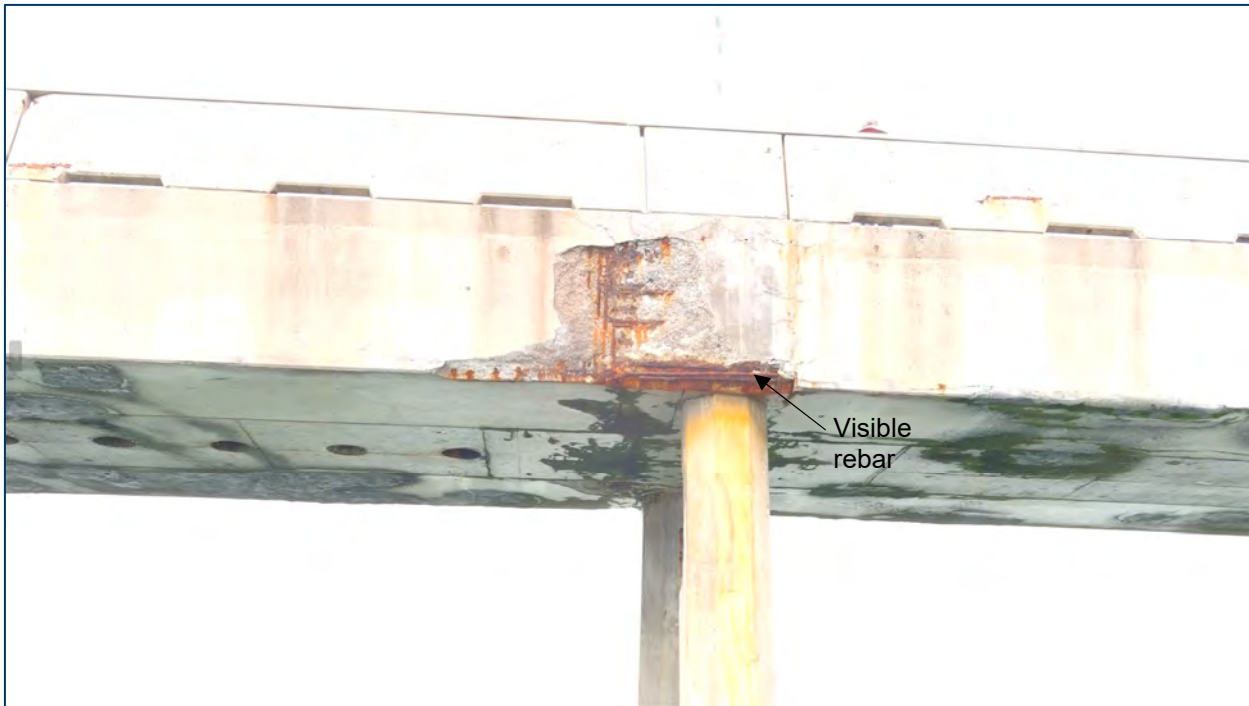
Figure A.3-61 Deck Exterior at Bent 10 – South Face

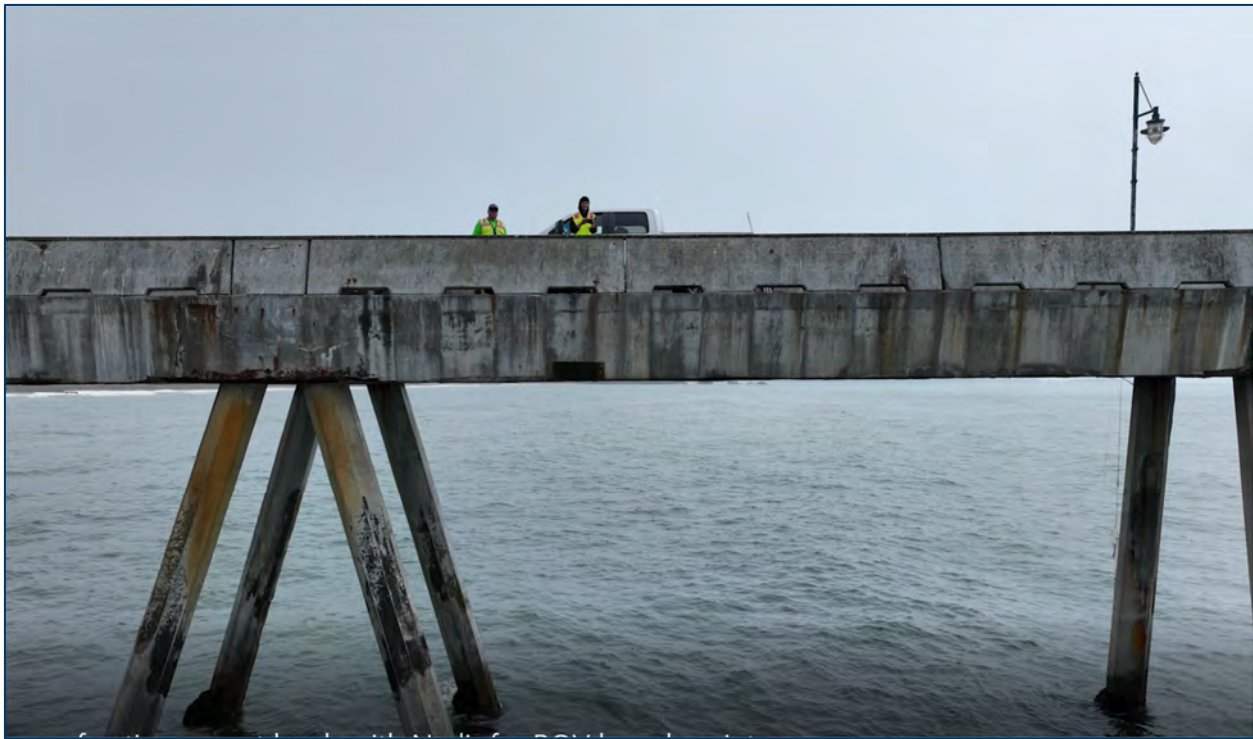
- Discoloration of concrete (black/green algae)
- Rust bleed stains around deck and handrail connection at some places, deck, and bent connection
- Minor spalls between Bent 1O and 1P
- Moderate to Severe corrosion and structural spalls around Bent 1P – Corroded Visible Rebar
- Moderate to Major cracks around and under Bent 1P
- Moderate to Major cracks between Bent 1O and 1P
- Rust stains and moderate cracks on piles
- Abrasion on piles
- Minor impact to Major corrosion/structural spalls on piles
- Overall rating for Deck – Major
- Overall rating for Bent - Severe
- Overall rating for Pile – Bent P-NE - Moderate, Bent P-NW - Major, Bent P-SE - Major, Bent P-SW - Major

Figure A.3-62 Deck Exterior around Bent 1P - North Face

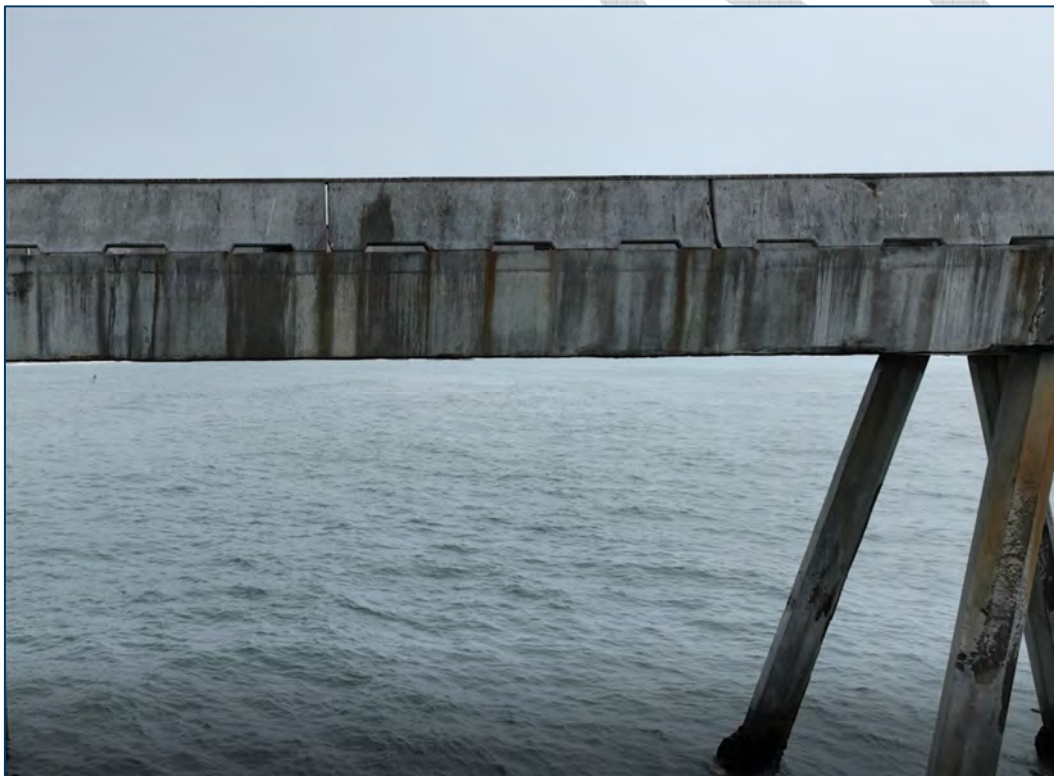
Figure A.3-63 Deck Exterior around Bent 1P - North Face

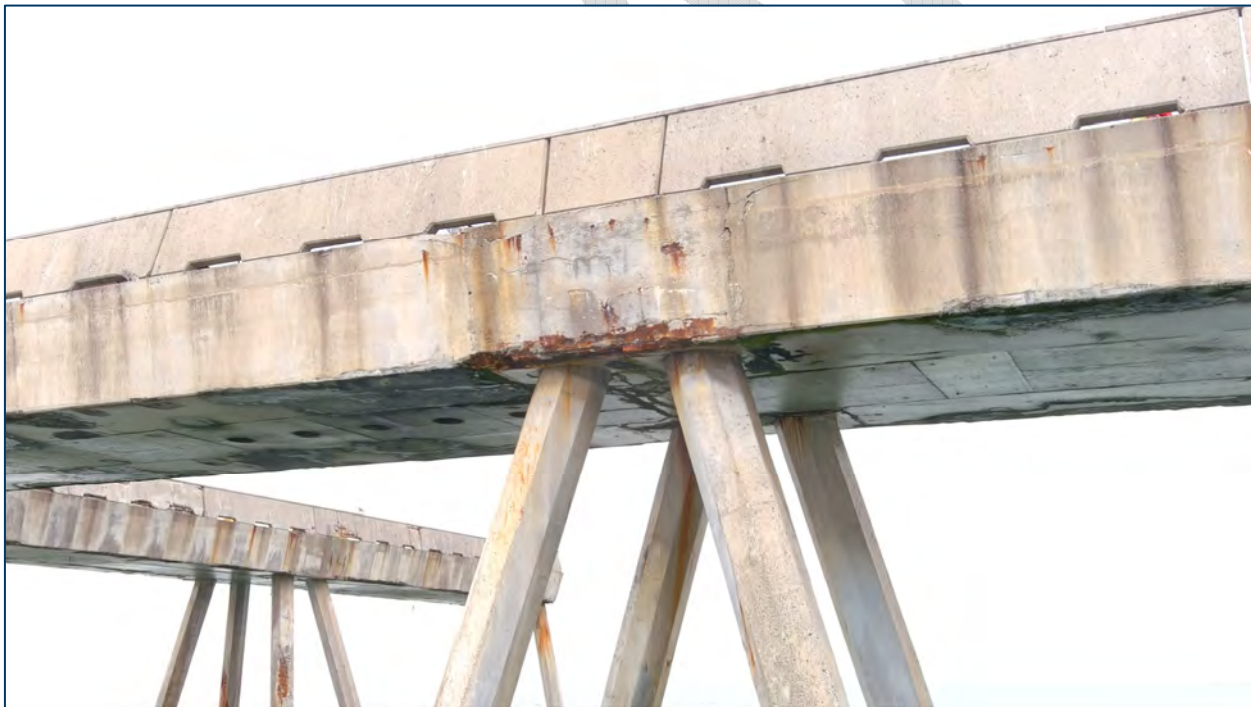
Figure A.3-65 Deck Exterior at Bent 1P - South Face
