Pacifica Municipal Fishing Pier

2023 Condition Assessment Report

City of Pacifica

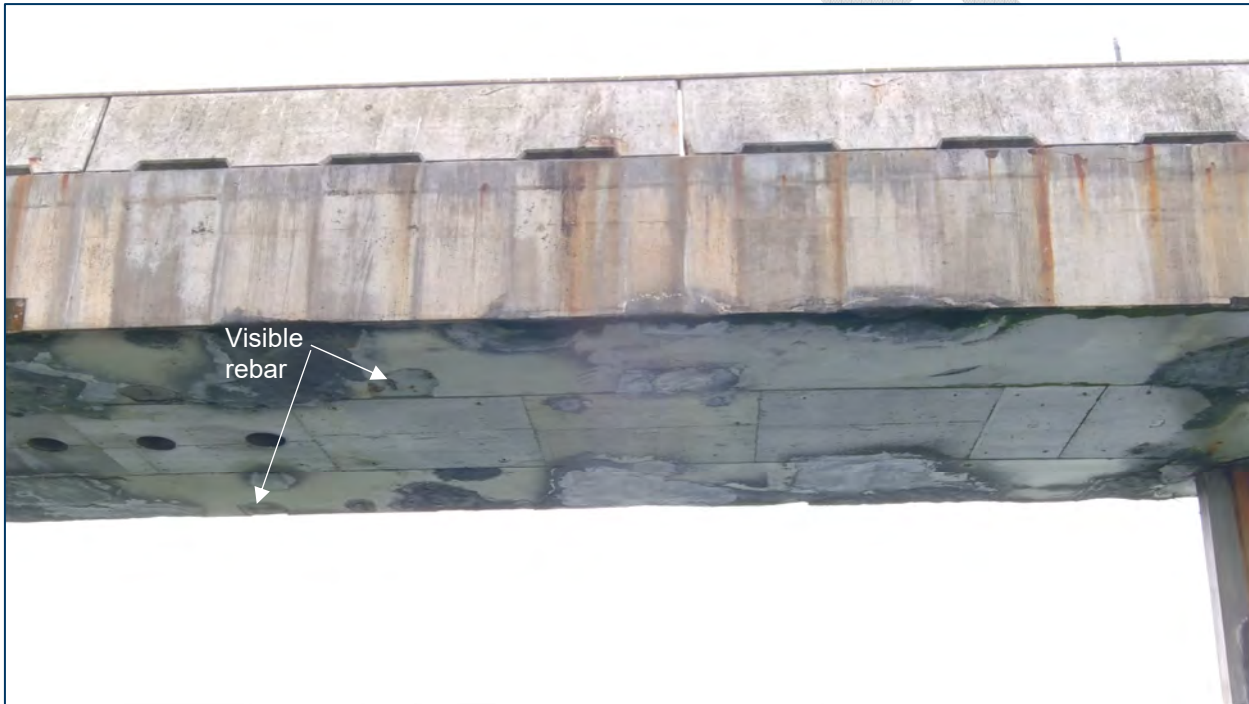
- Discoloration of concrete (black/green algae)
- Rust bleed stains around deck and handrail connection at some places, deck and bent connection
- Moderate to Severe corrosion and structural spalls between Bent 1P and 1Q – Visible Corroded Rebar
- Moderate to Severe corrosion and structural spalls around Bent 1Q – Visible Corroded Broken Rebar, Significant section loss around bent edges

- Moderate cracks around and under Bent 1Q
- Moderate cracks between Bent 1P and 1Q
- Rust stains and moderate cracks on piles
- Abrasion on piles
- Minor impact to Major corrosion/structural spalls on piles
- Overall rating for Deck – Severe
- Overall rating for Bent - Severe
- Overall rating for Pile – Major

Figure A.3-67 Deck Exterior between Bent 1P and 1Q – North Face

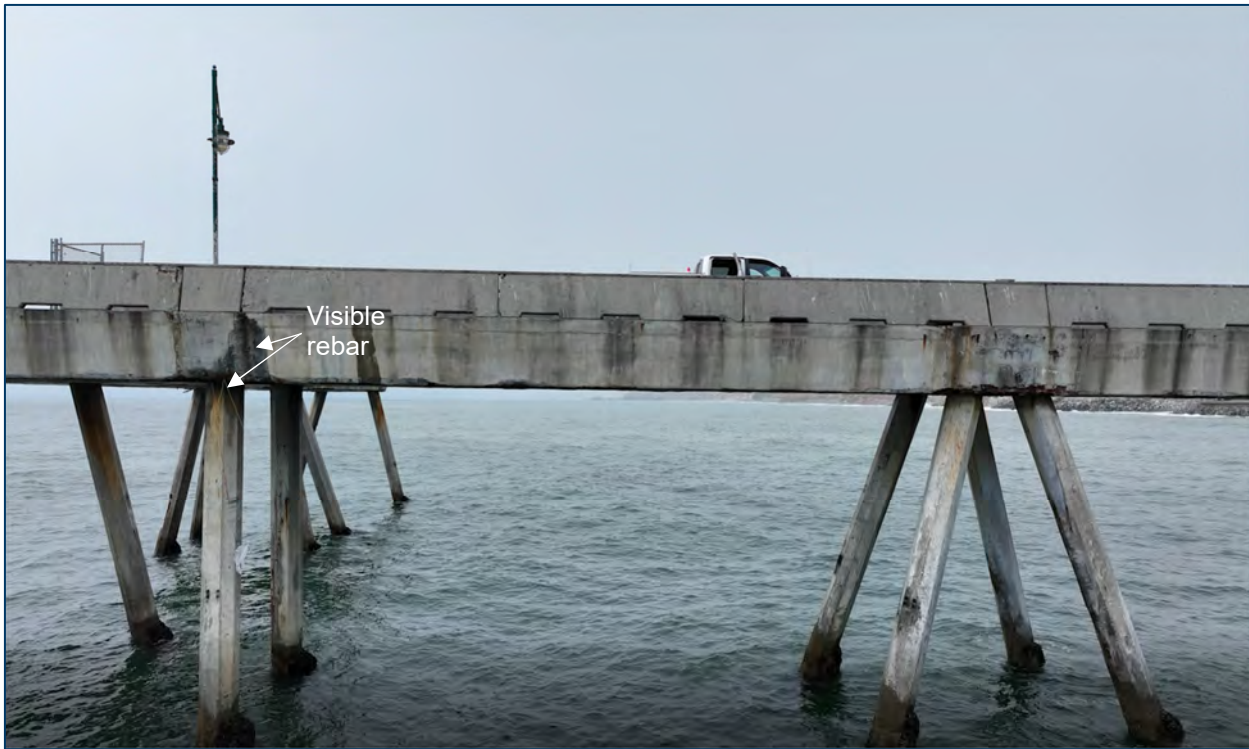
Figure A.3-68 Deck Exterior between Bent 1Q and 1P – South Face

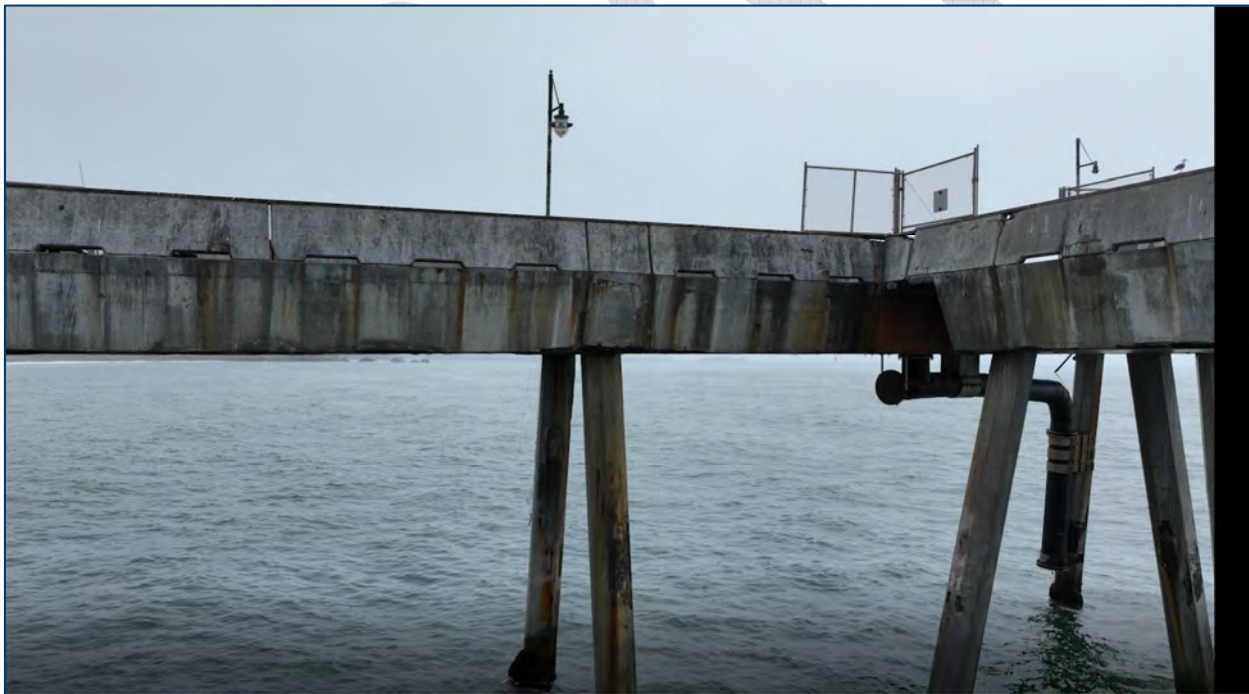
Figure A.3-69 Deck Exterior around Bent 1Q - North Face

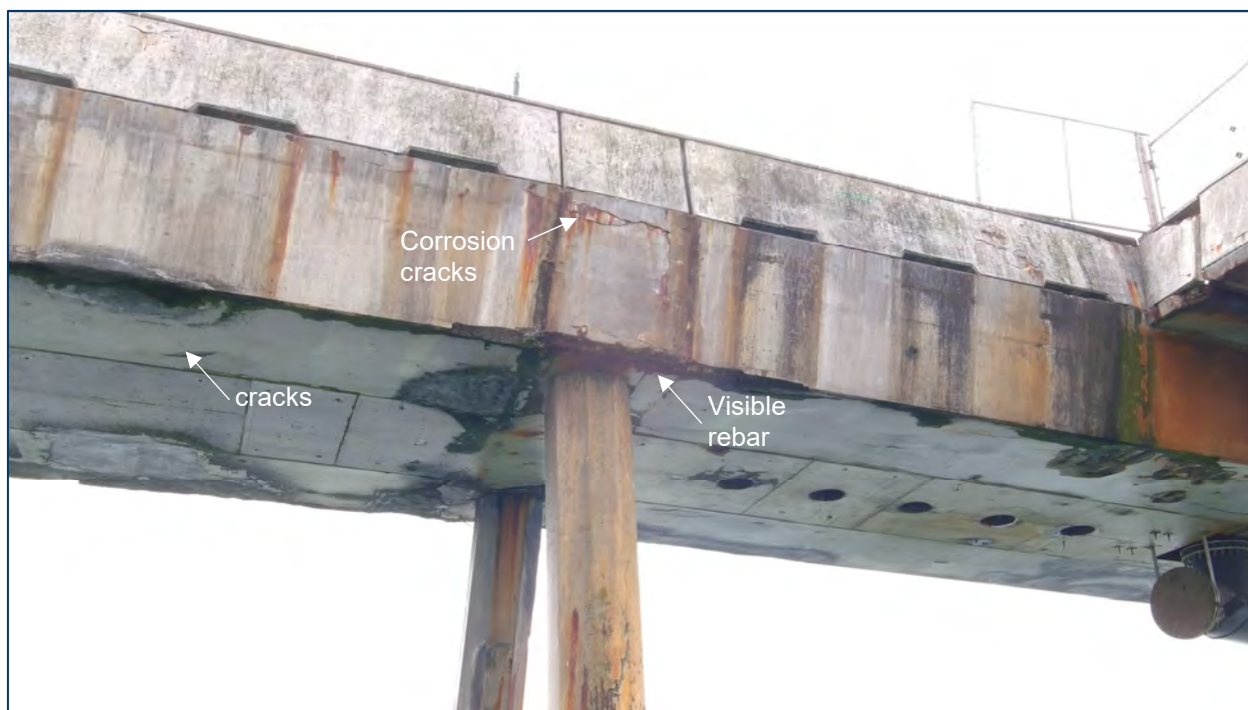
Figure A.3-70 Deck Exterior at Bent 1Q – North Face

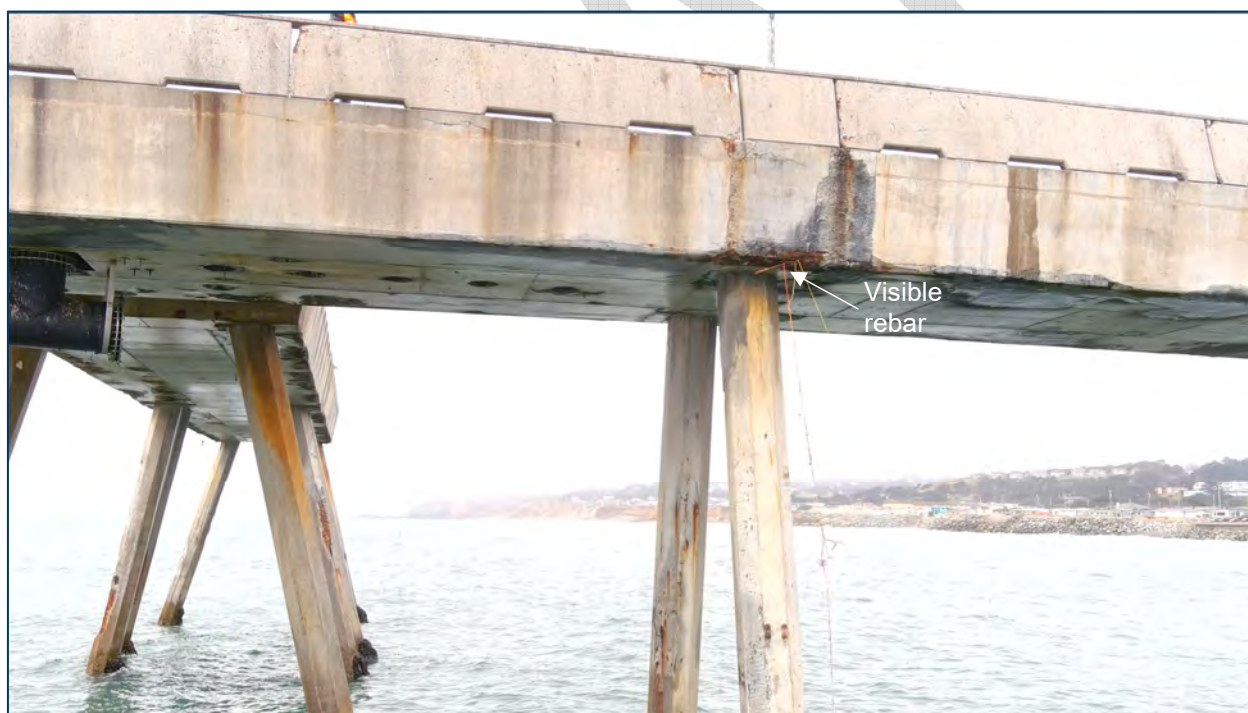
Figure A.3-71 Deck Exterior at Bent 1Q – South Face

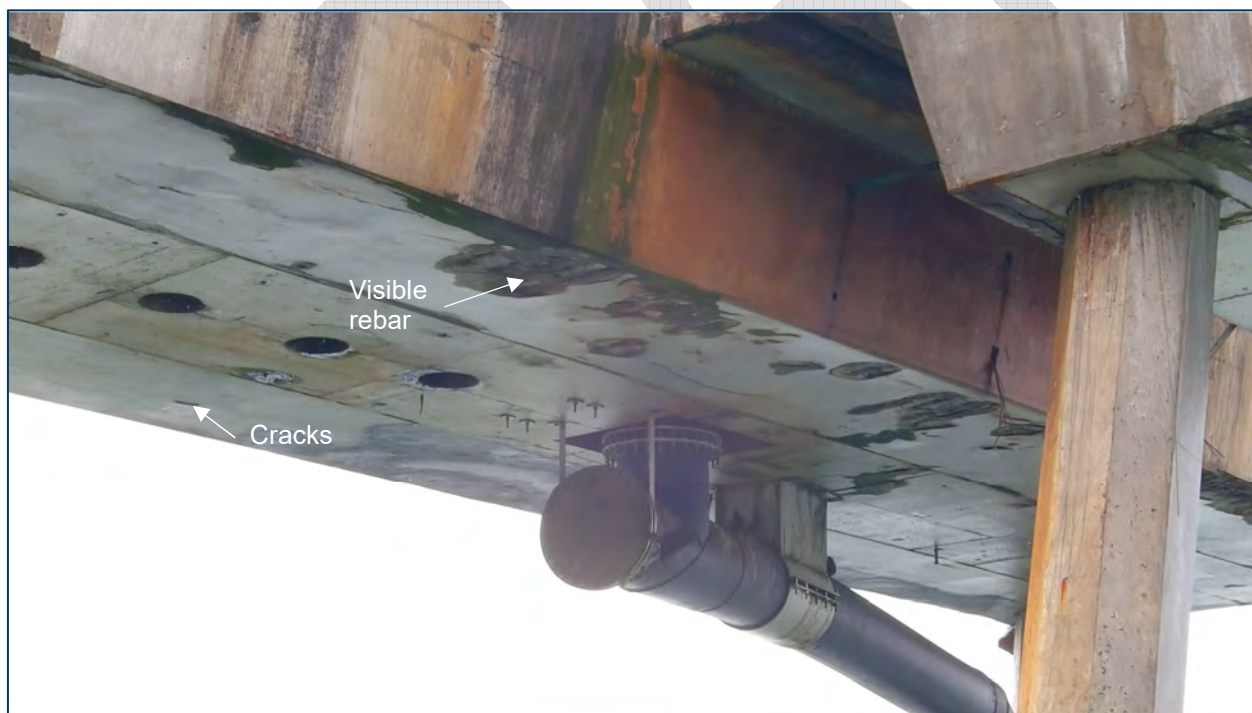
- Major to Severe corrosion and structural spalls between Bent 1Q and 1R – Visible Corroded Rebar, Significant section loss around bent edges
- Moderate to Major corrosion and structural spalls around E-W main pier and N-S Extension Pier Connection

- Moderate to Major cracks around E-W main pier and N-S Extension Pier Connection
- Moderate to Major cracks between Bent 1Q and 1R
- Major to Severe corrosion and structural spalls around Bent 1R – Visible Corroded Rebar, Significant section loss around one of the piles and bent edges, Broken chunks of concrete around bent and deck edges

- Moderate to Severe cracks around and under Bent 1R
- Moderate to Severe cracks between Bent 1Q and 1R
- Rust stains and moderate to major cracks on piles

Figure A.3-72 Deck Exterior between Bent 1Q and 1R - North Face

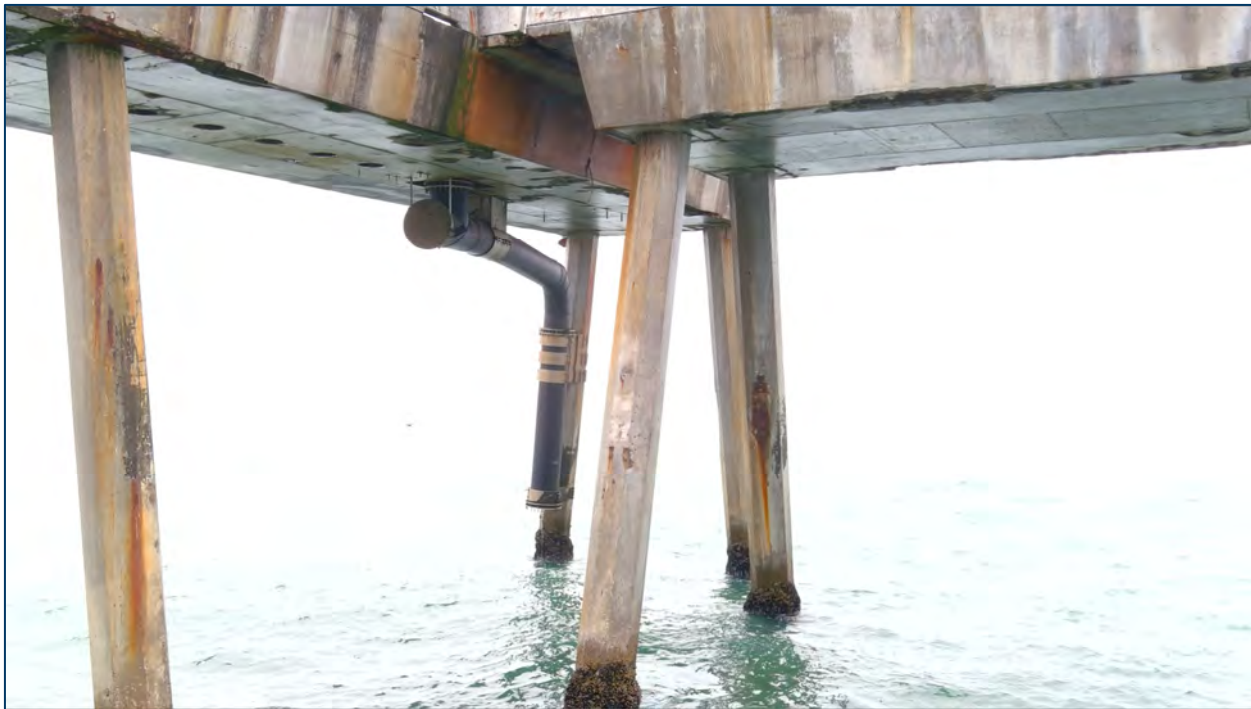
Figure A.3-73 Deck Exterior at N-S Extension Pier joint

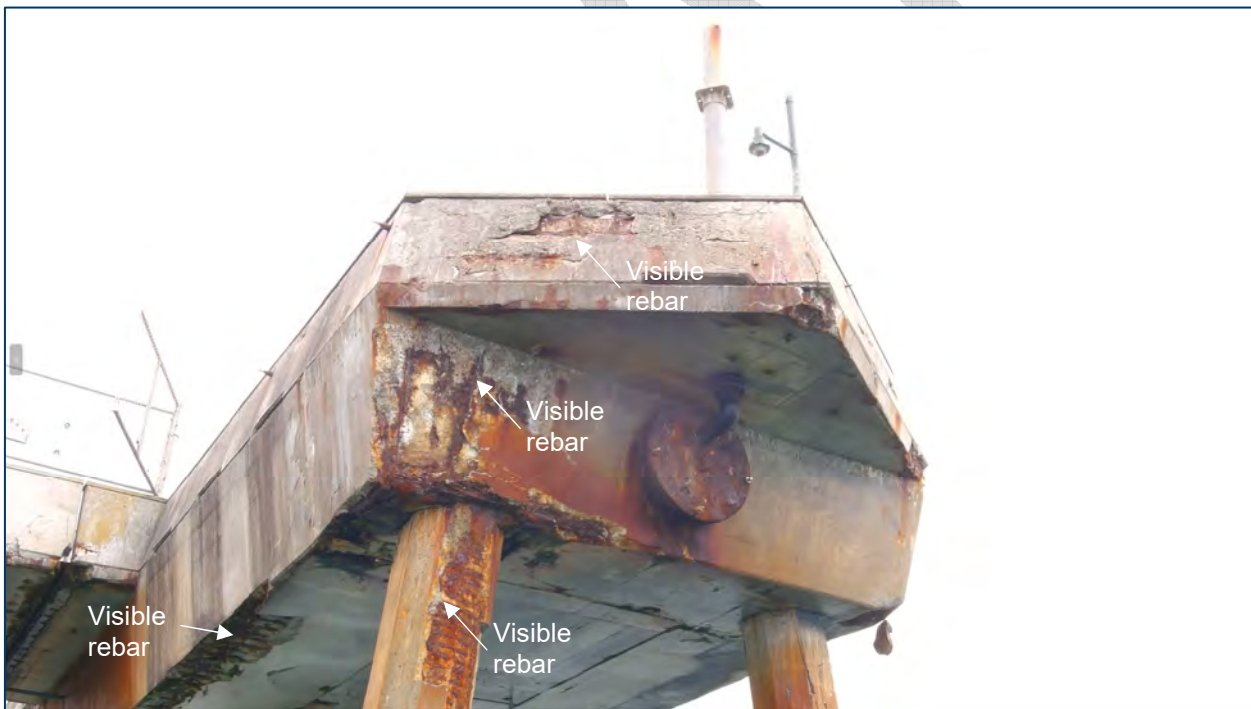
Figure A.3-74 Deck Exterior at Bent 1R and N-S Pier Extension Joint – North - West Face

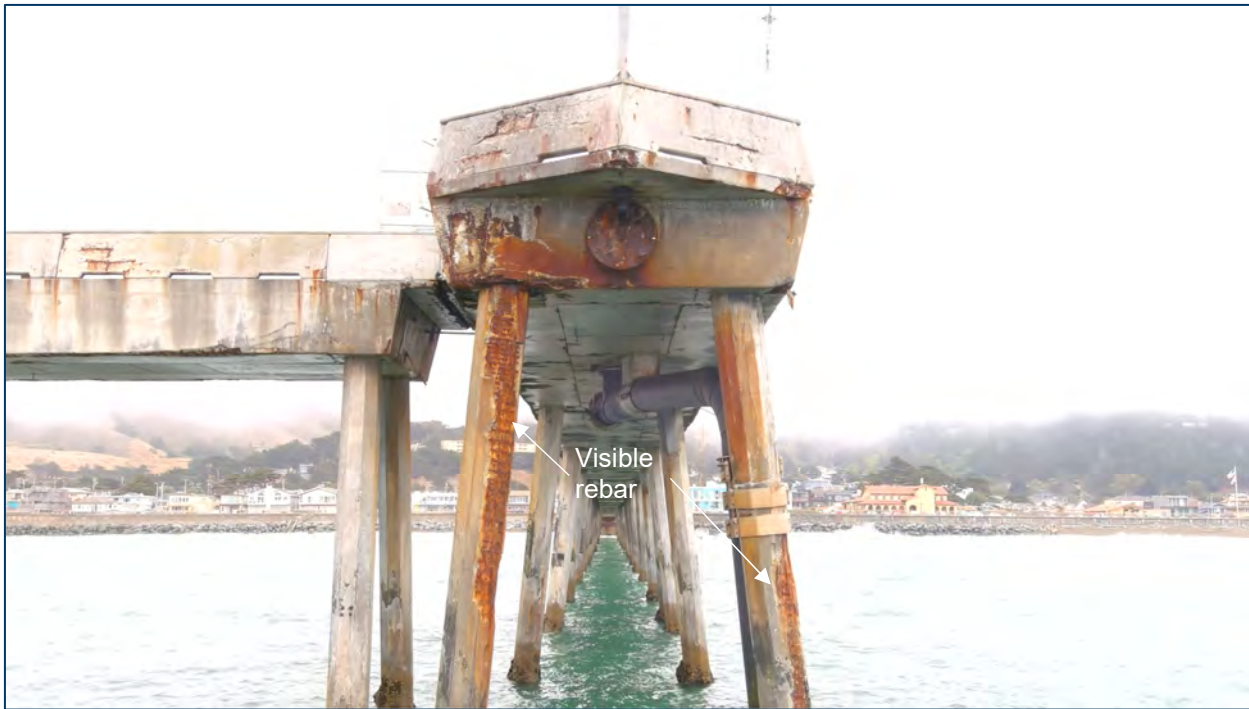
Figure A.3-75 Deck Exterior at Bent 1R – West Face

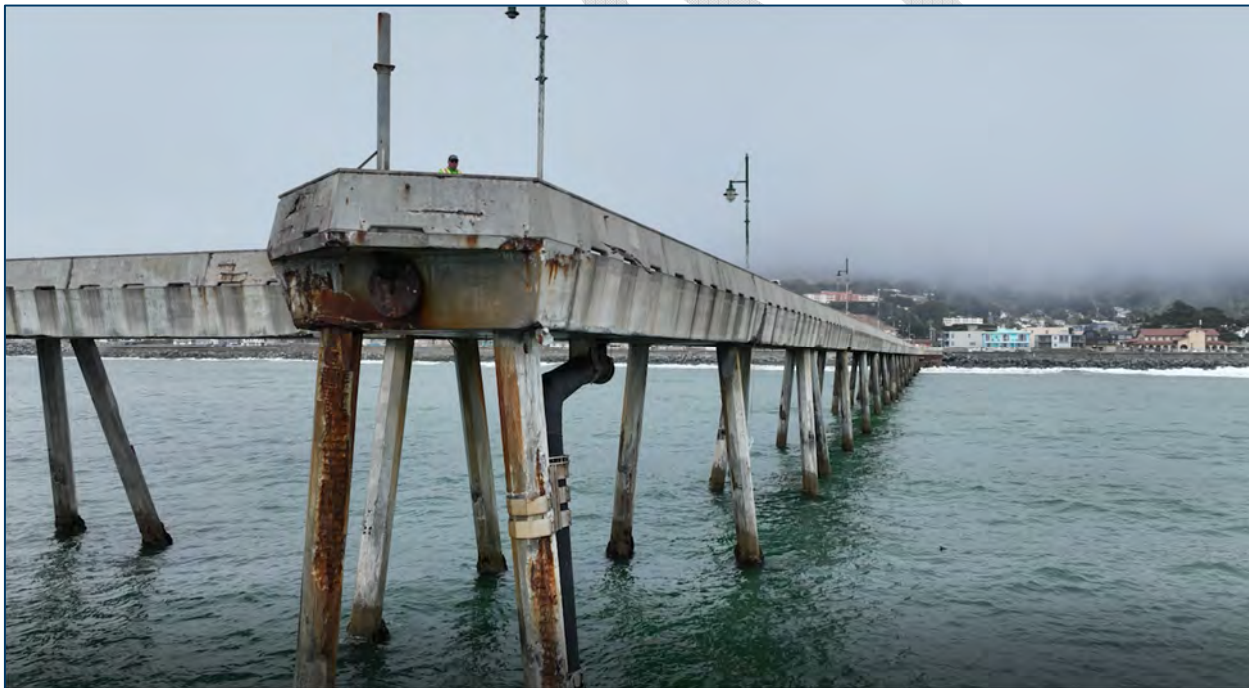
Figure A.3-76 Deck Exterior around Bent 1R – South Face

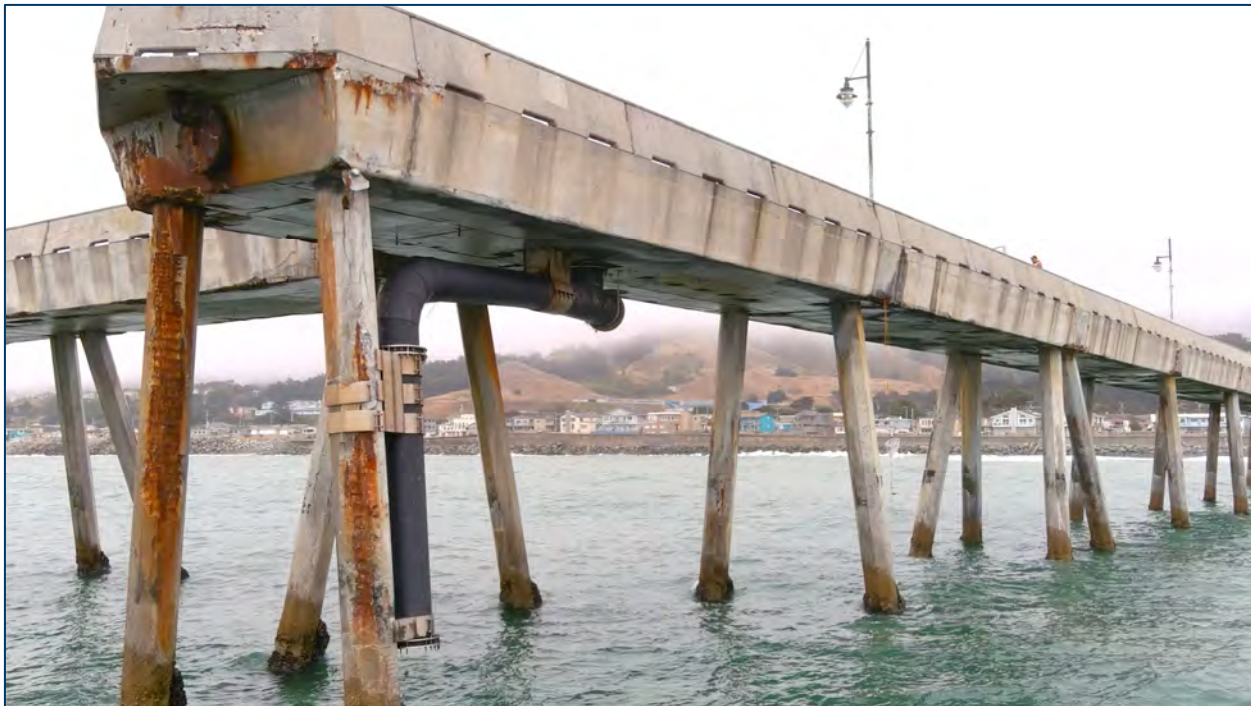
Figure A.3-77 Deck Exterior at Bent 1R – South Face

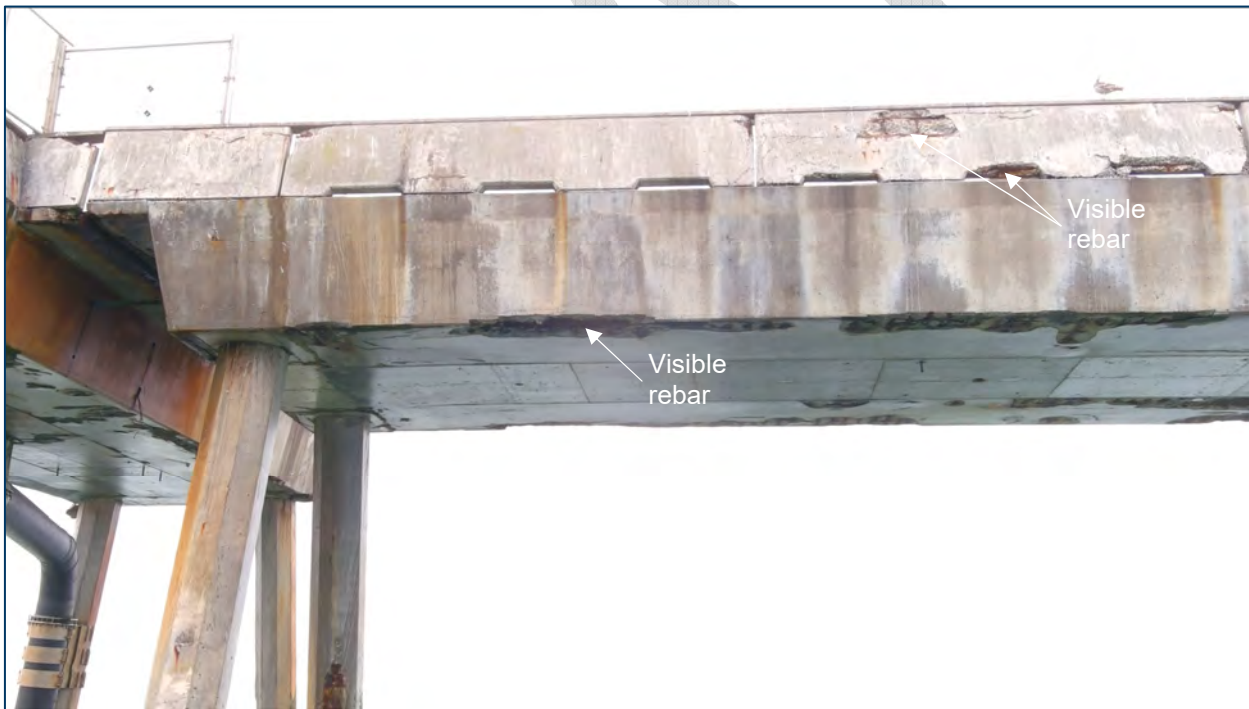
- Discoloration of concrete (black/green algae)
- Rust bleed stains around deck and handrail connection at some places, deck and bent connection
- Major to Severe corrosion and structural spalls between Bent 2 and 3 – Visible Corroded Rebar, Significant section loss around bent edges
- Moderate to Major corrosion and structural spalls around Bent 2
- Moderate to Major cracks around and under Bent 2
- Moderate to Severe cracks between Bent 2 and 3
- Rust stains and moderate cracks on piles
- Abrasion on piles
- Minor impact to Major corrosion/structural spalls on piles
- Overall rating for Deck – Severe
- Overall rating for Bent - Major
- Overall rating for Pile No – Bent 2W – Major, Bent 2E - Moderate

Figure A.3-79 Deck Exterior at & around Bent 2 - East Face

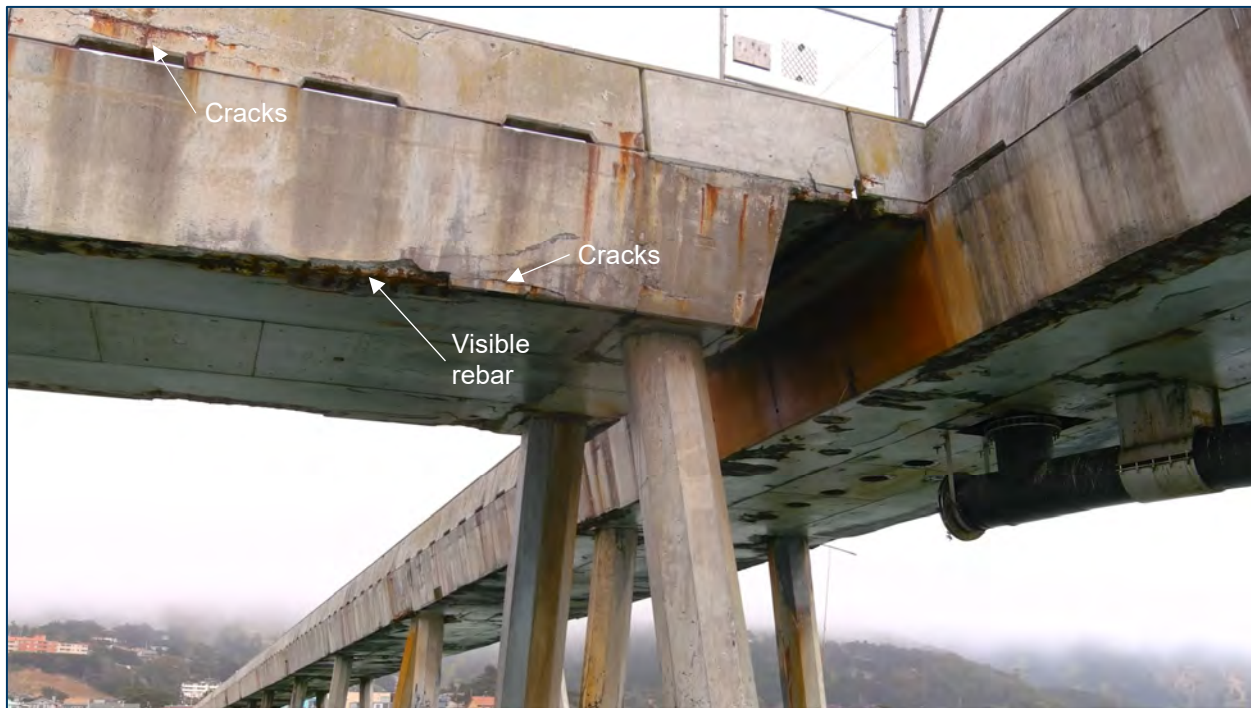
Figure A.3-80 Deck Exterior at Bent 2 and N-S Pier Extension Joint – West Face

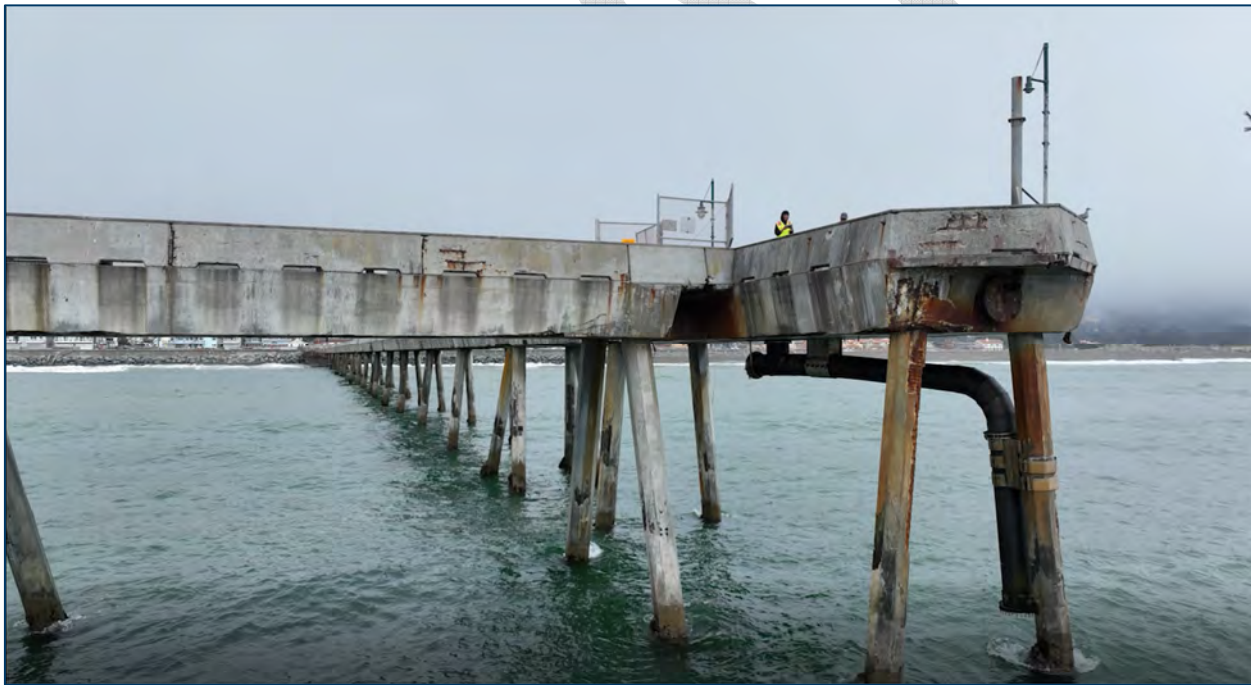
Figure A.3-81 Deck Exterior around Bent 2 and 1R – West Face

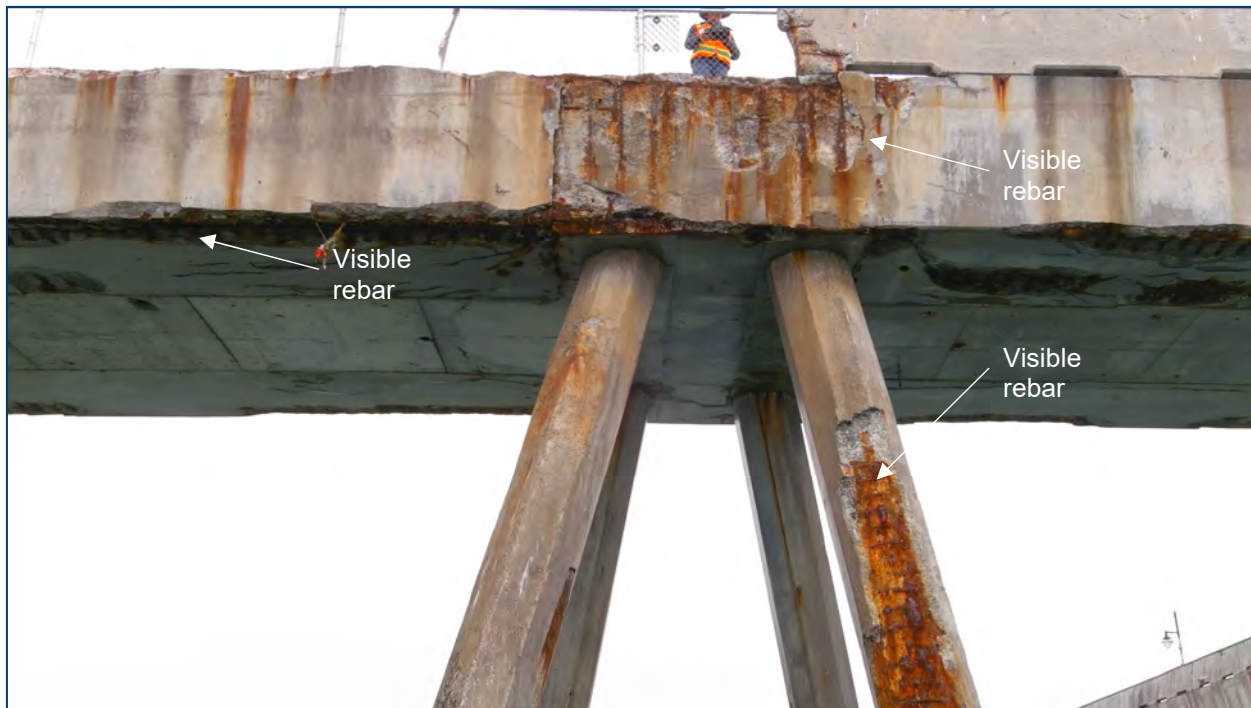
- Discoloration of concrete (black/green algae)
- Rust bleed stains around deck and handrail connection at some places, deck and bent connection
- Major to Severe corrosion and structural spalls between Bent 3 and 4 – Visible Corroded Rebar, Significant section loss around bent edges
- Major to Severe corrosion and structural spalls around Bent 3
- Moderate to Severe cracks around and under Bent 3
- Moderate to Severe cracks between Bent 3 and 4
- Rust stains and moderate cracks on piles
- Abrasion on piles
- Minor impact to Severe corrosion/structural spalls on piles – Visible corroded rebar in some piles
- Overall rating for Deck – Severe
- Overall rating for Bent - Severe
- Overall rating for Pile No – Bent 3NE - Moderate, Bent 3NW – Major, Bent 3SE - Severe, Bent 3SW - Severe

Figure A.3-83 Deck Exterior at Bent 3 – West Face

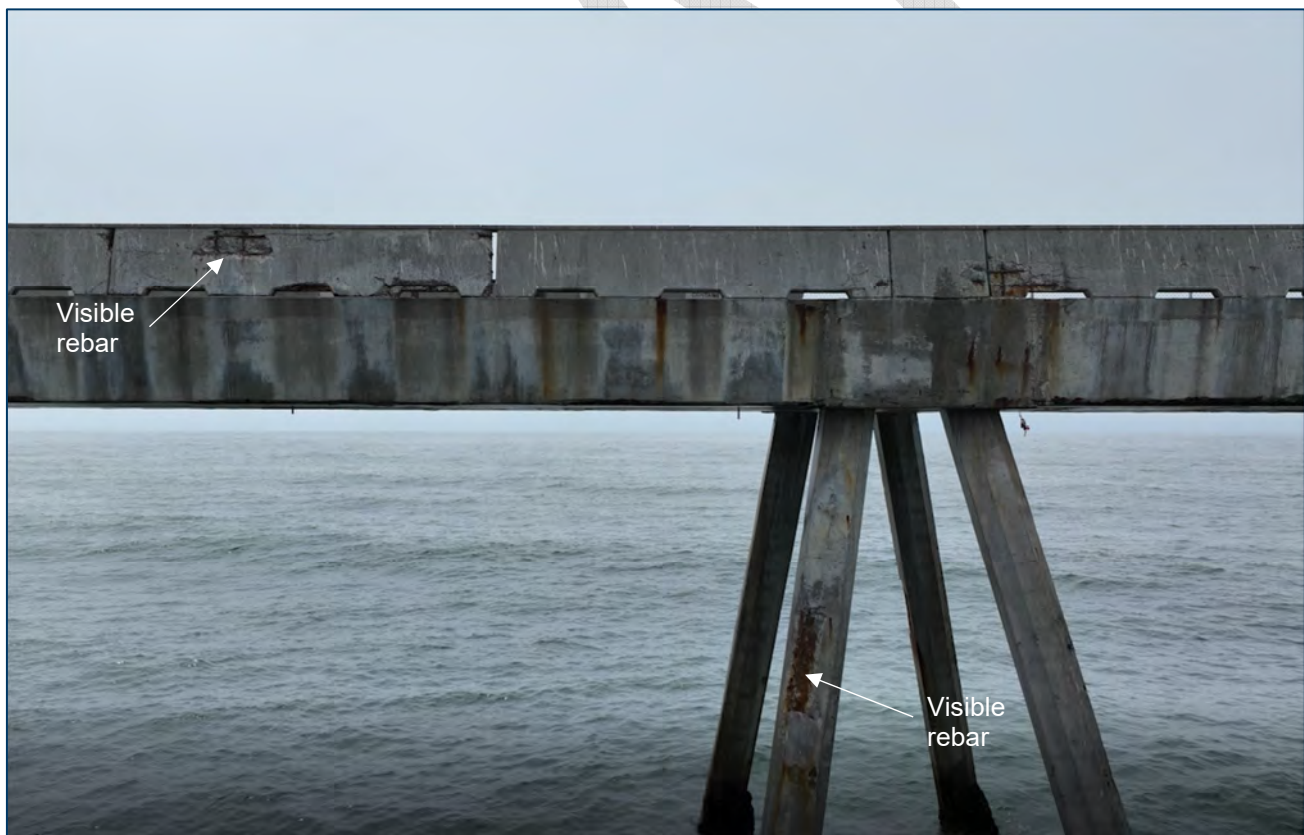
Figure A.3-84 Deck Exterior around Bent 3 – East Face

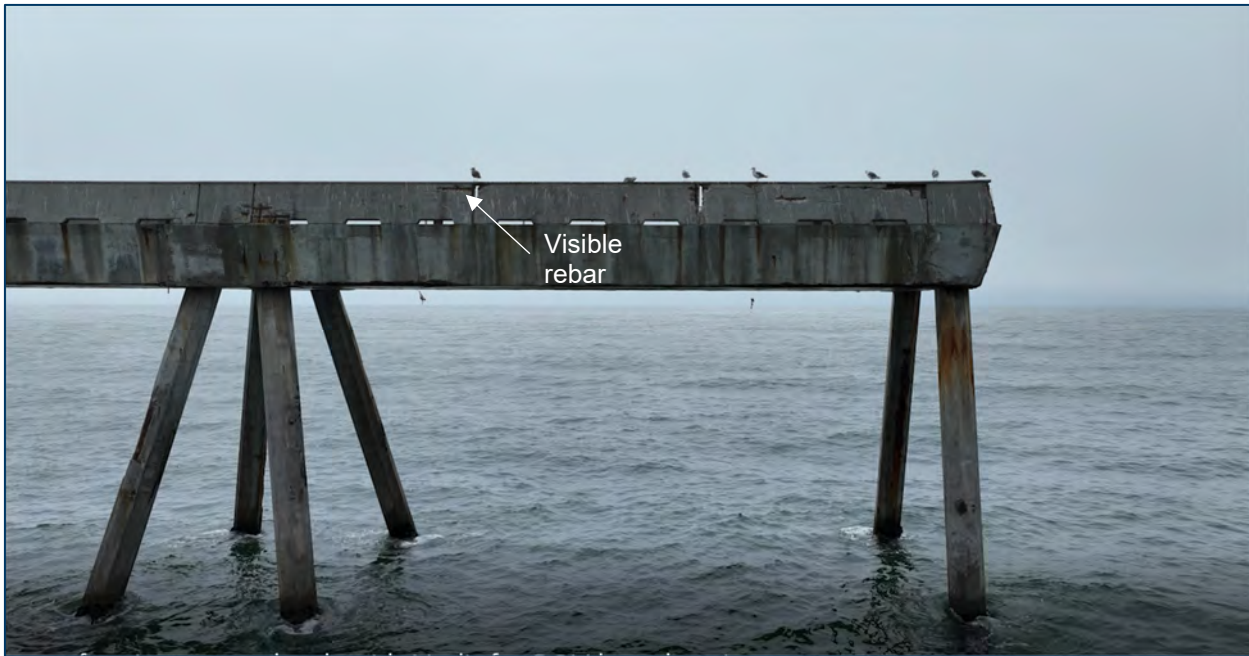
Figure A.3-85 Deck Exterior around Bent 3 and 4 - East Face

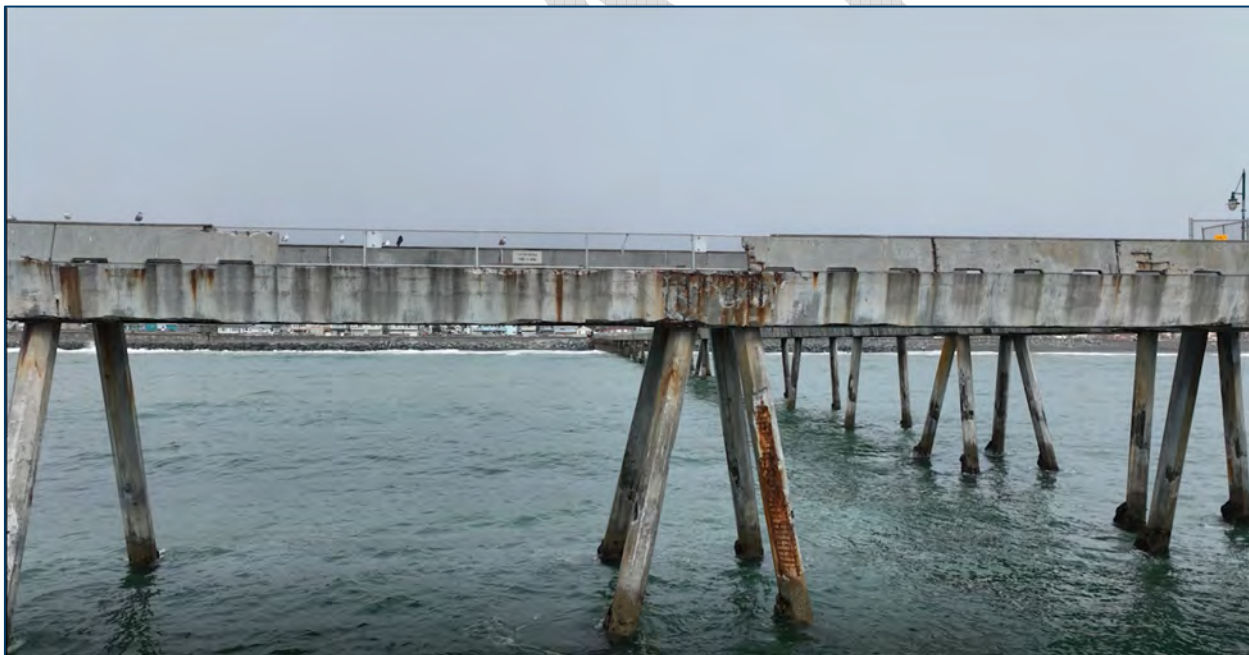
Figure A.3-86 Deck Exterior around Bent 4 and 3 - West Face

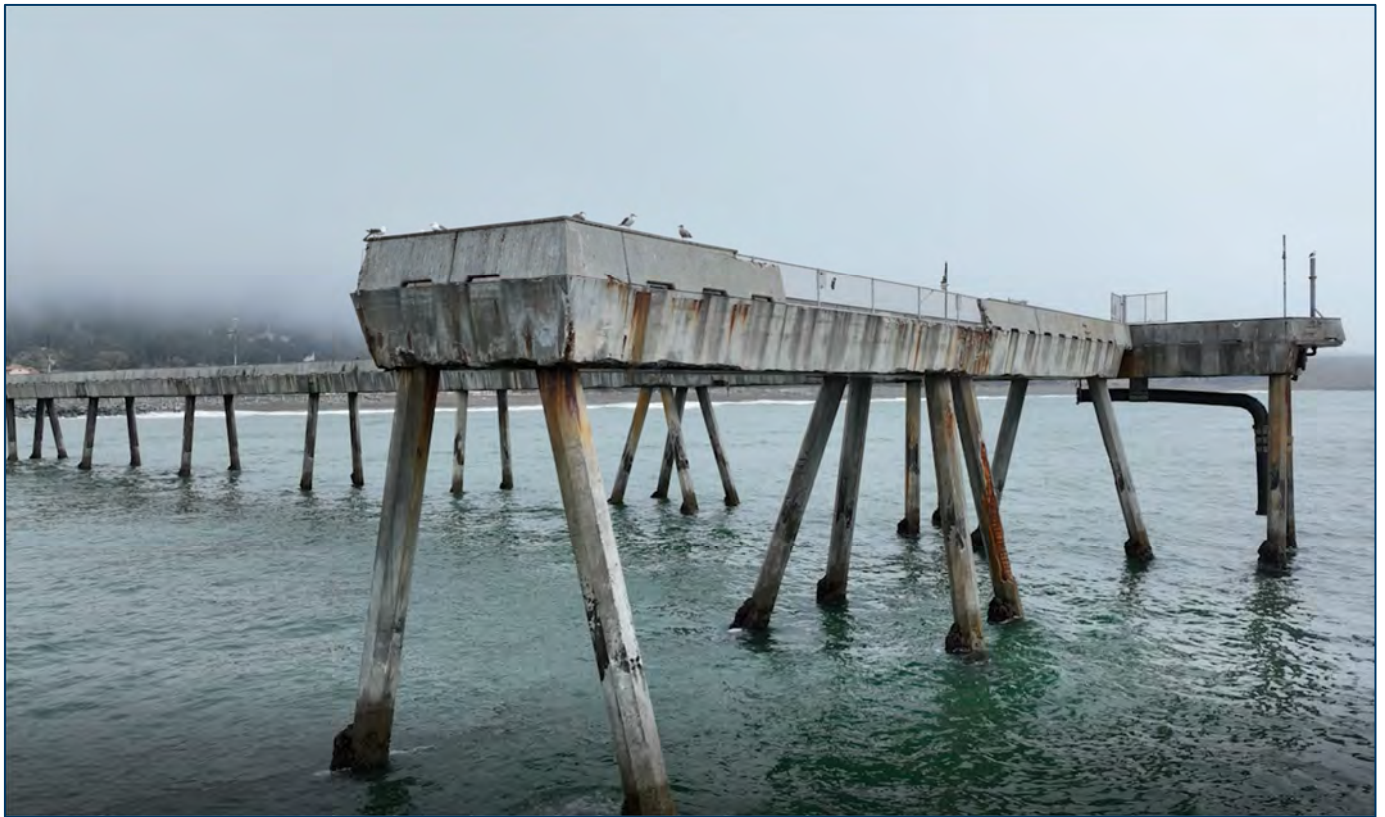
- Discoloration of concrete (black/green algae)
- Rust bleed stains around deck and handrail connection at some places, deck and bent connection
- Major to Severe corrosion and structural spalls between Bent 3 and 4 – Visible Corroded Rebar, Significant section loss around bent edges

- Major to Severe corrosion and structural spalls around Bent 3 – Visible Corroded Rebar, Broken rebar around bent edge, Significant section loss in between piles and around pile-deck connection (Visible corroded spiral reinforcement)

- Moderate to Severe cracks around and under Bent 4
- Moderate to Severe cracks between Bent 3 and 4
- Rust stains and moderate to major cracks on piles
- Abrasion on piles

- Minor impact to Severe corrosion/structural spalls on piles – Visible corroded rebar in some piles
- Overall rating for Deck – Severe
- Overall rating for Bent - Severe

- Overall rating for Pile No – Bent 4E – Moderate, Bent 4W - Severe

Figure A.3-88 Deck Exterior around Bent 4 – West Face

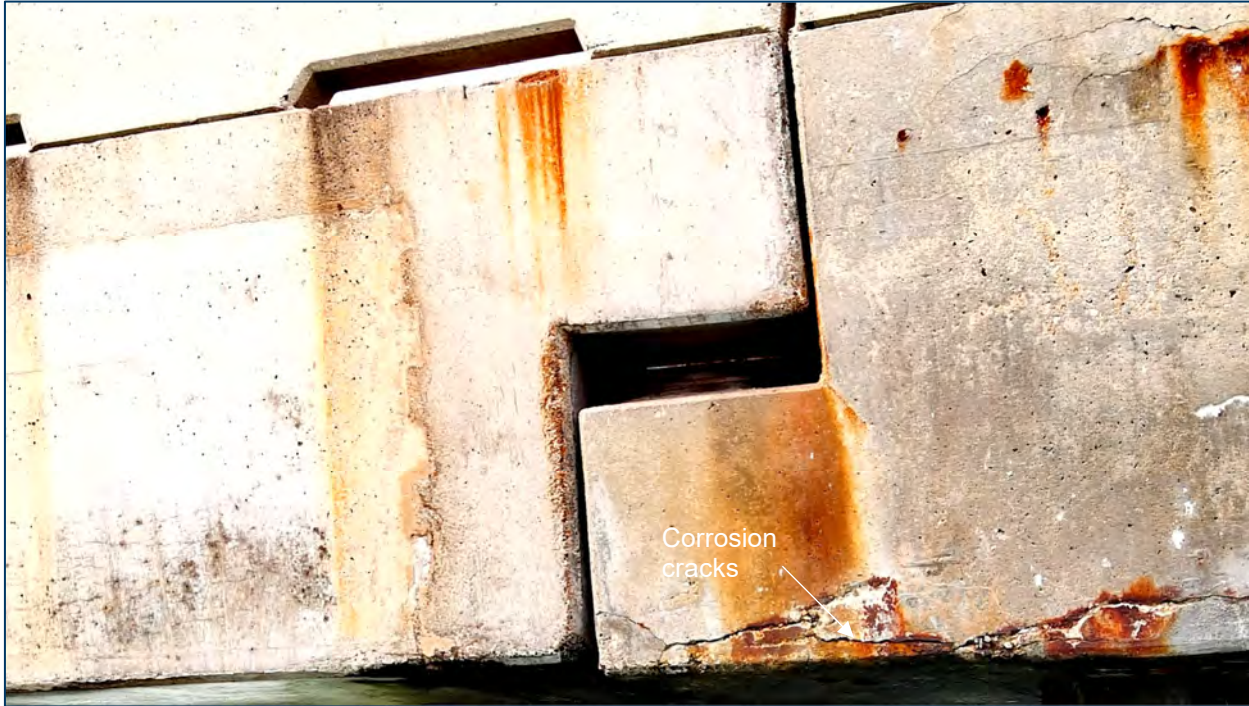
Figure A.3-90 *Bearing Plate at Deck and Bent Connection*

- Rust bleed stains around deck and bent connection with bearing plates can be probably due to corroded bearing plates

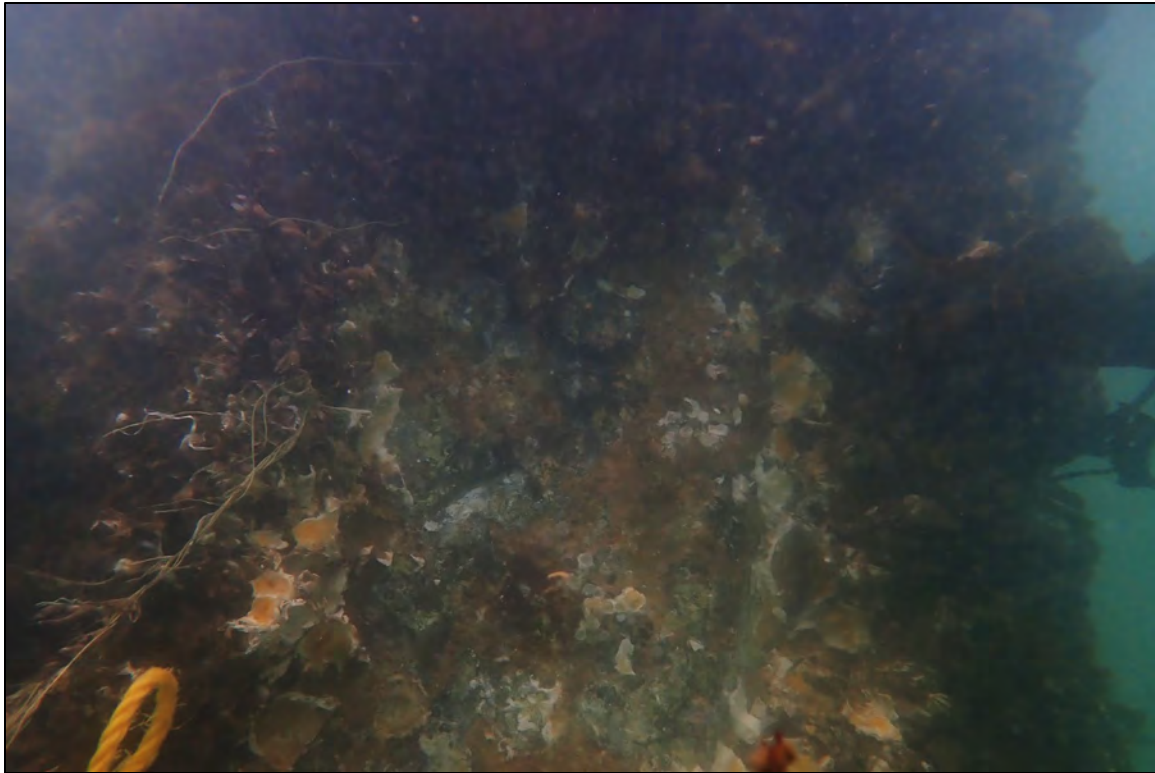
PHOTOGRAPH 9: Pile K-SW Level II tidal zone

The underwater portions of the inspected Pacifica Municipal Pier prestressed concrete piles are in **Good** condition, with no damage observed. However, it should be noted that the overall condition of the piles is downgraded when considering damage above MHW and outside of the underwater inspection. Numerous open spalls with exposed reinforcement, closed spalls, cracks, and evidence of corrosion exist above MHW (out of scope). Two piles have above-water cracks that extend to the top of the marine growth; however, underwater, no evidence of the crack could be found. One of these cracks is located on Pile K-SW, where a Level II

underwater inspection cleaning was done. No evidence of the crack was found on the cleaned portion of the pile below water.

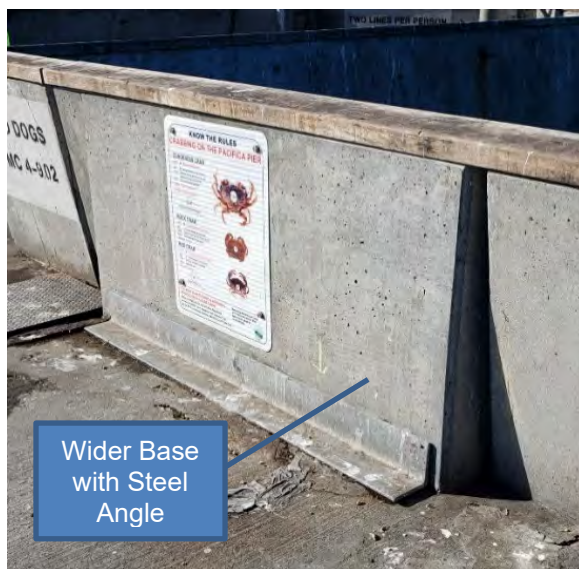
Figure 10: Repaired Handrail Panel

One panel has been previously repaired. The exterior surface follows the profile of other panels, but the inside face is vertical, creating a wider base for stability. A galvanized steel angle section has been installed at the inside face, with anchors embedded into the panel and presumably into the deck to provide an improved connection.

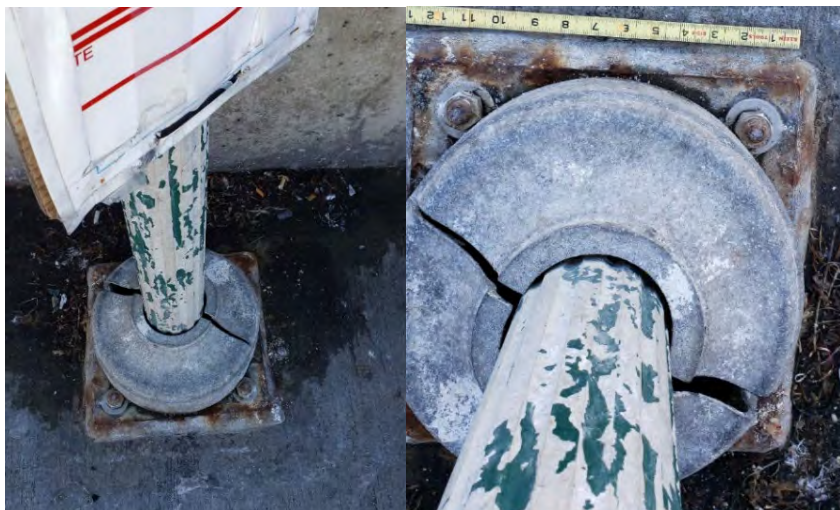
Figure 9: Typical Light Post Foundation

The light posts on the pier are connected to the pier deck using 4 bolts and steel base plate. The base plate and anchor bolts show signs of corrosion. The nuts seem to be stainless steel material, showed some discoloration but didn't show significant corrosion. There was no visible damage to the connections or grout pad around the base plate indicating movement of the light post due to a weakened connection.
